MINUTES
of the
YANKEE DRYER SAFETY SUBCOMMITTEE
OCTOBER 27, 2003
8:30 AM CST

HYATT REGENCY CHICAGO
CHICAGO, ILLINOIS, USA

Yankee Cracking Incident

Yankee Dryer Shell Crack

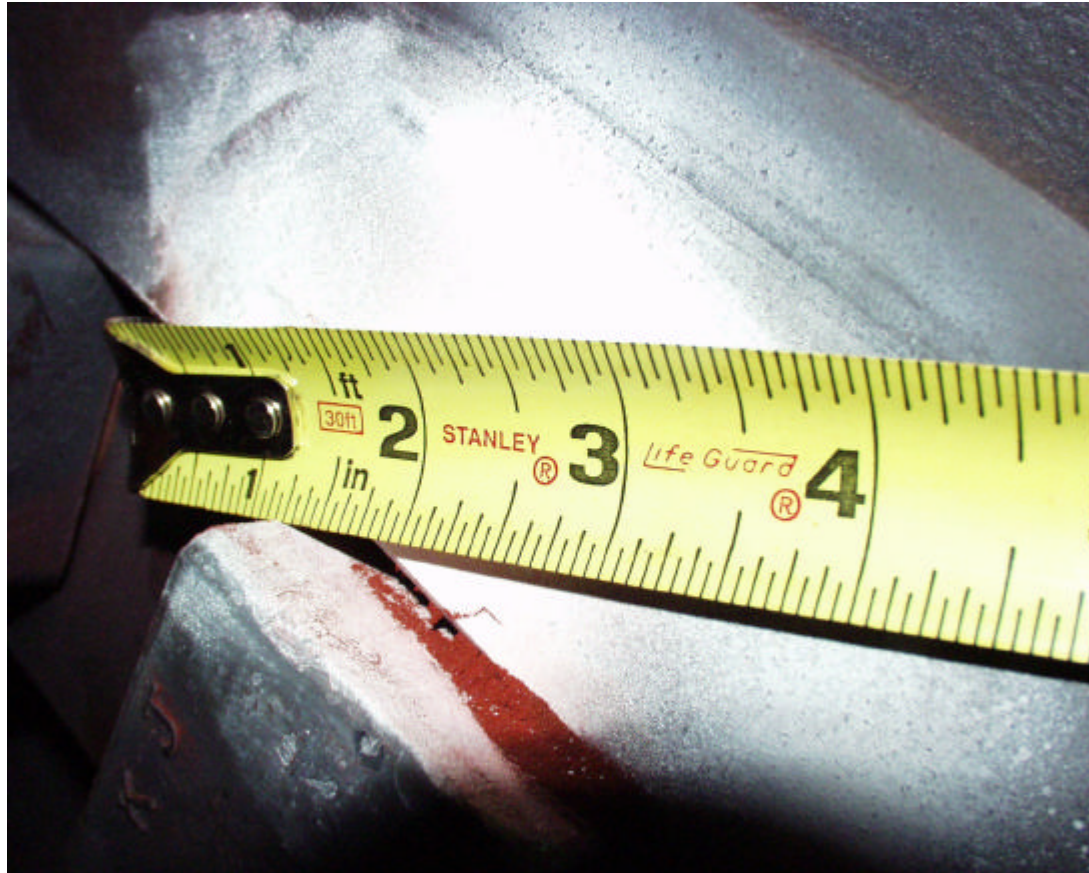
The first indication was 1/4" long and in the corner of the internal nut stop flange for the center stay on the front head. The indication was blended out by grinding and proved less than 1/8" deep. This is an area of the head that carries very little stress. The flaw was considered trivial.

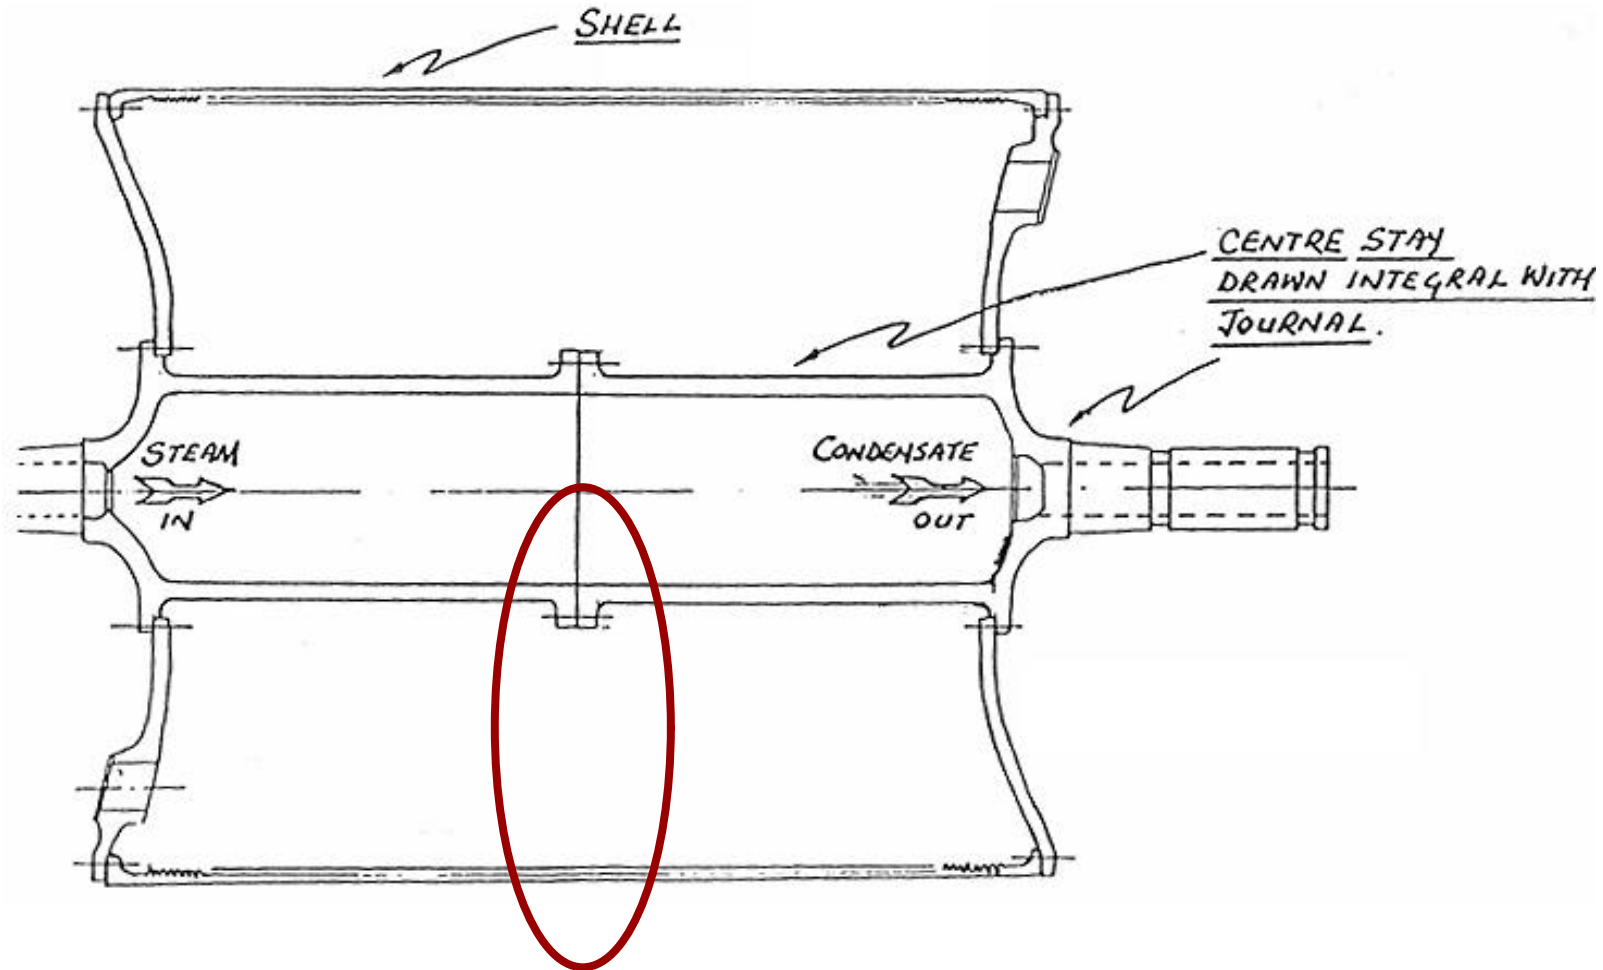
The second indication was in the central flange of the front half center stay.

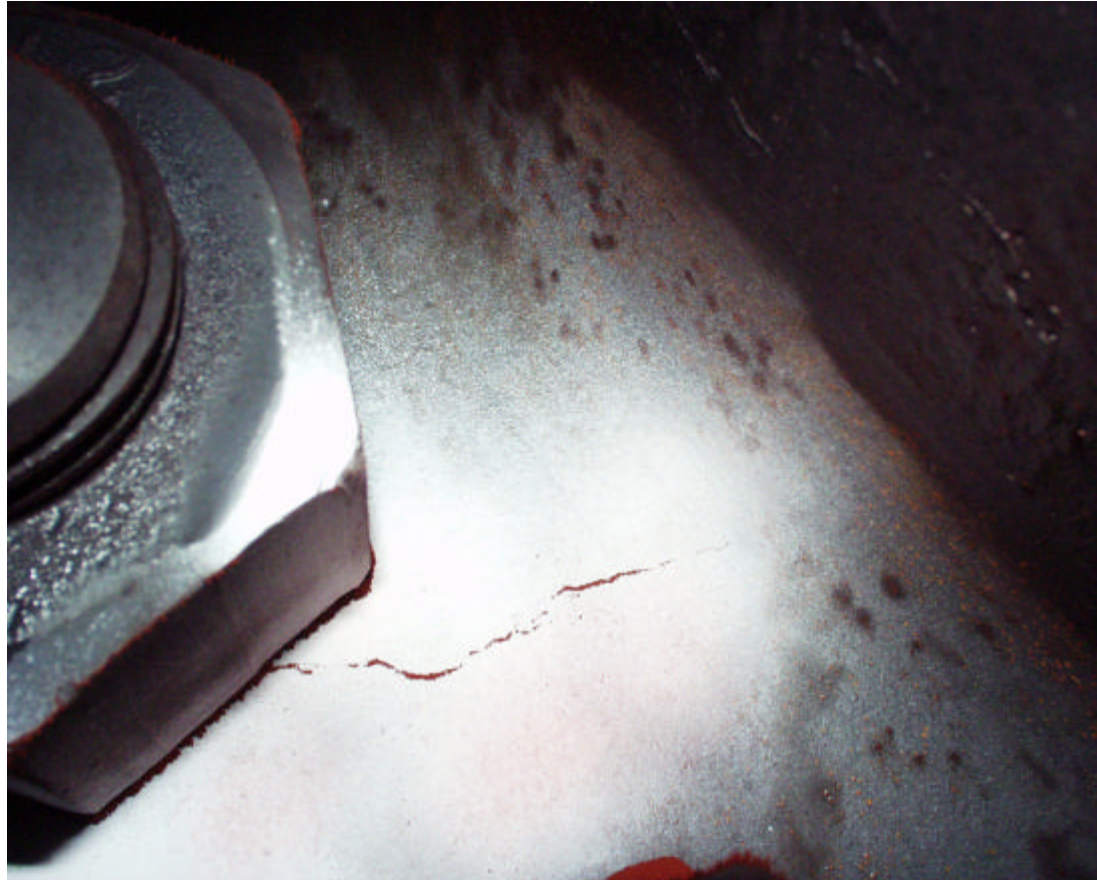
Based on its orientation, the second indication did not appear to be stress related. The end of the indication was marked and the MG Cylinder put back into service until another down day would allow further analysis.

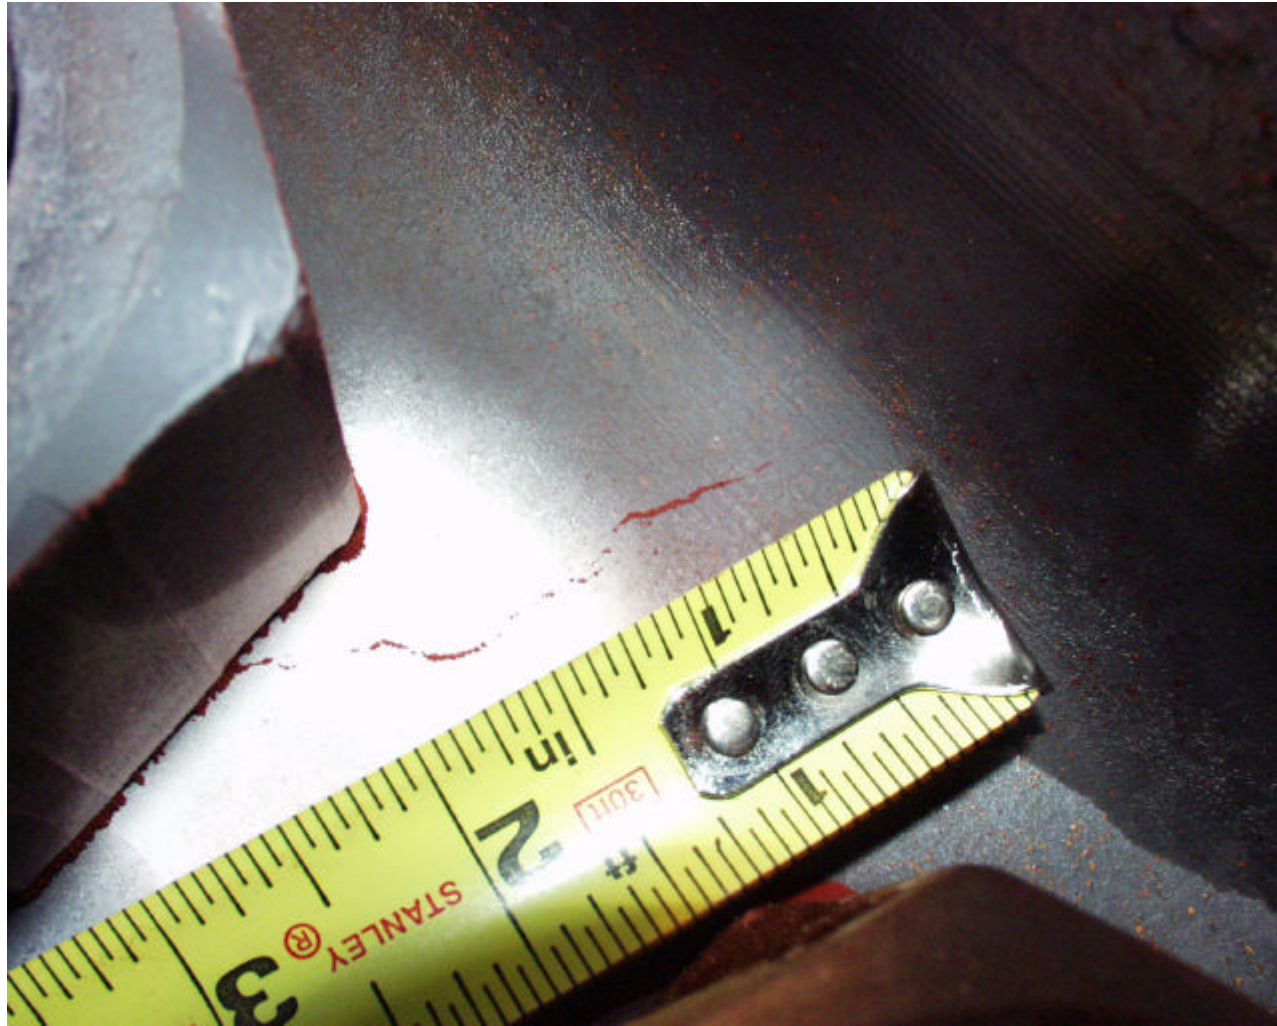
The second indication was 3" long and extended from near a bolt hole towards the flange to shaft radius of the center stay.

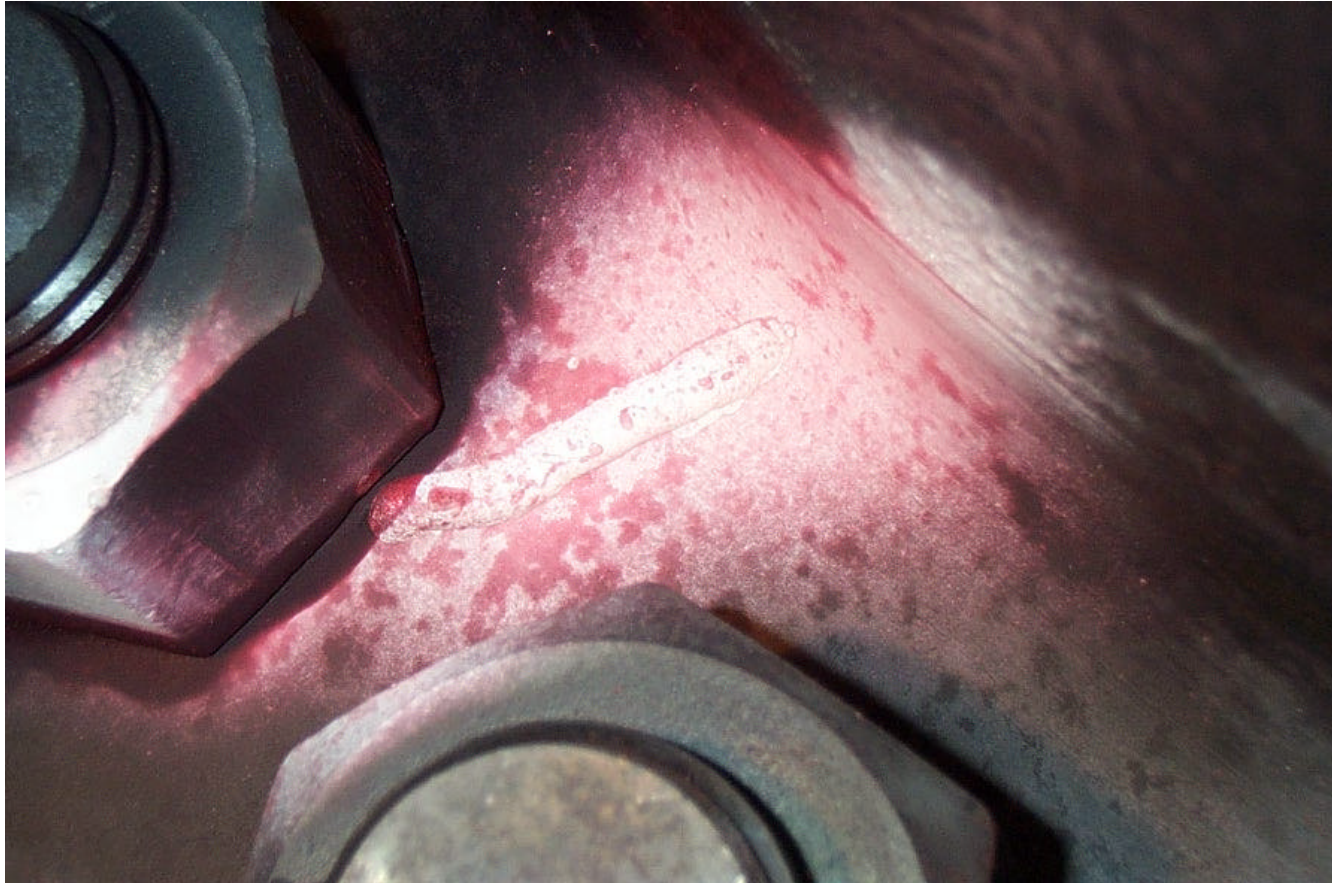
Initial testing on August 27th was done with dye penetrant (PT) rather WFMT. The indication was extremely tight and could not be revealed with PT but showed up when WFMT was used.

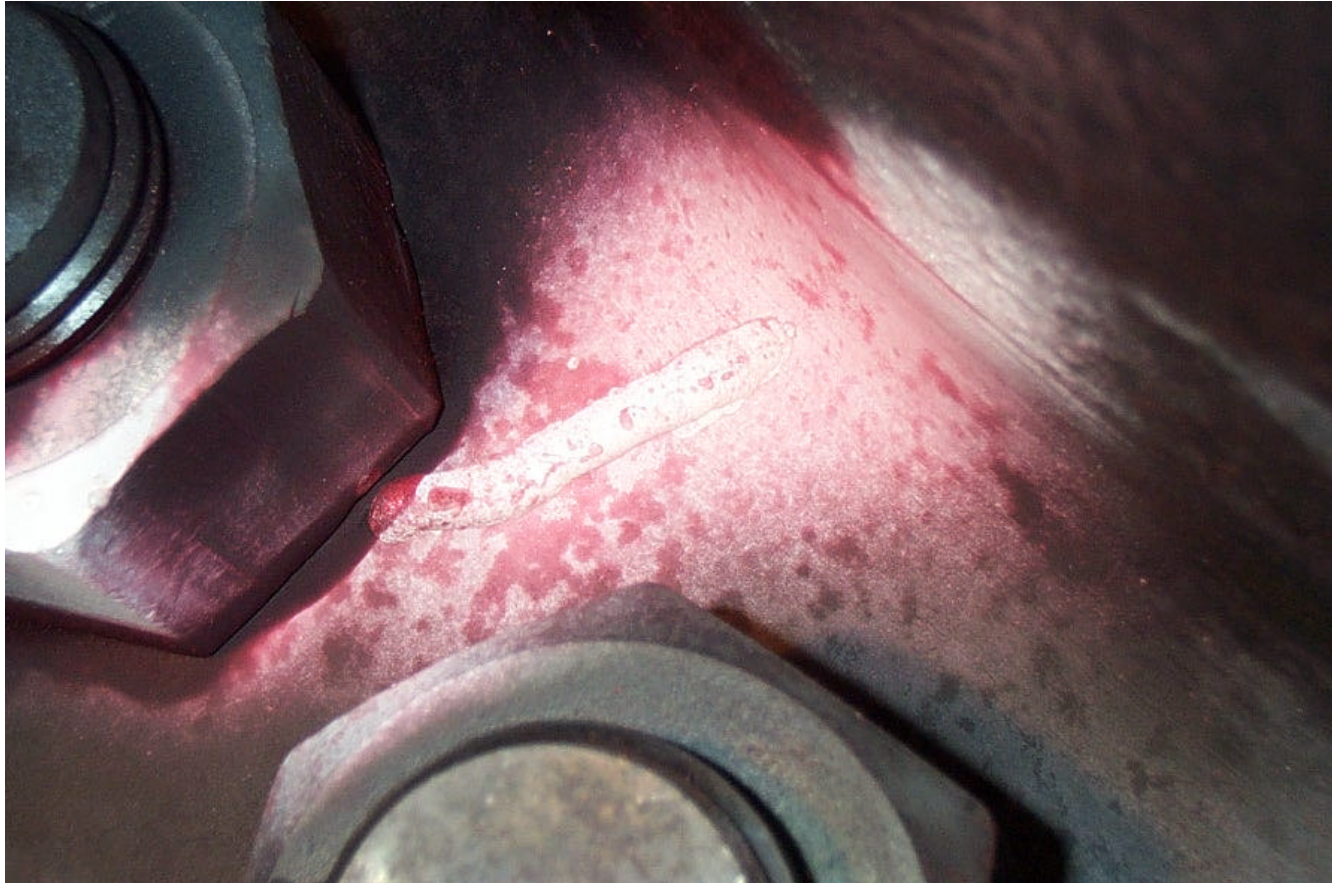
A light grind to $\frac{3}{16}$ th of an inch was made.
The indication showed tails and side indications with WFMT.
Now PT did reveal some of the indication.

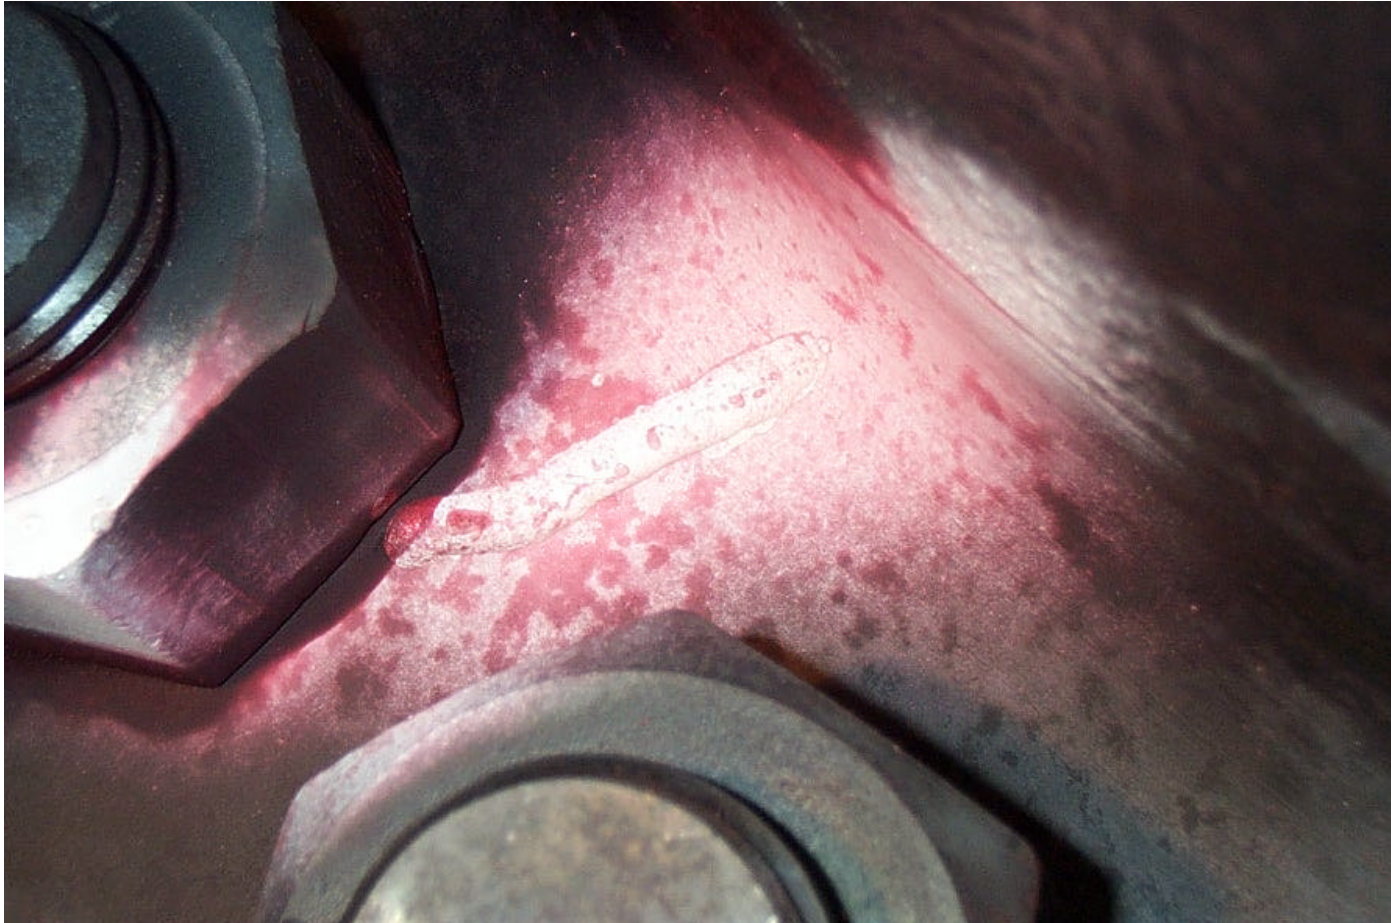
On August 28th the bolt was removed from the hole.
WFMT disclosed the flaw did not involve the hole.

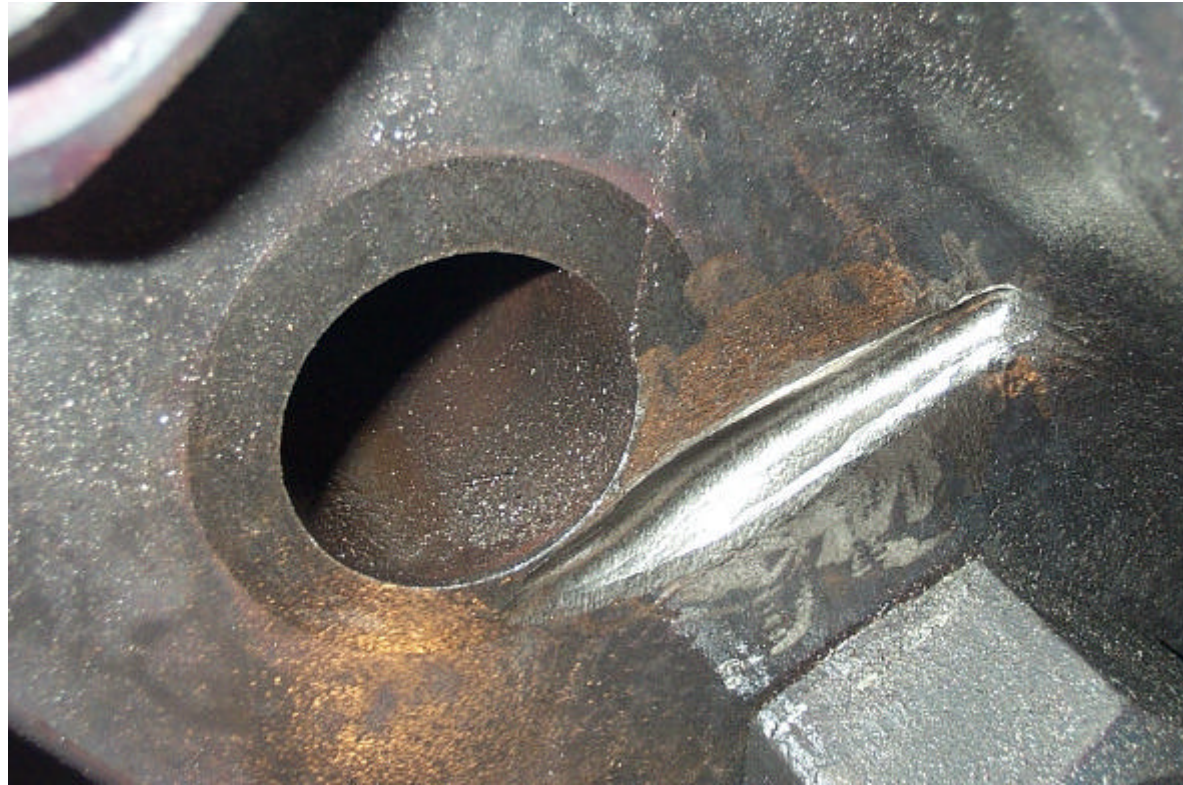
The second indication was removed by grinding. It was removed and proven gone with WFMT at a depth of only 3/8". This left a 3" long by 3/8" deep, smoothly blended excavation in the 5" thick flange. The excavation will be examined with WFMT during the next outage to make sure that the indication does not reappear.

While grinding out the second indication, the grinder encountered pockets of "inclusions". These foundry inclusions were probably the origin of the flaw.

The orientation of the flaw suggests that it is not a service related crack.

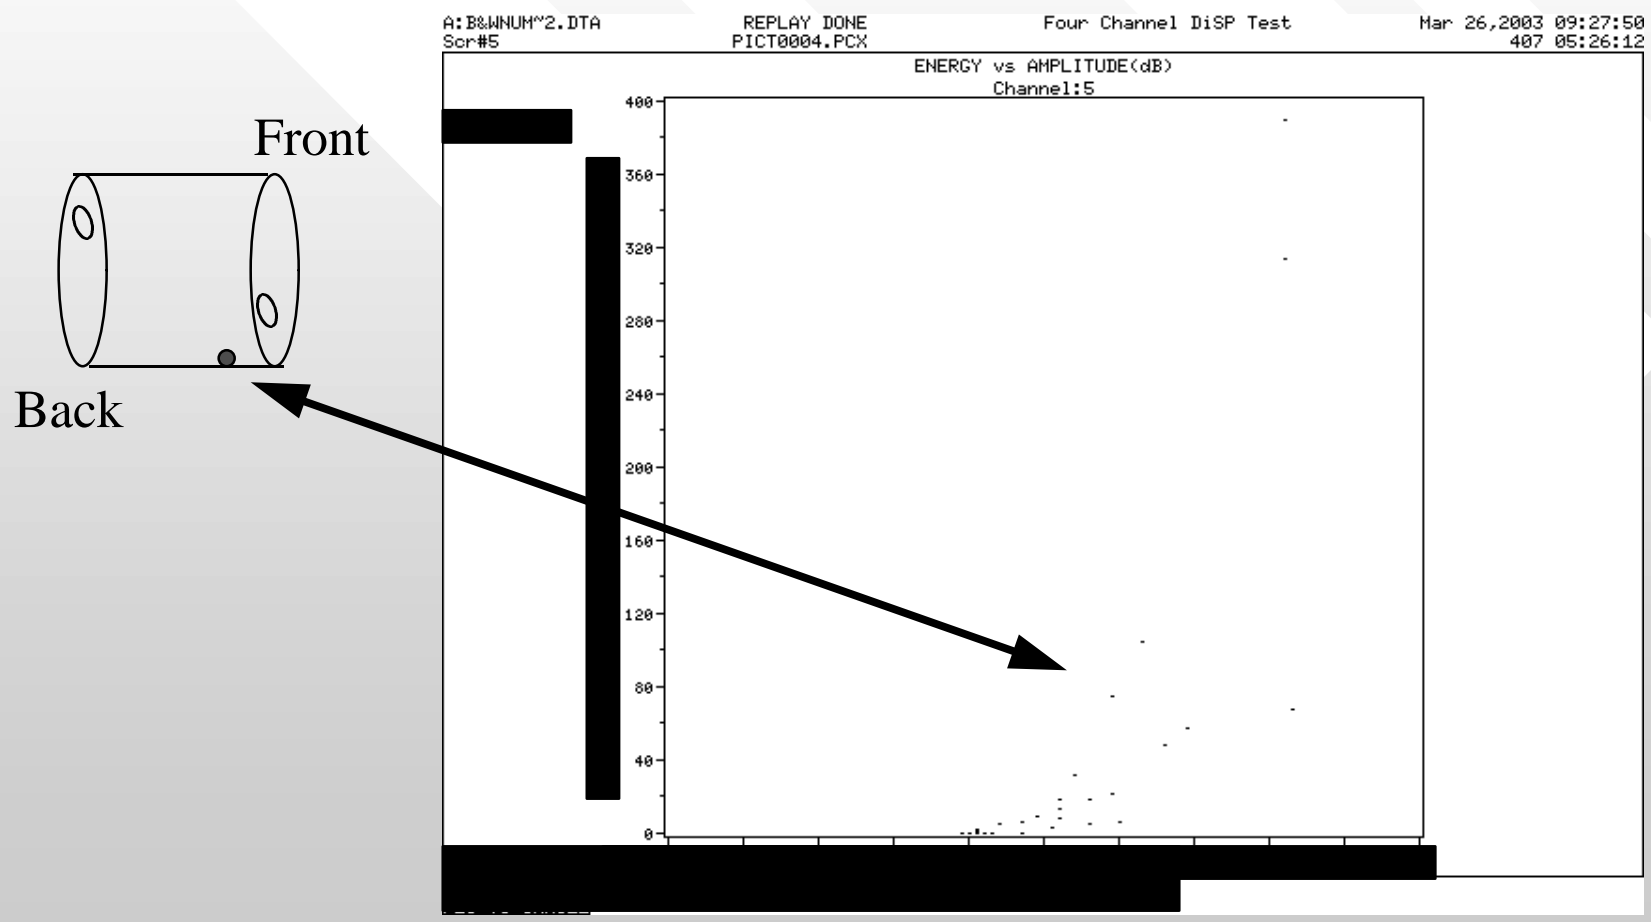
Dryer B: 3 Cracks, 1/8" long x 1/32" deep Header bracket attachment hole on ID rib (30 min)

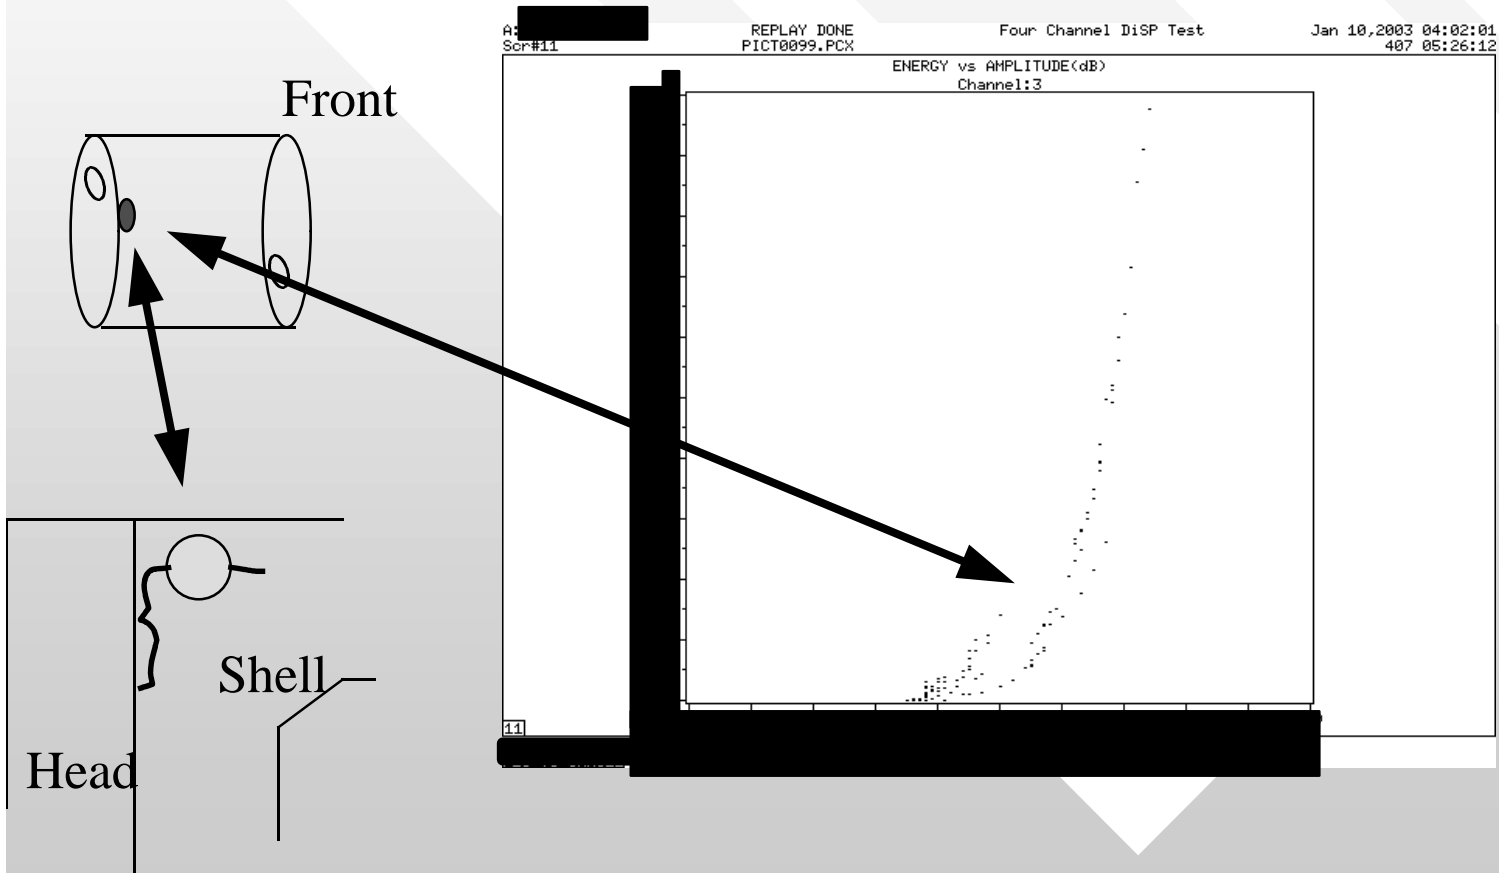
Dryer C: 2 cracks, length $\sim 1''$ $\sim 3/4''$ on one side & $\sim 1/4''$ either of shell plug (30 min)

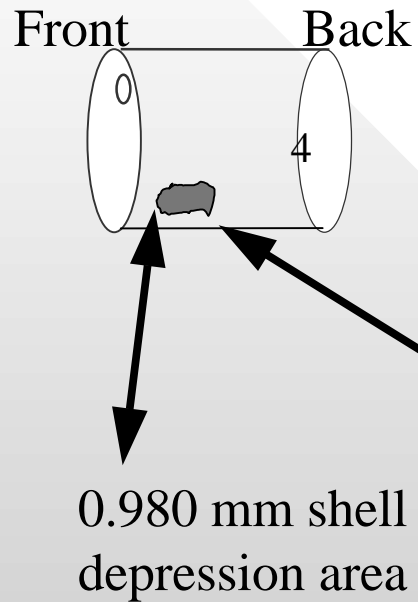
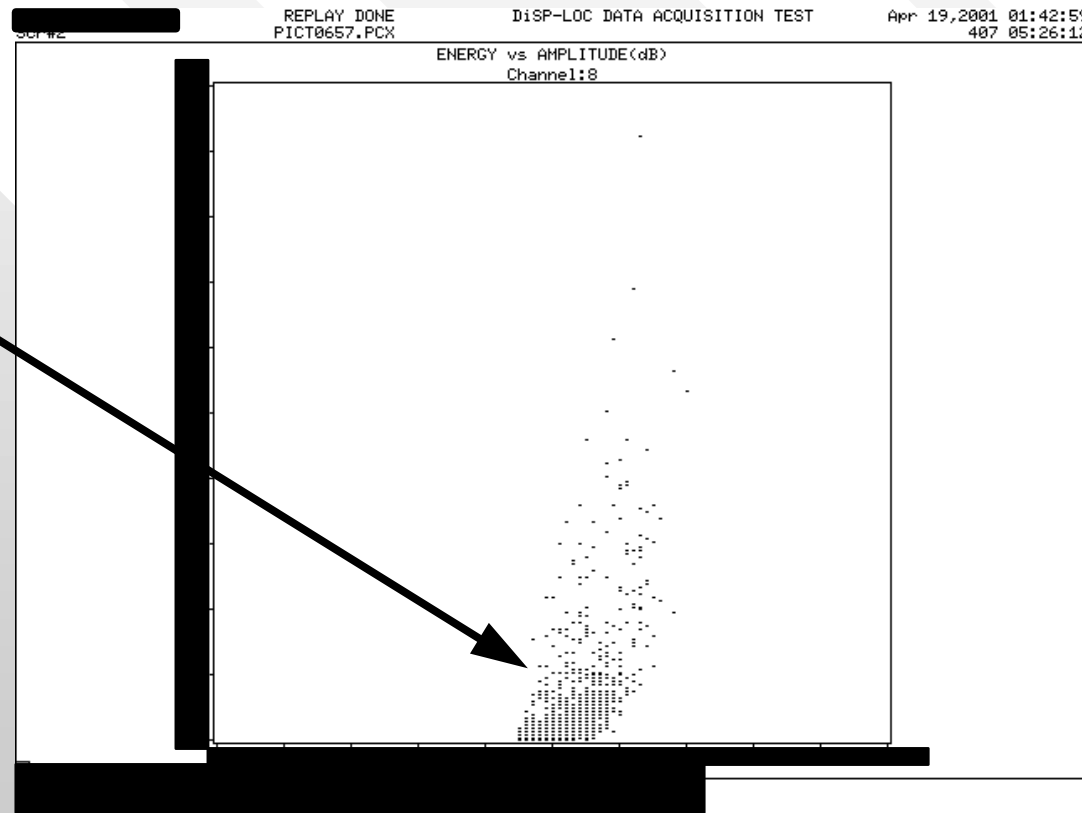
Dryer D: O.D. Shell Crazing Impact Damage AE data to 0.8 bar (< 20 minutes)

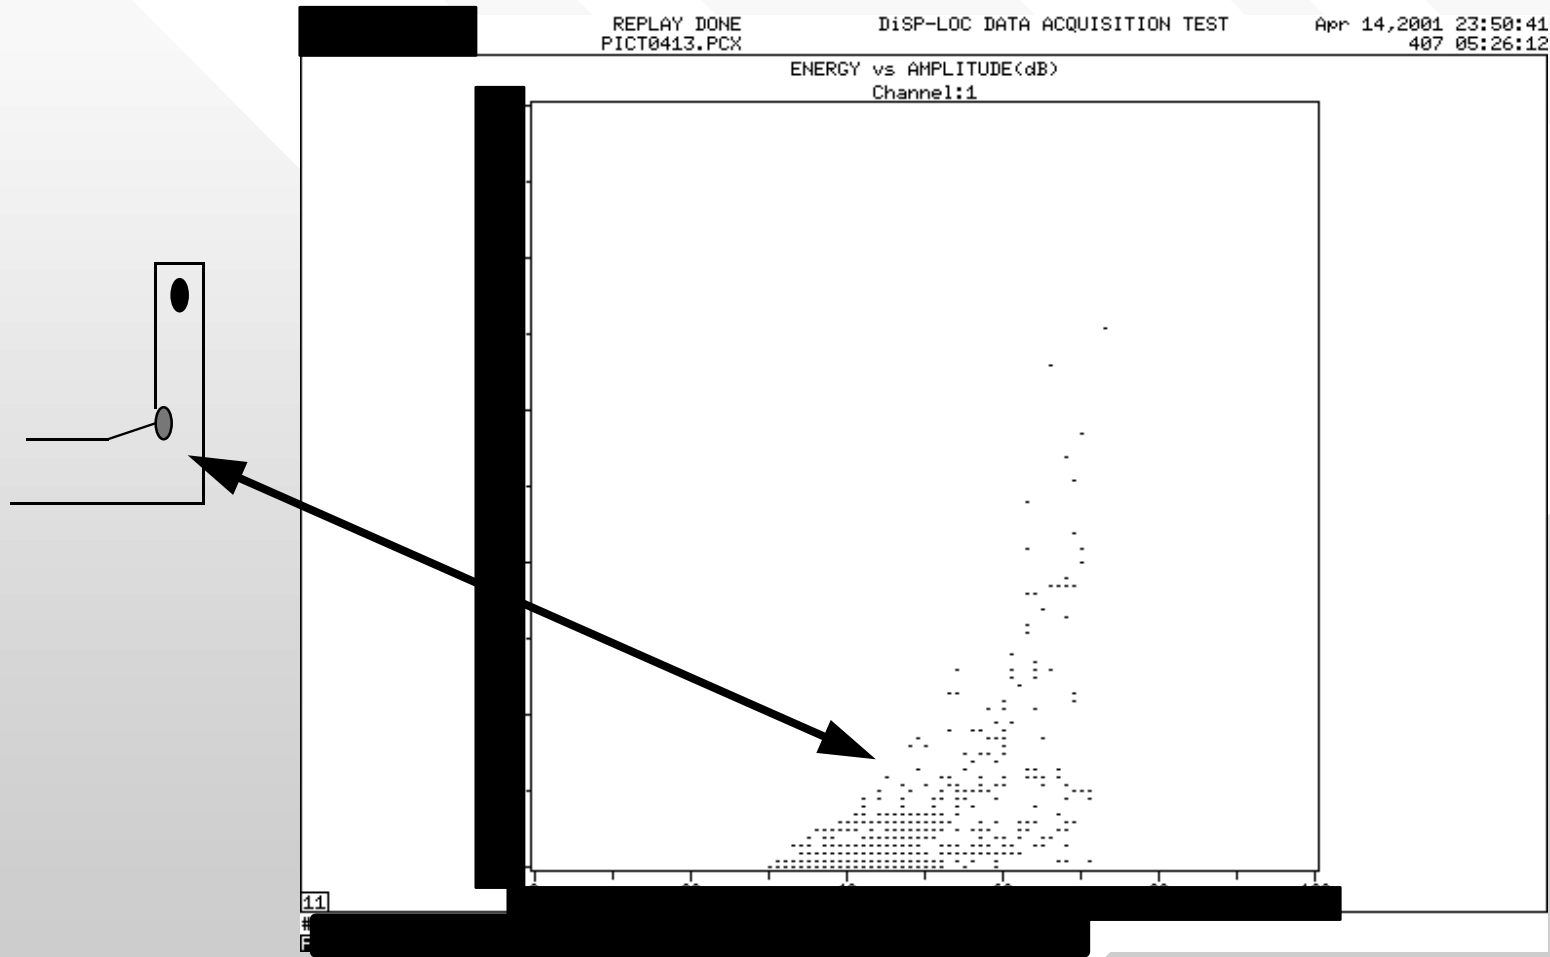
~4" Swing Arm Crack

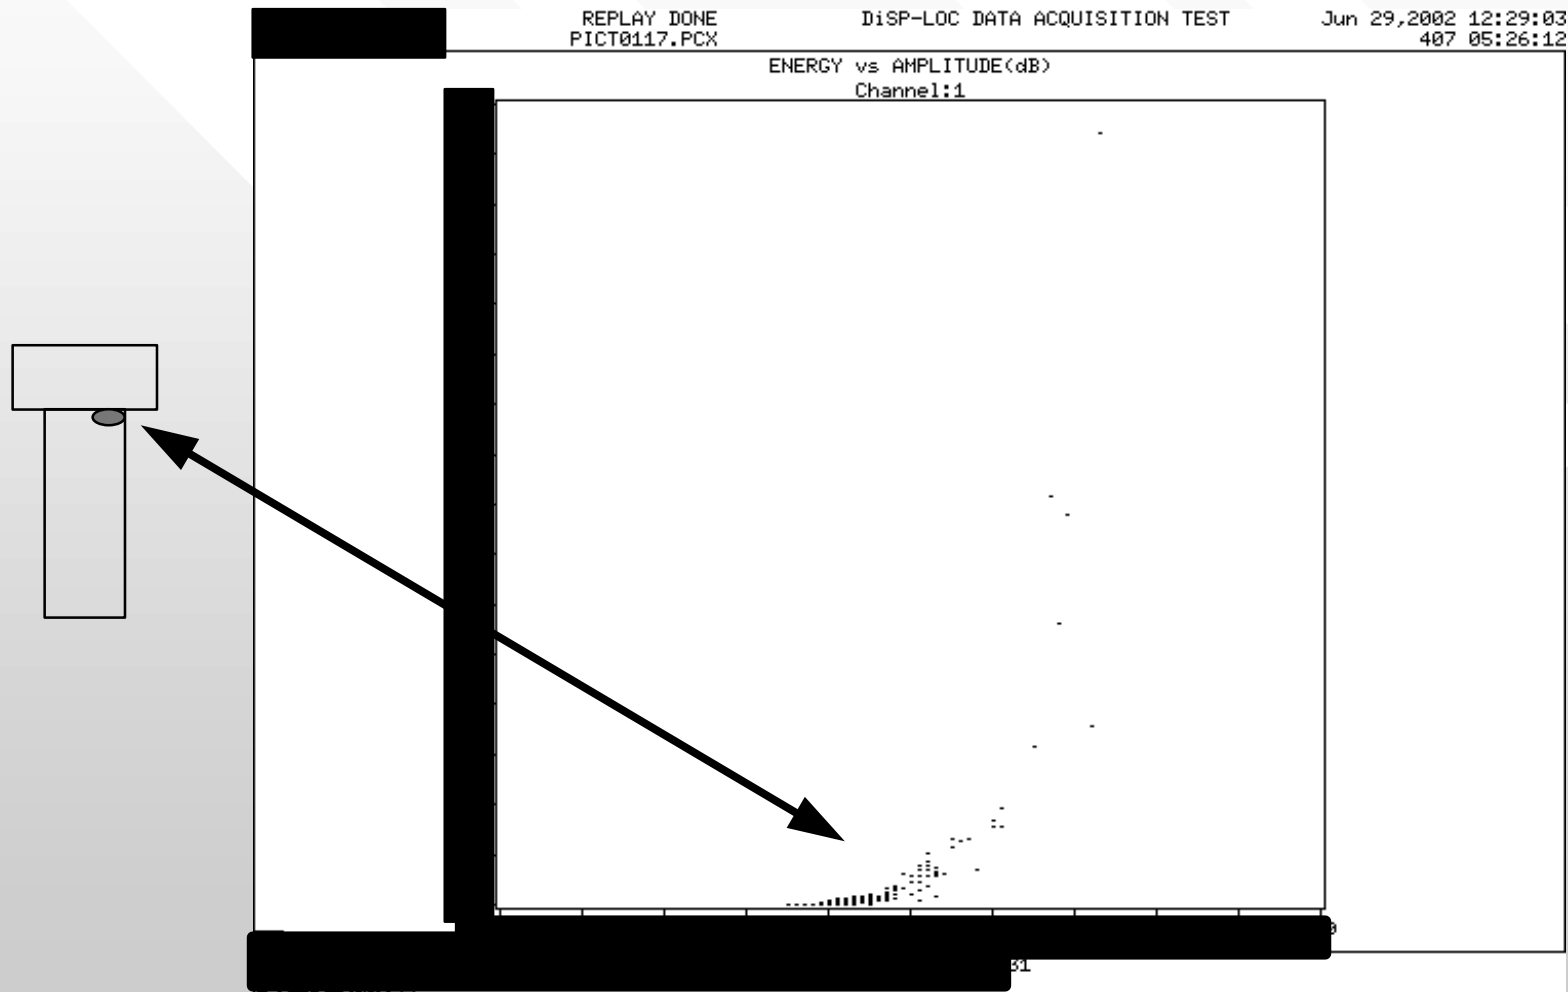
Cracked Head Bolt

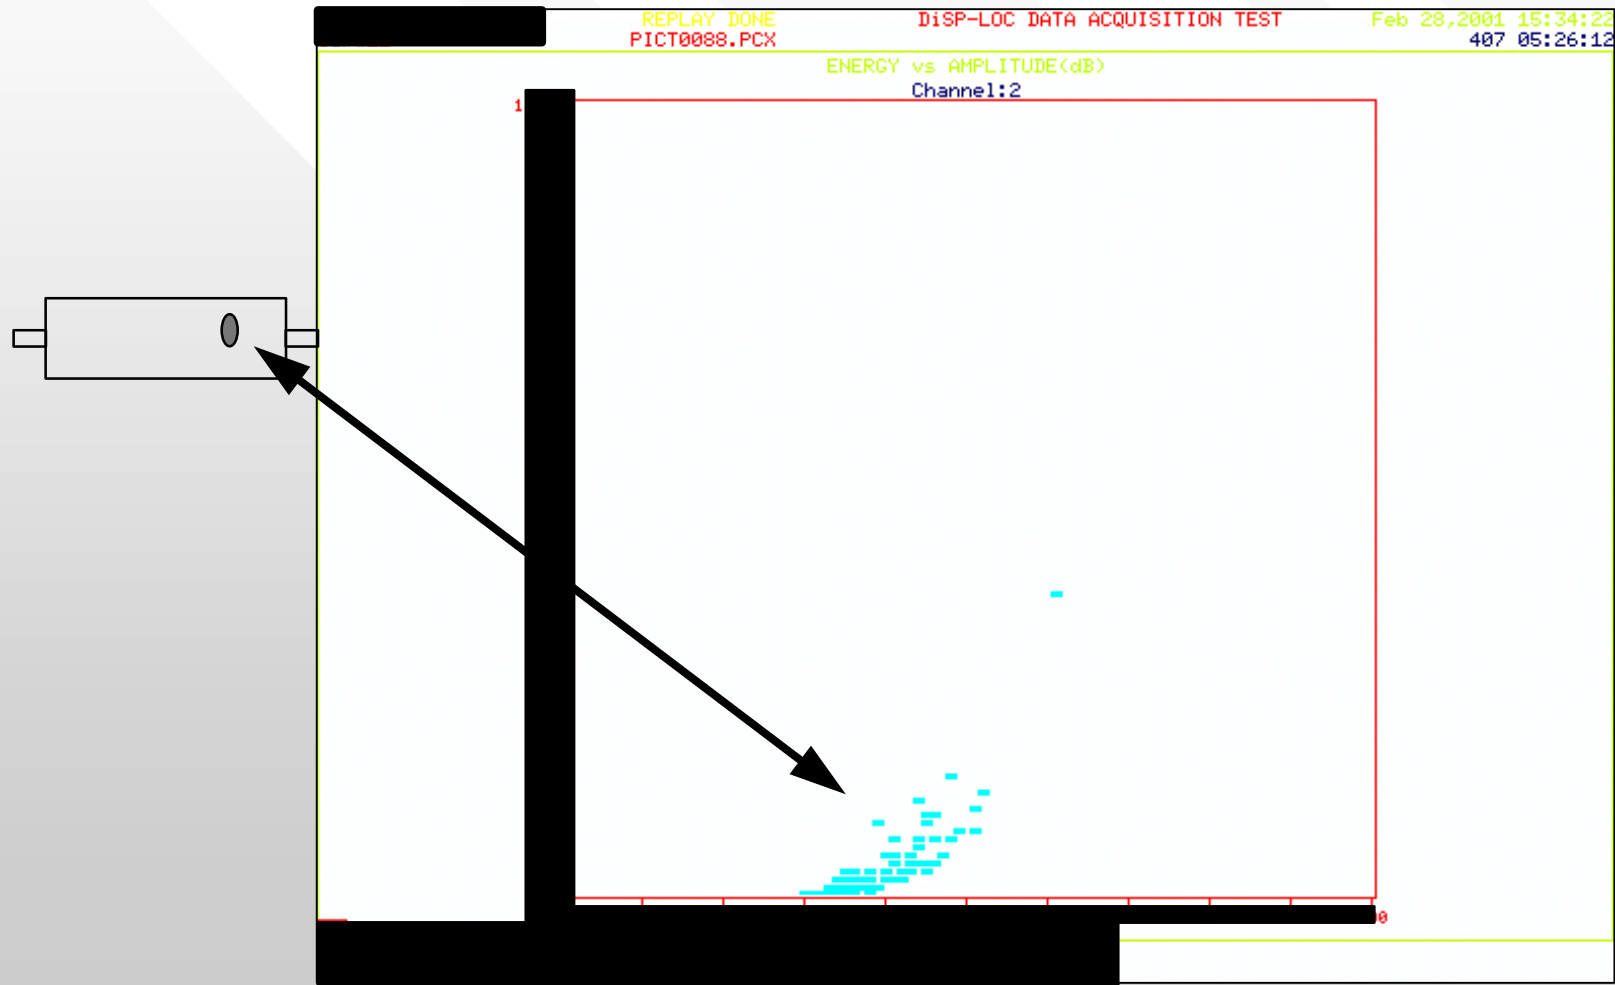
Suction Roll: small cracks initially undetected with other NDE methods

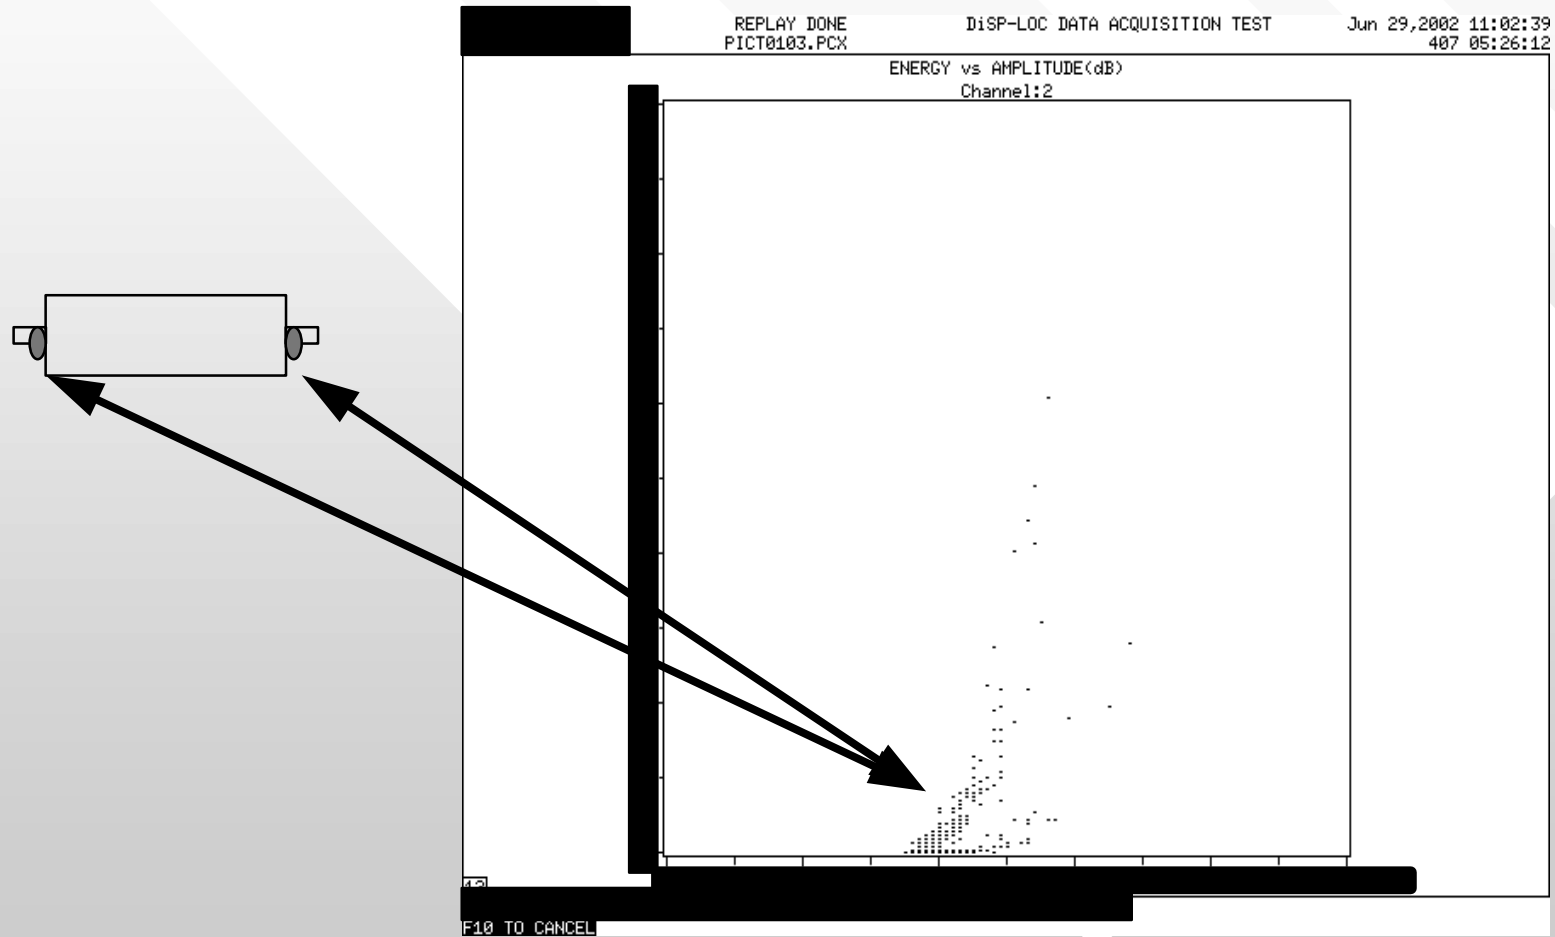
Felt Roll: Journal Cracks
