# COMBATting LIME KILN RINGING PROBLEMS AT THE ARAUCO CONSTITUCIÓN MILL

## **Eduardo Keim**

Celulosa Arauco y Constitucion SA  
Constitución, Chile

### **ABSTRACT**

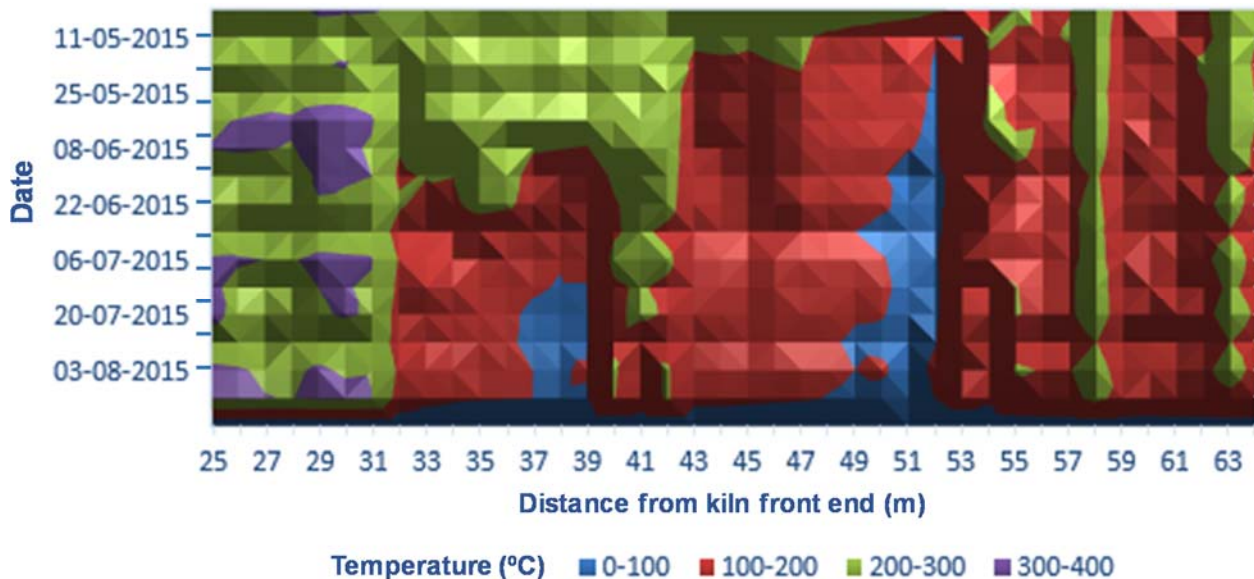
**Figure 1.** Change in kiln shell temperature profiles during a ringing incident in 2015.

As rings built up, they insulated the kiln shell from the hot flue gas, causing the shell temperature to drop. As a result, the color of the square area changed progressively from purple to green, to red, and then to blue as rings grew thicker with time. For this ringing incident, for example, the shell temperature at 32 – 40 m from the kiln front end decreased from 200 – 300°C (green) on May 11 to 100 – 200°C (red) on June 22. In a small region, the shell temperature decreased further to below 100°C (blue) and remained low in this temperature range until the kiln was shutdown for ring removal in August.

The change in kiln shell temperature profiles suggests that rings were formed initially at two locations (blue and red squares) between May and August 2015. They spread out and connected after 3 months of operation, forming a long, massive ring at about 30 – 60 m from the discharge end. This 30 m long ring had a thickness varying widely with location, from a few centimetres to almost 1.2 m.

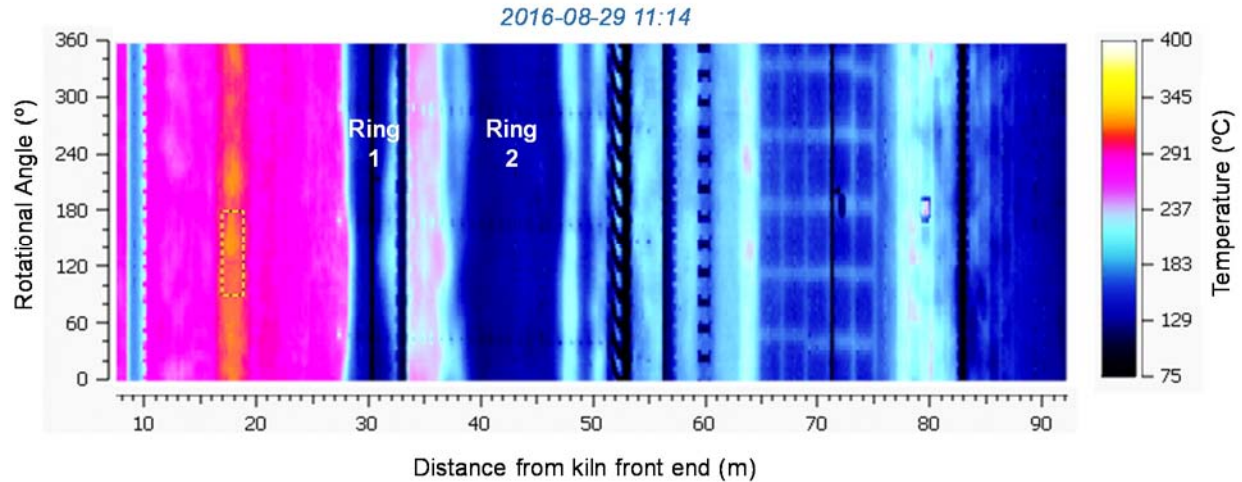
At a constant burner flame (or flue gas) temperature inside the kiln, the shell temperature at a given location would decrease if there is a ring built up at that location. The infrared camera would consequently register a “cold” (lower shell surface temperature) area on the shell. **Figure 4** shows a thermal image of the kiln shell taken on August 29, 2016 at 11:14 AM, about 2 months after the kiln was in operation. Comparing this image to that shown in Figure 2 (when the kiln was clean) suggests that there were two separate rings formed on the kiln wall: one was at 28 to 33 m and the other at 38 to 47 m from the discharge end.

**Figure 4.** Infrared image of kiln shell temperature on August 29, 2016 at 11:14 AM.

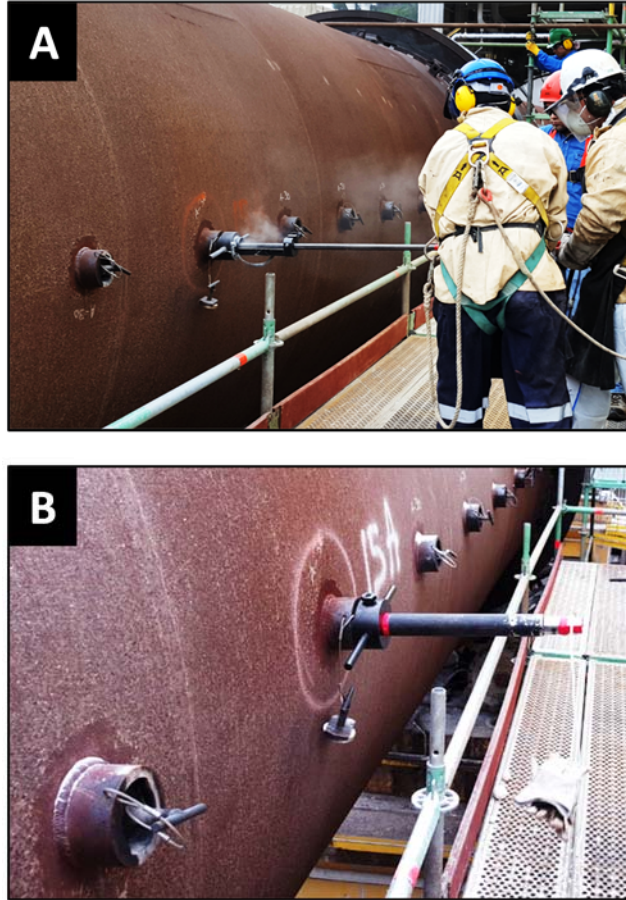
**Figure 5.** *A) a ring cleaning crew drilling a hole through a socket into the refractory brick and ring buildup, and B) a liquid CO<sub>2</sub> cartridge securely placed in the socket and ready to be detonated.*

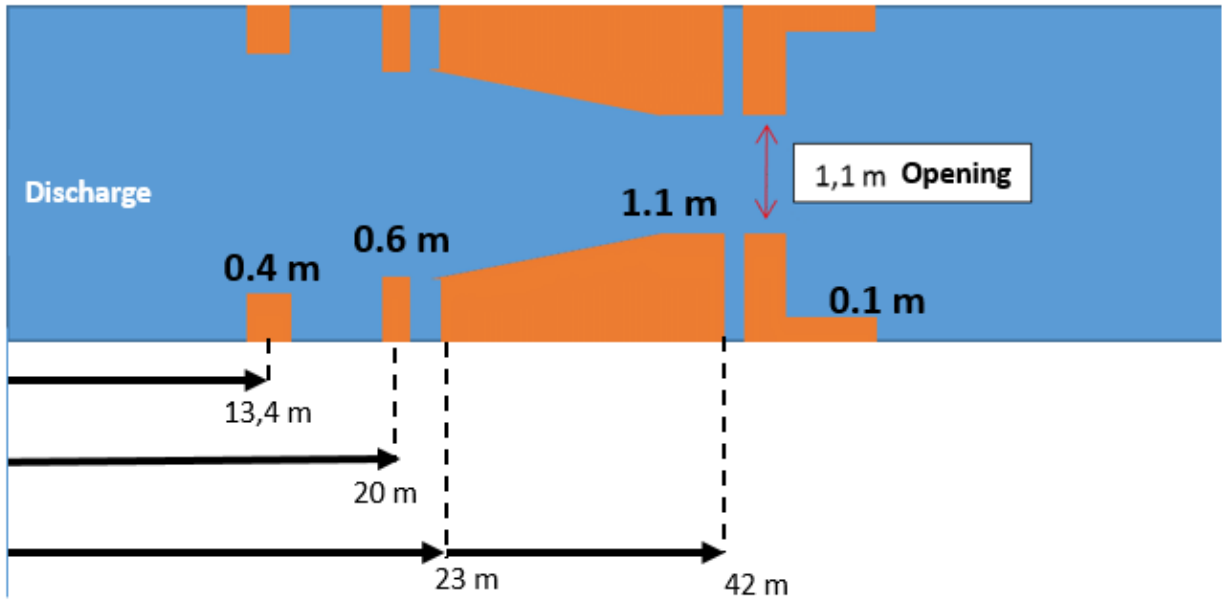
**Figure 6** schematically shows how the ring thickness changes with location in the kiln after 8 months of operation. The buildup was not uniform along the kiln length. There was little buildup in some sections and massive buildup in others. The first blast was carried out at the end of September 2016 and repeated every two weeks until the annual maintenance shutdown in January 2017 when the kiln was cleaned and inspected.

**Figure 6.** Ring thickness observed during the January 2017 maintenance kiln outage.

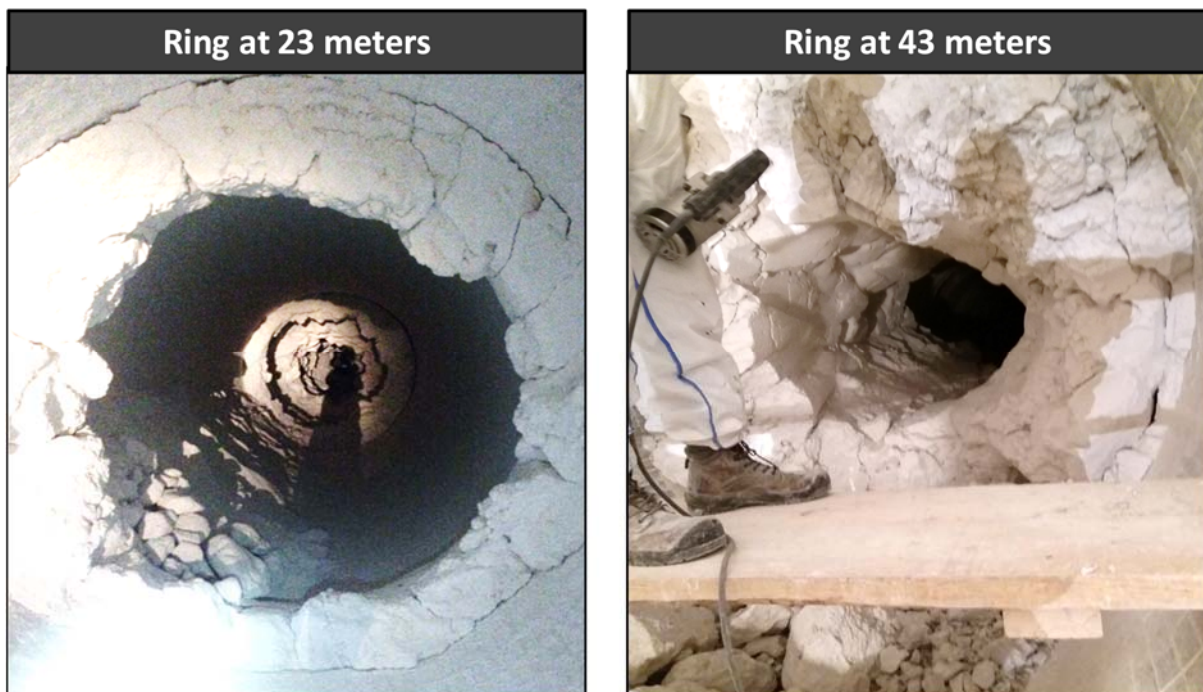
**Figure 7** shows rings formed at 23 and 43 m from the kiln discharge end. Despite repeated blasting, only holes were made in the rings (**Figure 8**). The liquid CO<sub>2</sub> cartridge system was simply not effective enough to cause rings to fall and be removed.

**Figure 7.** Rings form at 23 and 43 meters from the discharge end.

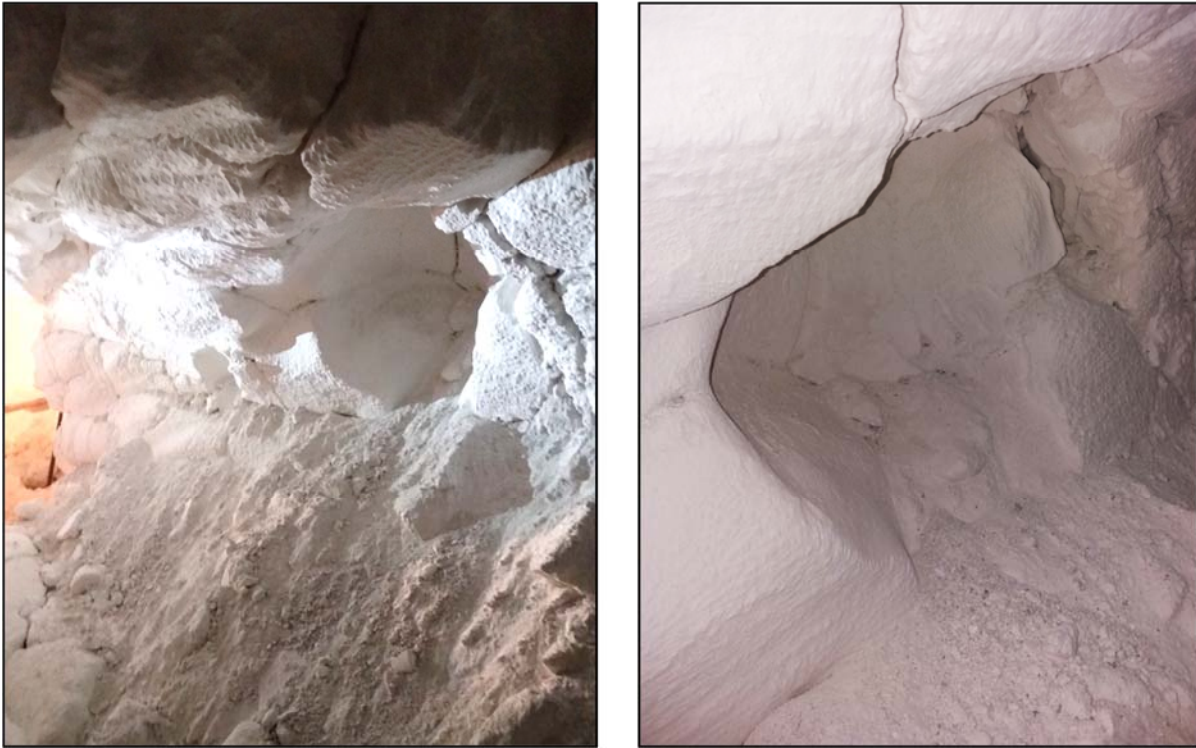
**Figure 8.** Holes formed in rings as a result of liquid CO<sub>2</sub> blasts.

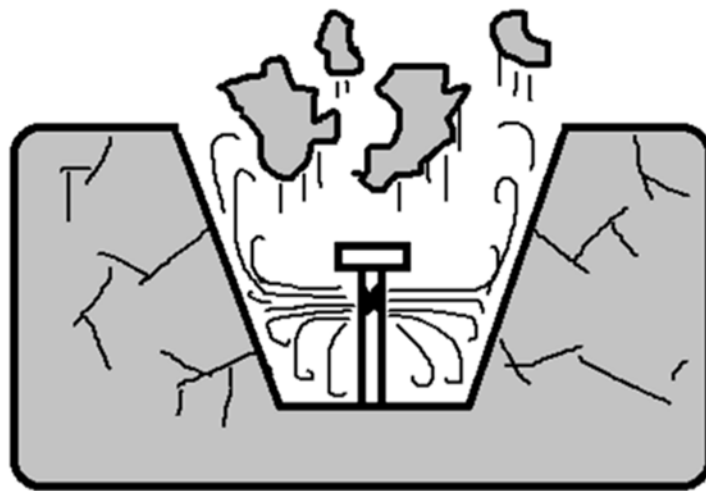
**Figure 9** schematically shows how holes might form in the ring as a result of blasting. As the CO<sub>2</sub> cartridge is inserted into the ring and detonated, the force produced by the blast should ideally shatter the ring apart causing it to collapse. But if the blast force is not strong enough, it can only fracture or remove a small portion of the ring. The debris subsequently falls out as the kiln rotates after it is back in operation, leaving behind a hole in the ring.

**Figure 9.** A hole may form in a ring if the blast force generated by the liquid CO<sub>2</sub> cartridge is not sufficiently strong.

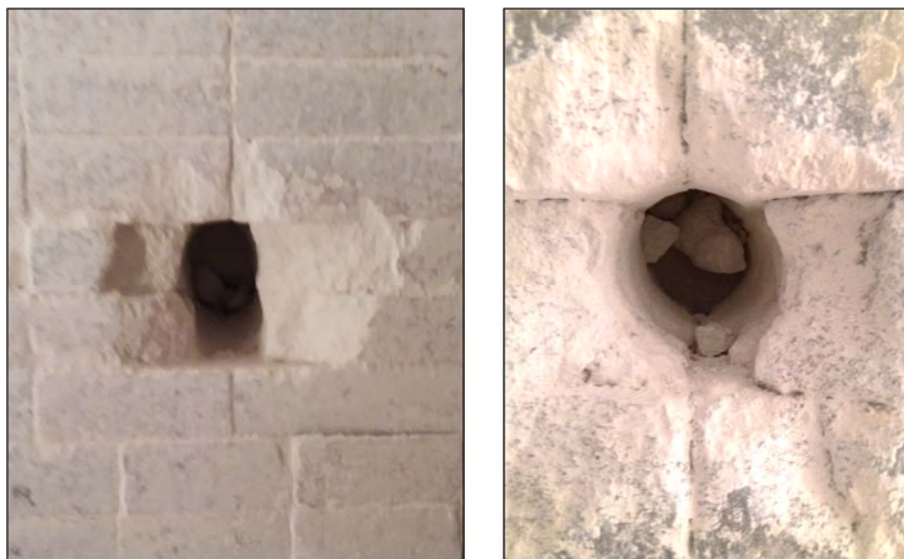
Inspection of refractory bricks after rings were removed showed no indication of brick damage caused by blasting. The failure patterns suggested that most brick damage was sustained during hole drillings (**Figure 10**).

**Figure 10.** Brick damage incurred during drilling.

An improved hole-drilling practice was subsequently devised to minimize brick damage. This involved both row and column drillings. Row drilling refers to drills that are made parallel to the kiln shell, while column drilling indicates drills that are made normal to the shell (**Figure 11**).
