Bleach Plant Materials Selection

Margaret Gorog

Houghton Cascade Holdings, LLC

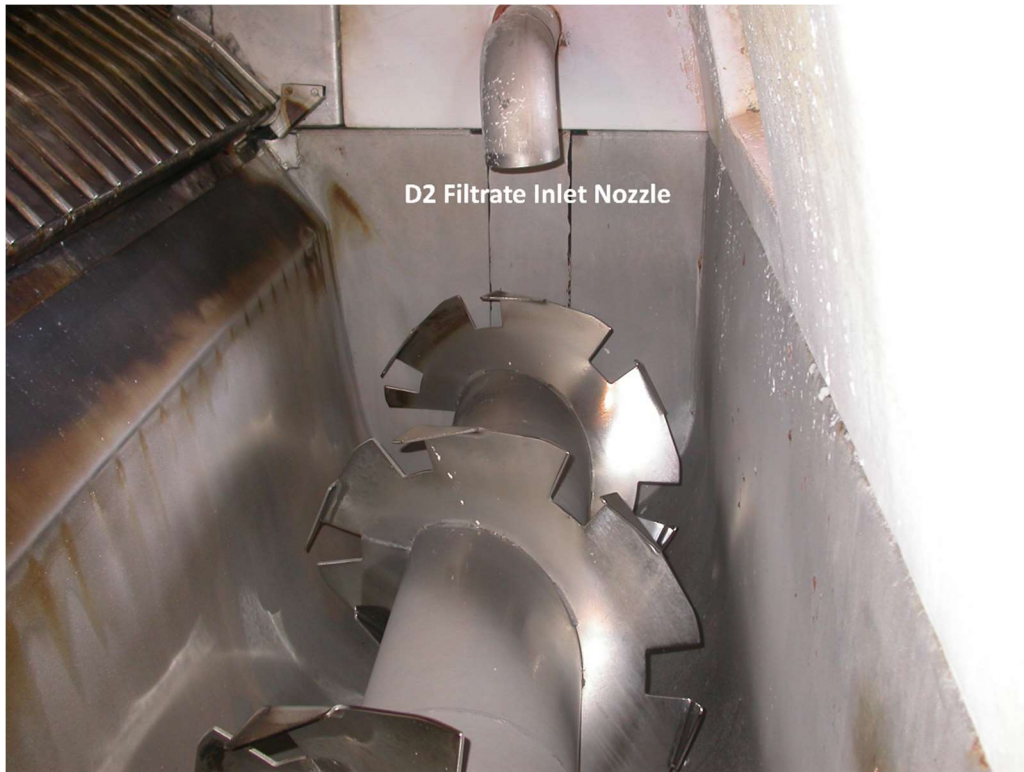
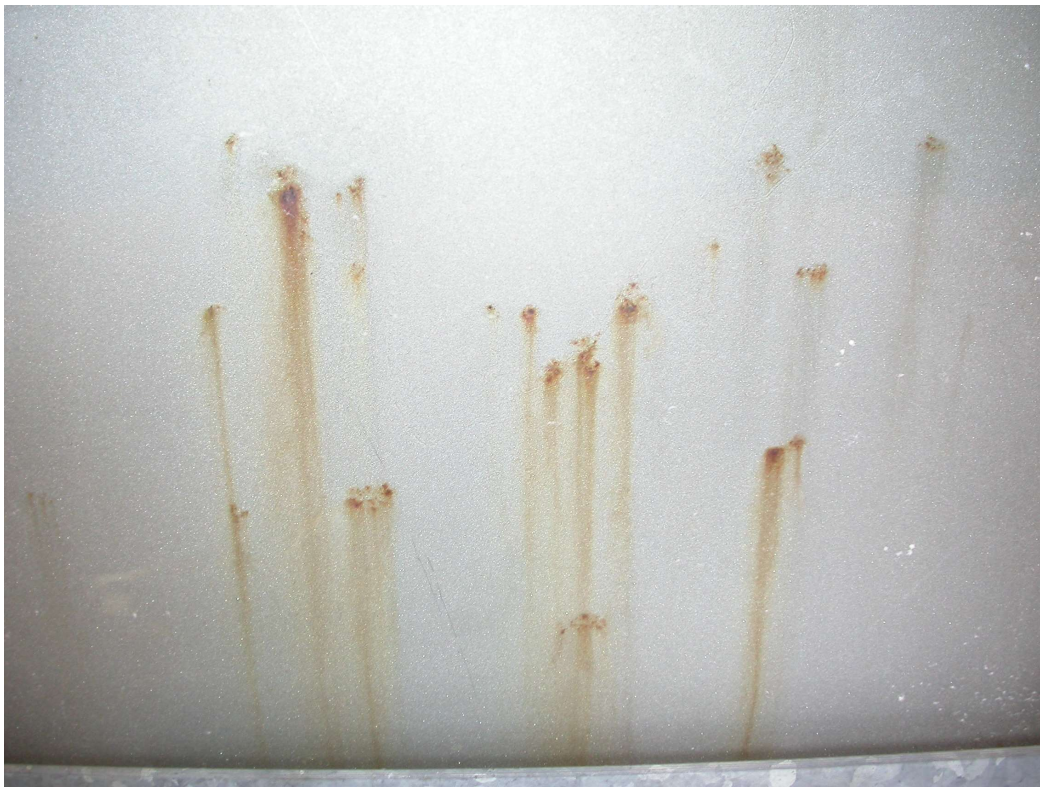
Pitting and crevice corrosion of stainless steel in acidic, chloride solutions containing bleaching oxidizers is the damage mechanism associated with chlorine dioxide. Visually the damage appears as pitting, rust may or may not be present. Crevices are highly susceptible to corrosion. If the residuals are high enough bare plate, absent of welds, deposits or crevices will pit as well. Figure 1 shows a 317L stainless steel E/O repulper that was using recycled D2 filtrate (50 – 80 mg/l residual ClO₂ at 71 °C (160 °F)). The rotor and trough are experiencing localized pitting and crevice corrosion under the D2 inlet pipe.

Figure 1. A 317L E/O repulper exposed to D2 filtrate (top) and detail of pitting on the bare trough metal below the inlet pipe (bottom).

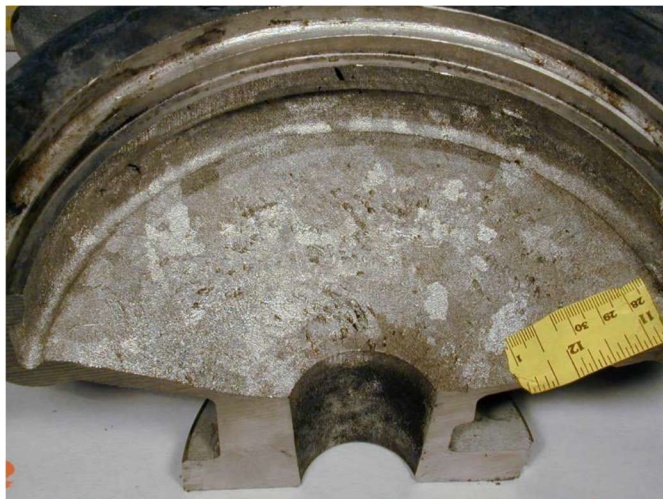
Sulfuric acid resistance is defined by concentration, temperature and velocity [11]. Figure 3 shows a corroding alloy 20 pump casing. This alloy was designed for sulfuric acid and even though the acid concentration and temperature were within the alloy's tolerance, the velocity was too high. Carbon steel is used for concentrated sulfuric acid. Once it is diluted the acid becomes very corrosive to carbon and stainless steel. Upstream of dilution, piping material is often switched to PVDF line steel pipe. If the reaction temperature is too high, PTFE line pipe may have to be used instead.

Figure 3. Alloy 20 pump casing corrosion in the form of etching and pitting. The acid concentration was less than 10% acid and the temperature 71 °C (160 °F). High velocity caused it to corrode.

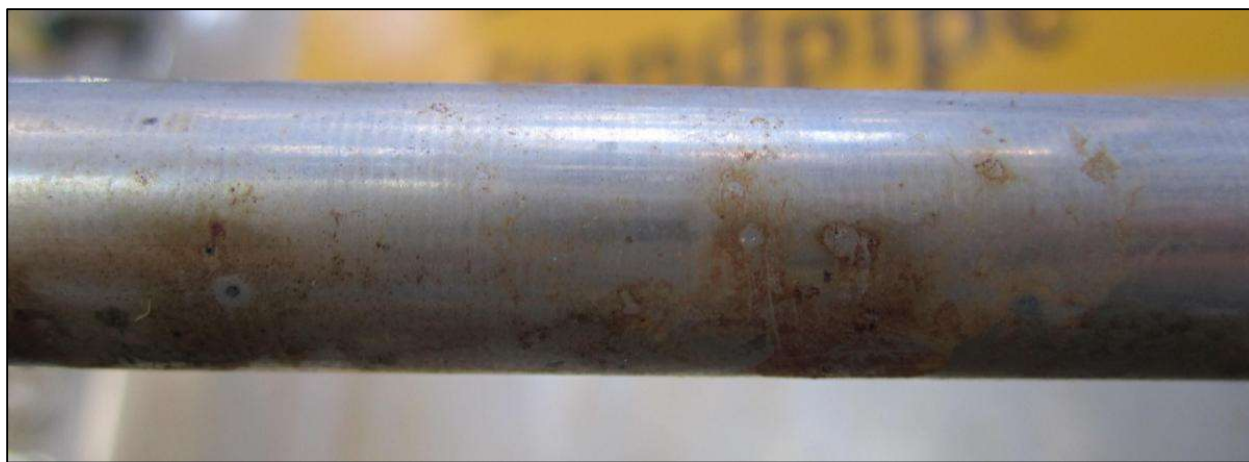
There is almost no corrosion information on this acid. Supplier product brochures claim that it behaves like inhibited hydrochloric acid so is not a corrosive. It has been used for scale removal without issue. However, limitations have been noted that if the temperature is too high or the solution is too dilute, it can behave as hydrochloric acid. Figure 4 shows a pitted 316L line used to deliver urea HCl for pH control to a standpipe. It is possible that the feed was not continuous and stagnant conditions as a result of residual urea HCl standing in the pipe caused the metal to pit. The line was replaced with C276.

Figure 4. Urea hydrochloride used for pH control pitted 316L piping.

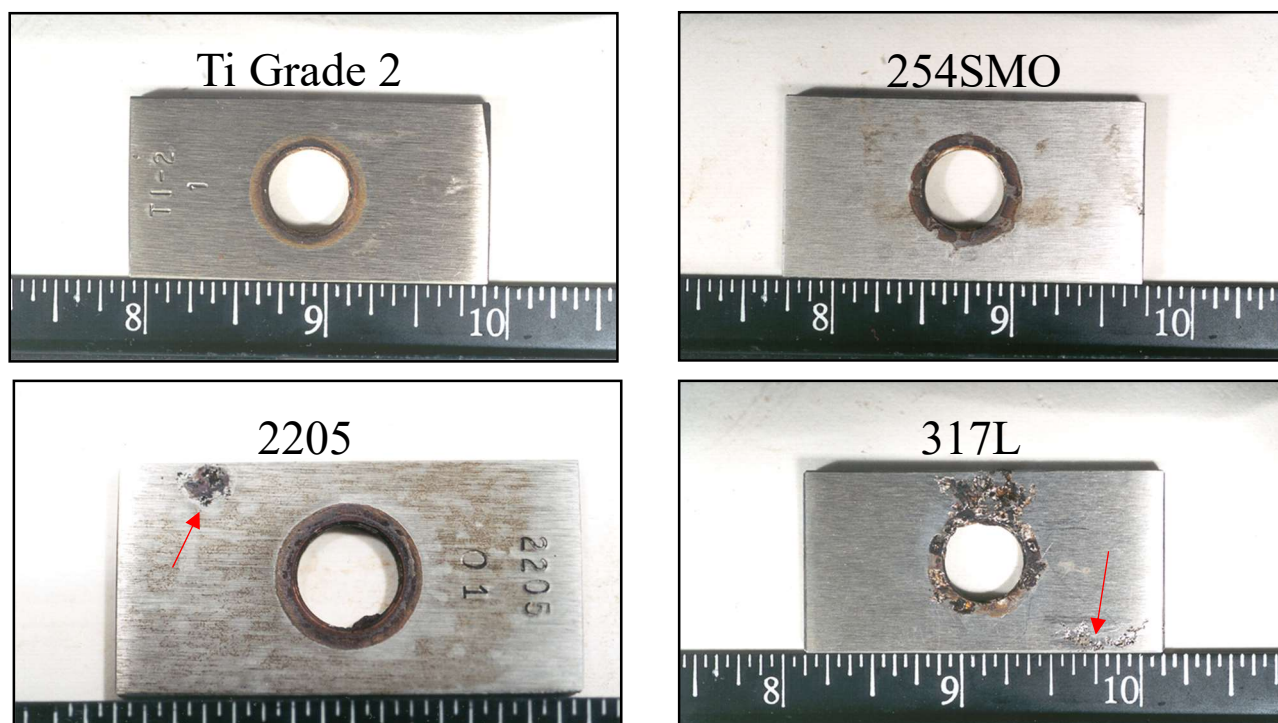
Four coupons each of 317L, 2205, 254SMO and Titanium Gr. 2 were mounted on two racks and installed in the D2 filtrate tank. The test duration was approximately 345 days. Visual results of selected coupons are shown in Figure 6. For titanium, there was some staining around the central hole but otherwise there was no apparent corrosion nor was any corrosion rate measured. For 254SMO there was some staining and small pits around the hole. For 2205, not only was there staining and pitting around the hole, but also some pitting on the open portion of the surface. Even so the corrosion rate was slightly lower than 254SMO. The 317L coupon showed the most damage. It had the highest corrosion rate and much more severe pitting around the hole and bare surface. The results are summarized in Table II. The corrosion rate in mils per year (mpy) is an average of four coupons.

Because the primary damage mechanism in D stage service is pitting and crevice corrosion, 254SMO had the edge in corrosion resistance over 2205. Even so, 2205 outperformed 317L and was chosen as the replacement material.

Figure 6. Mill 1 visual tests results. 2205 and 317L are pitting on the bare face. 254SMO pitted in the crevice area. Titanium did not corrode.

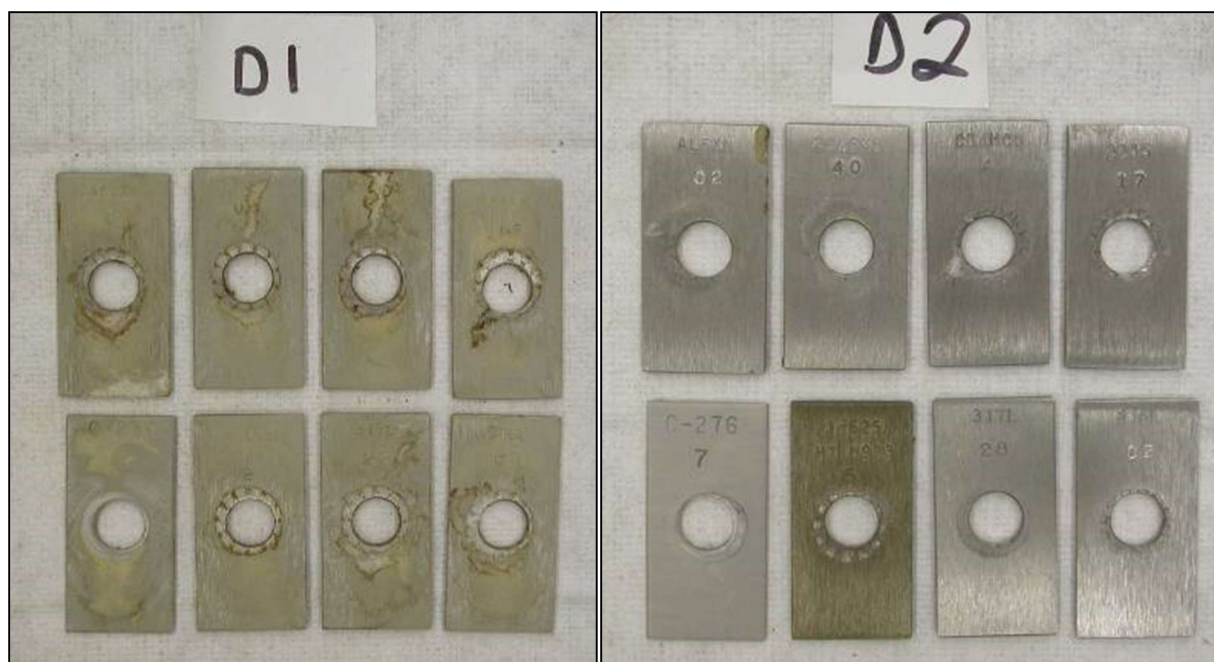
A coupon rack was installed below the liquid level in each of the D1 and D2 filtrate tanks. When they were returned to the lab after one year, the D1 coupons were coated with a yellowish-white deposit which was easily removed. After cleaning there were no signs of pitting or corrosion. The D2 coupons were generally free of deposits and needed little cleaning. The 625 coupon had changed color. Figure 7 shows the post immersion coupons.

Figure 7. Round 1 coupons after one year of immersion in the D1 and D2 filtrate tanks. The D1 coupons were easily cleaned. No pitting was observed on any of the surfaces.

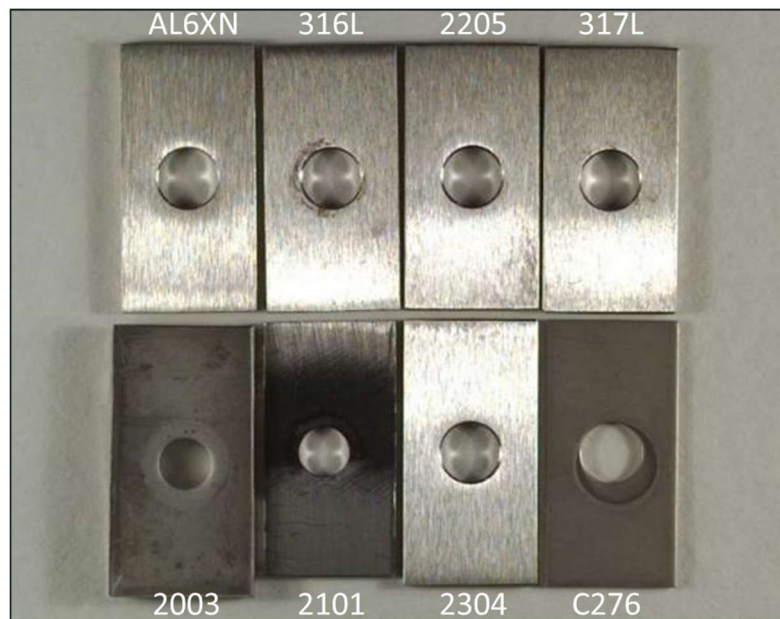
Table V shows that the filtrates are mild though somewhat more oxidizing than the first round which had been completed a year earlier. There was no pitting of the D1 coupons and again the corrosion rates were all under 1 mil/yr. Even though the rate is very low, C276 has the highest rate similar to the first round. The staining of the coupon may reflect this somewhat higher rate. Again, the D2 filtrate is more corrosive than the D1 filtrate but this time 316L, 317L and 2101 were pitted in the crevice area round the central hole. The approximate percentage of surface area covered by the pitting is included in the table. Though it couldn't be seen without magnification, there was fine pitting on the bare surface of the 2101 coupons.

Figure 8. The bottom side of the Round 2 coupons after one year of immersion in the D2 filtrate tank. Pitting around the hole of the 316L coupon is visible. Crevice pitting of the 317L and 2101 is present but cannot be seen in this view.

For immersion service 316L is adequate for D1 filtrate. Duplex stainless would add more protection in the event there were any process upsets, particularly with the filtrate tank; piping is more easily replaced. For the D2 filtrates, austenitic stainless steels and 2101 don't have sufficient pitting resistance. The remaining choices are 2003, 2304, 2205 or 6% Mo stainless steel. With lower molybdenum and nickel concentrations, 2003, should offer a cost advantage over 2205, however it is not readily available. 2304 is not made as piping so the best choice for duplex stainless steel is 2205.

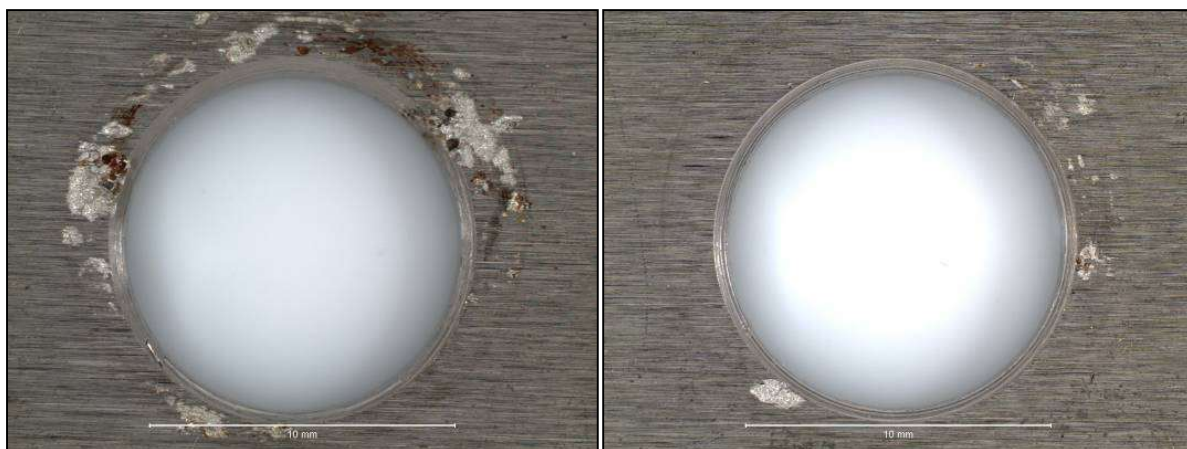
Figure 9. Pitting on the bottom side of the crevice area on the 316L (left) and 317L (right) coupons.

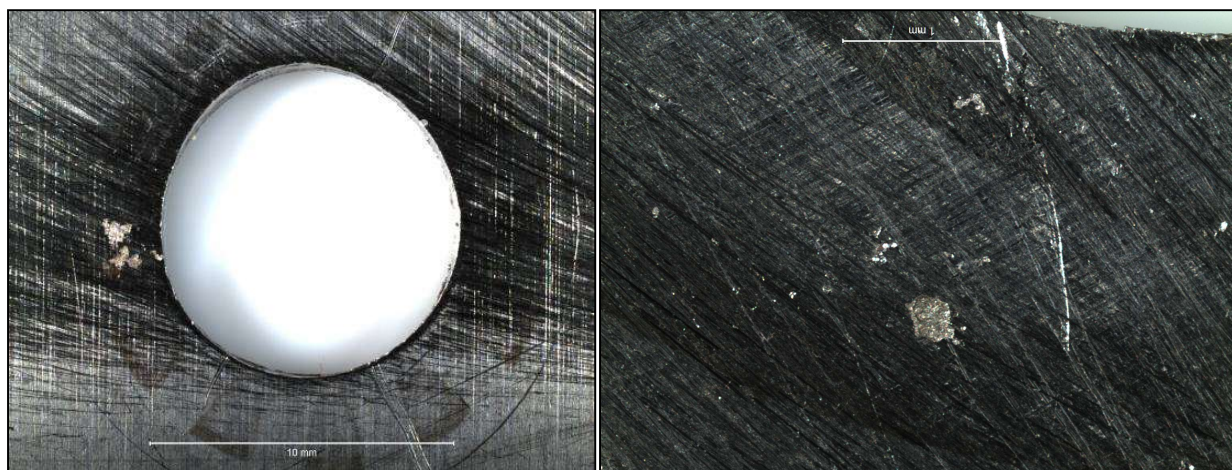
Figure 10. Pitting on the top and bottom side of the 2101 coupon. The bottom side view is enlarged because the pits are difficult to see by eye.

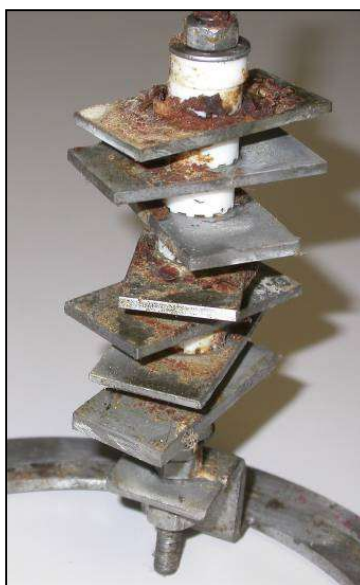
The racks for this test were mounted in the vapor space above the liquid level. The D1 filtrate tank was not accessed for two years which accounts for the test duration. The coupons were covered with thicker deposits, Figure 11, than those that were immersed in the filtrate solution but cleaned up easily. None of the coupons were pitted and the corrosion rates were very low as seen in Table VI.

Figure 11. D1 coupons after exposure to the filtrate tank vapor space for two years.
