## **Continuous Digester – A Story of Shell Corrosion Under Insulation (CUI)**

**By Kyle Lindsay (Georgia-Pacific LLC)**

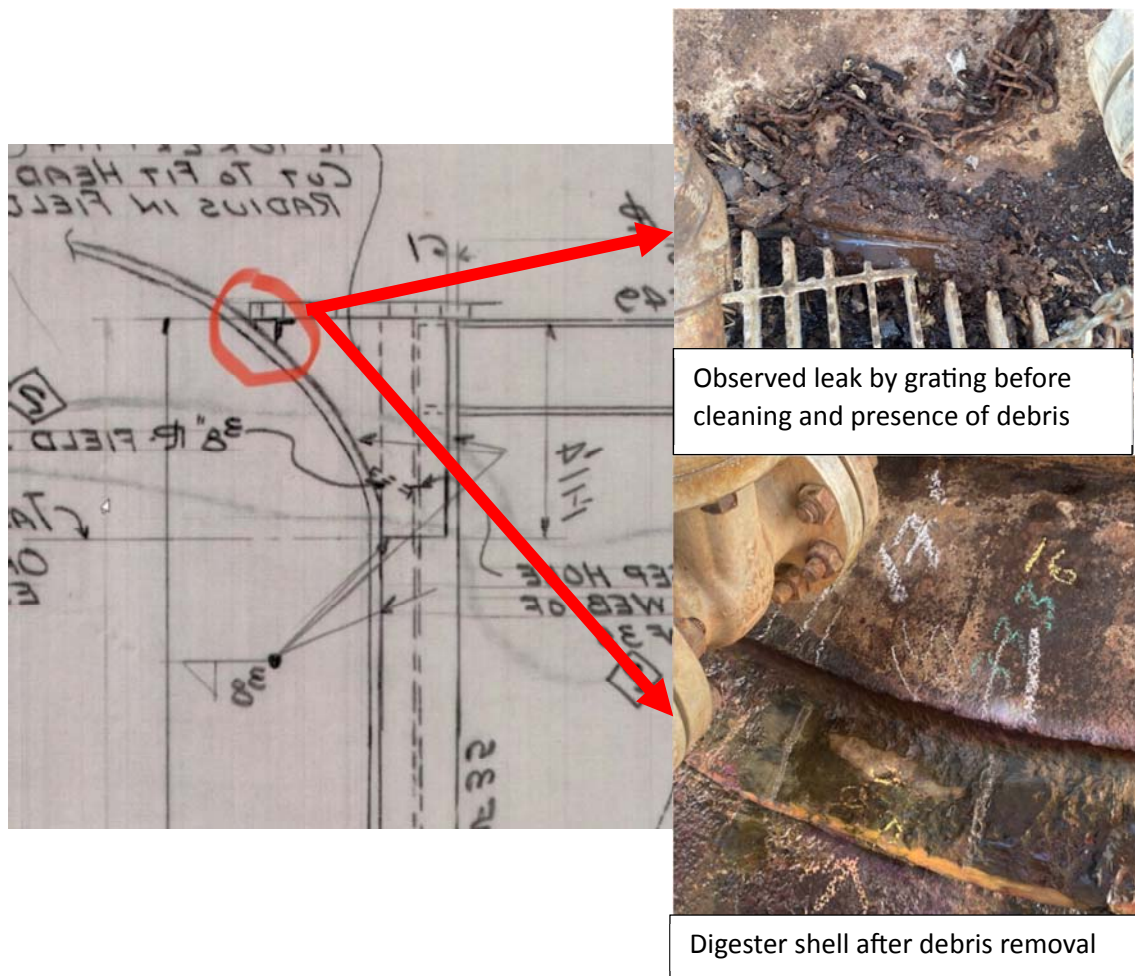
Figure 1 Formation of water by Top Separator repad during hydro testing of Digester A occurred around the top separator nozzle repad in Digester A.

After discovering the water, the digester was drained and the area around the top separator nozzle repad was excavated to investigate its source further. Once the area was clear of debris and obstruction, exterior corrosion had degraded Digester A's carbon steel dome, with spots of the stainless-steel cladding visible. A crack indication was noted in the cladding where the leak was observed, and general corrosion of the carbon steel was observed in the vicinity.

Ultrasonic Thickness Testing (UT) was performed around the entire Top Separator nozzle repad and other suspected areas to quantify the amount of general corrosion. Testing confirmed that several other areas which had been corroded past  $t_{min}$ .

A Root Cause Failure Analysis (RCFA) investigation was conducted, and it was concluded that a platform support attachment to Digester A's dome allowed for the collection and build-up of debris, water, and potential liquor from packing leaks causing exterior CUI. Although there was

no thermal insulation on the area surrounding the Top Separator nozzle repad, this failure can be grouped under CUI since the debris and support attachment acted to contain a corrosive liquid against the vessel shell, like how it might occur with CUI with insulation.

Digester A's startup from its annual outage was delayed for 5 days to allow for flush plate patch repair of the digester dome.

4. Developed mitigation strategy for risks associated with digester shell attachments.
  - o Grating supports modified on Digester A to allow for proper drainage and eliminate potential for long term debris buildup.

5. Managed potential for accumulation of seal water at the top of digester – appropriate drains for Top Separator, etc.
  - o Proper routing of drain hoses was accomplished along with ensuring drainage pipes were unclogged and allowed to drain freely. Checking for proper drainage of Top Separator seal water was added to operator inspection rounds.

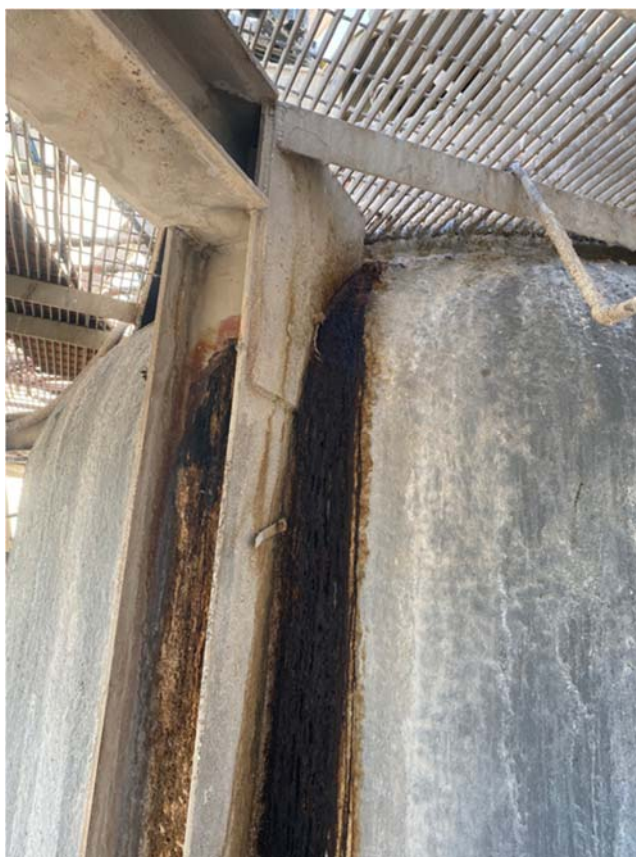
During a routine operator round walking down the vessel, an apparent leak containing cooking liquor was observed around a beam attachment to the top of the digester dome (Figure 2). Digester B was operating under normal operating conditions at this time. Due to vessel integrity and safety concerns the digester was blown empty and locked out for maintenance immediately after discovery of the leak. The structural support beams were removed, revealing exposed stainless-steel cladding behind them. There was a crack indication in the exposed cladding where the leak was located. This observation resulted in Digester B being down for 3 weeks to complete curved insert flush plate patch repair of the digester dome in several areas, which were tested and found below  $t_{min}$ .

*Figure 2 Cooking liquor leak originates behind the digester structure support beam.*

The Root Cause of Digester B's shell breach was like that of Digester A and was discovered only 3 months after Digester A. The digester super structure attachment beams and spray insulation created a void that collected debris and liquid. These areas did not drain freely and allowed continuous contact between the entrapped liquid and the carbon steel digester shell, allowing for

- o Support beam attachments which create cavities for collection of debris such as what caused the penetration of Digester B's shell have been modified to where they are free draining and will not collect debris or retain moisture.

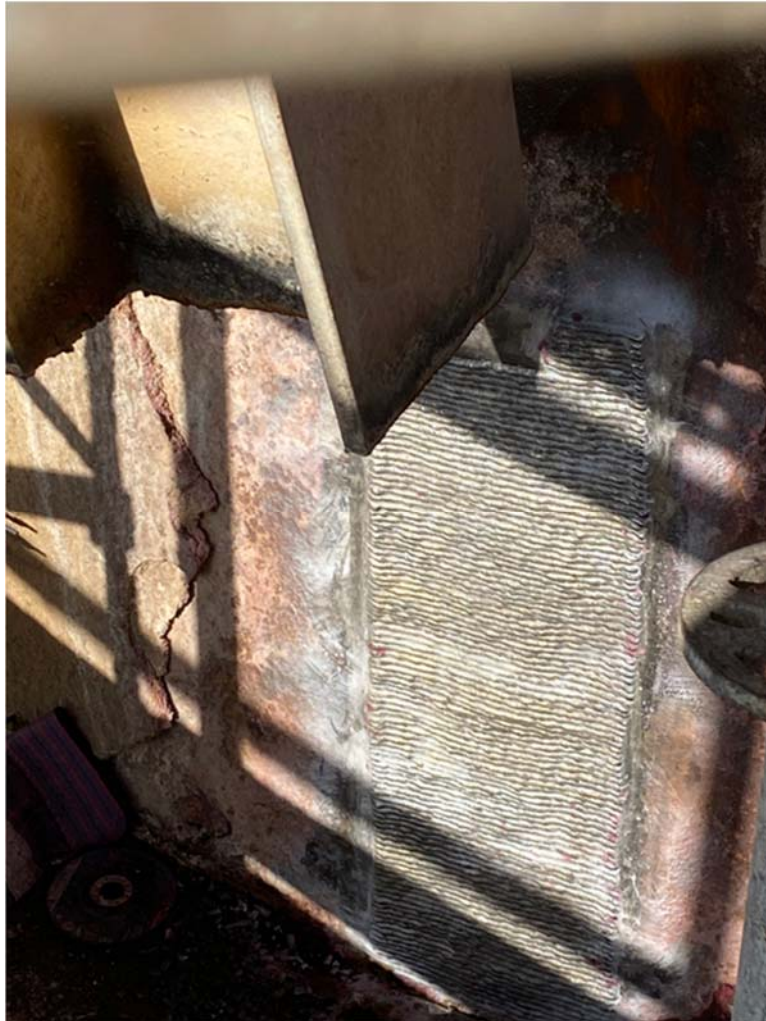
corrosion. During the next annual outage for Digester B, the lower portions of the structural beam attachments were inspected for suspected corrosion. These lower beam attachments created a void area further down on Digester B's shell where an insulation ring beneath them prohibited drainage. Several areas below  $t_{min}$  were weld code repaired with base metal restoration welding.

*Figure 3 ASME Code repair of exterior CUI found behind a structure support beam.*
