# Continuous Digesters- A Story of Shell Corrosion Under Insulation (CUI)

Kyle Lindsay – Georgia Pacific (GP) COE Engineer

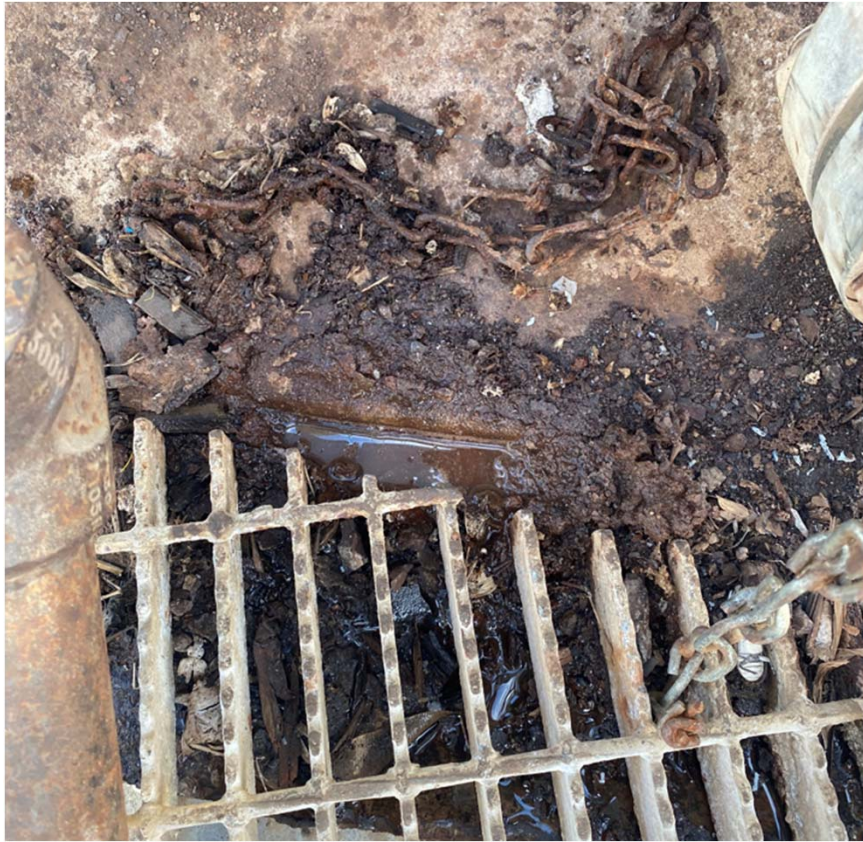
# Digester “A” Discovery

- Discovered during walkdown after hydro of the vessel coming up from annual outage
- Pool of Water forming slowly by Top Separator Nozzle Repad while digester was squeezed for checking of over pressurization protection interlocks
  - Did not leak at operating pressure

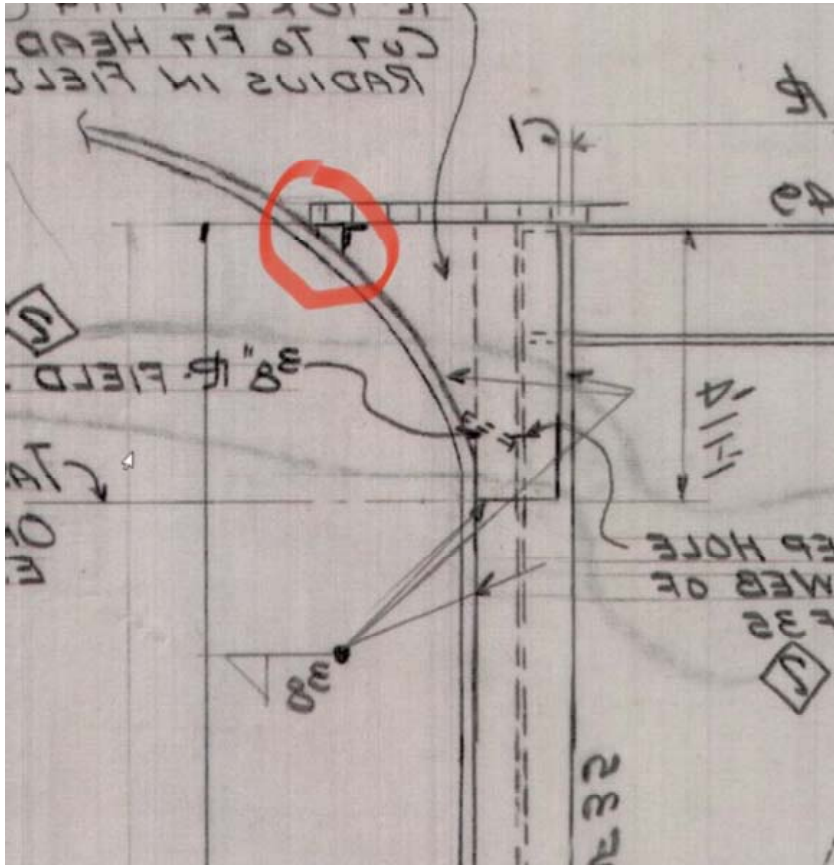
# Digester "A" Discovery

- Grating support ring allowed for collection of debris, seal water, and liquor
- These type attachment supports no longer utilized due to pressure vessel code changes

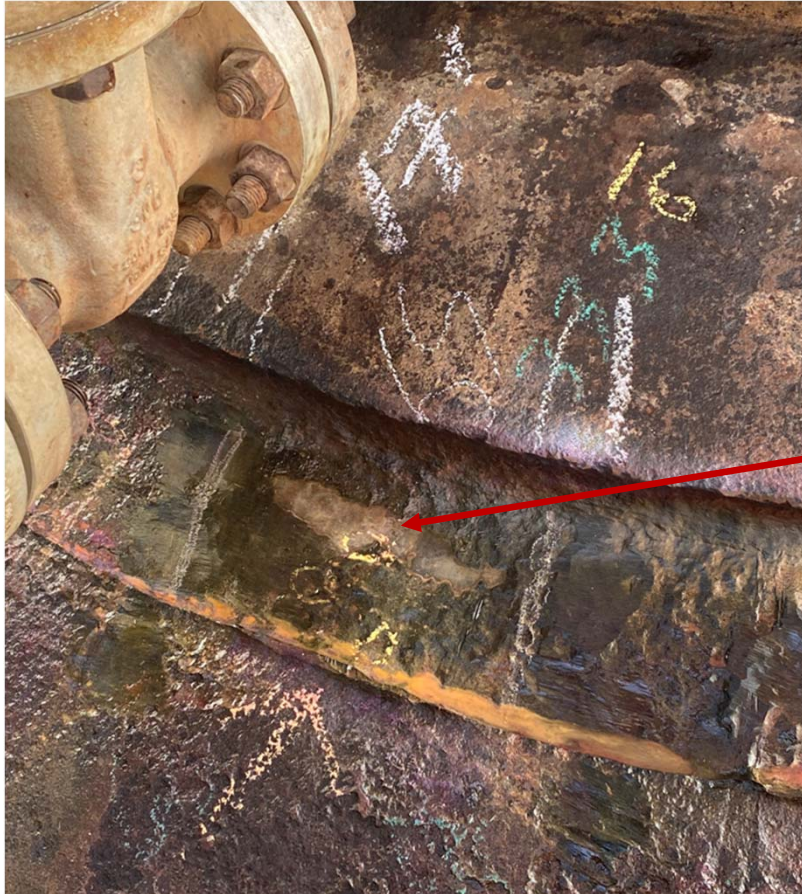
Crack in Exposed Cladding

- Exterior corrosion down to cladding of the digester dome
- Extensive repairs had to be made to circumference of the digester dome

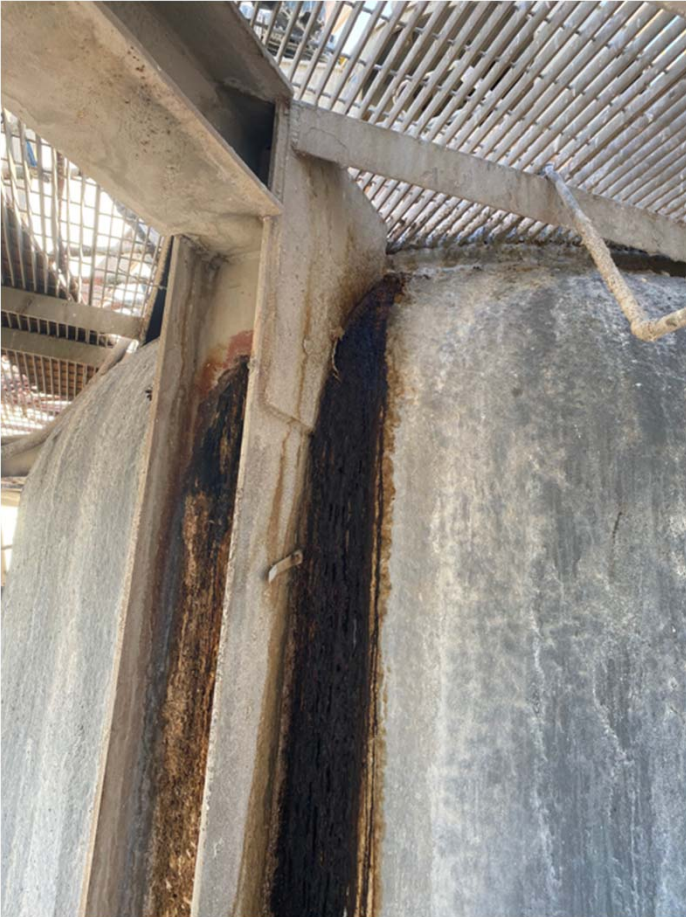
- Liquor leak discovered on upper digester dome during routine walkdown of the vessel 3 months after breach discovered on digester A
- Same mechanism where design of superstructure attachments to vessel created a void for collection of debris which blocked drainage of any water or liquor collected

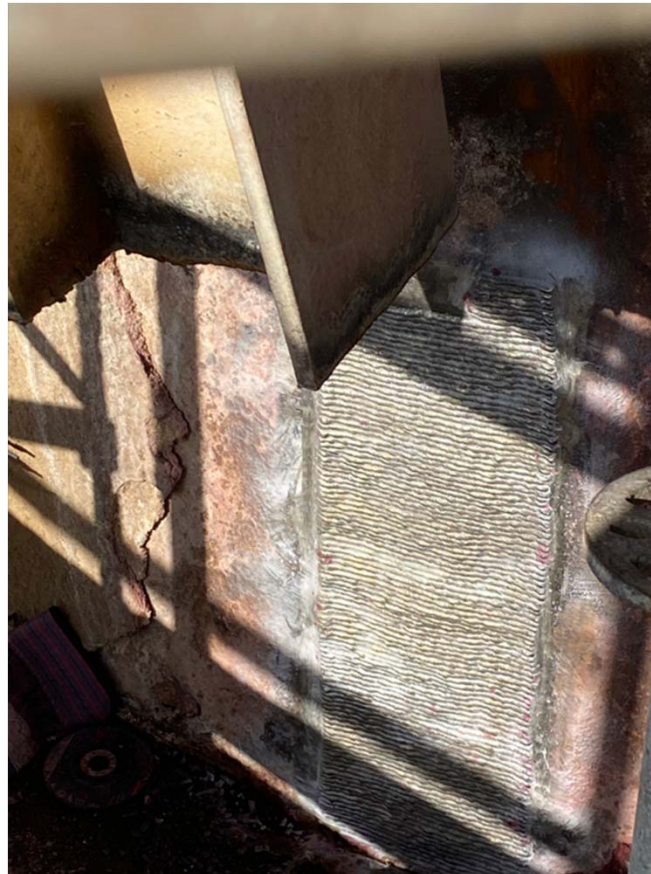
- Code repair of another attachment support area which had CUI below T-min

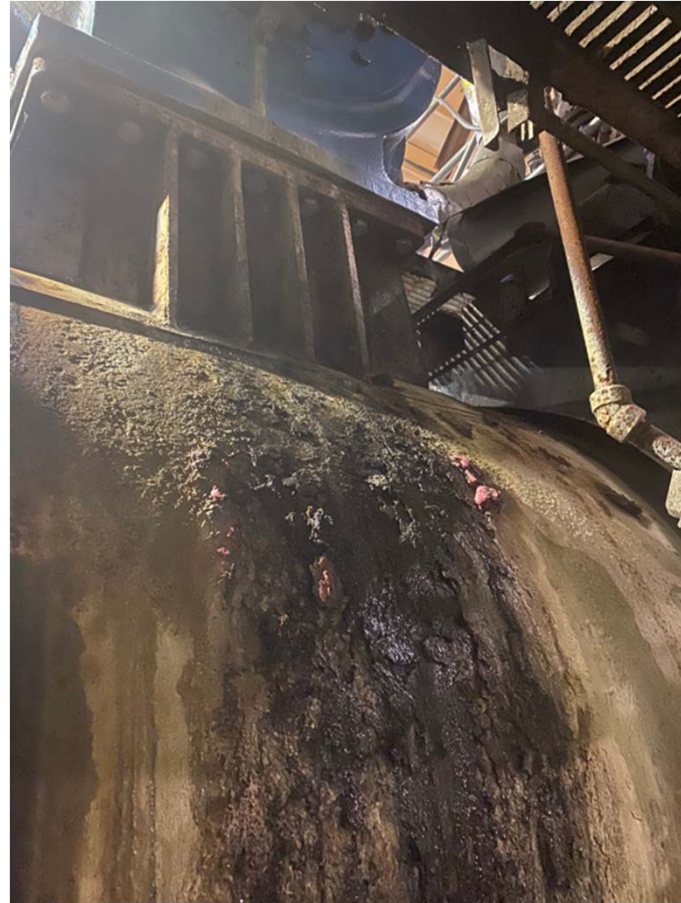
- Same mechanism of exterior corrosion seen on other equipment
  - Seal water draining onto steaming vessel
  - General Piping
