# Continuous Digester Process Safety Improvements

# Continuous Digester Stress Corrosion Cracking (SCC) Case Studies

## Digester “A” SCC case study information

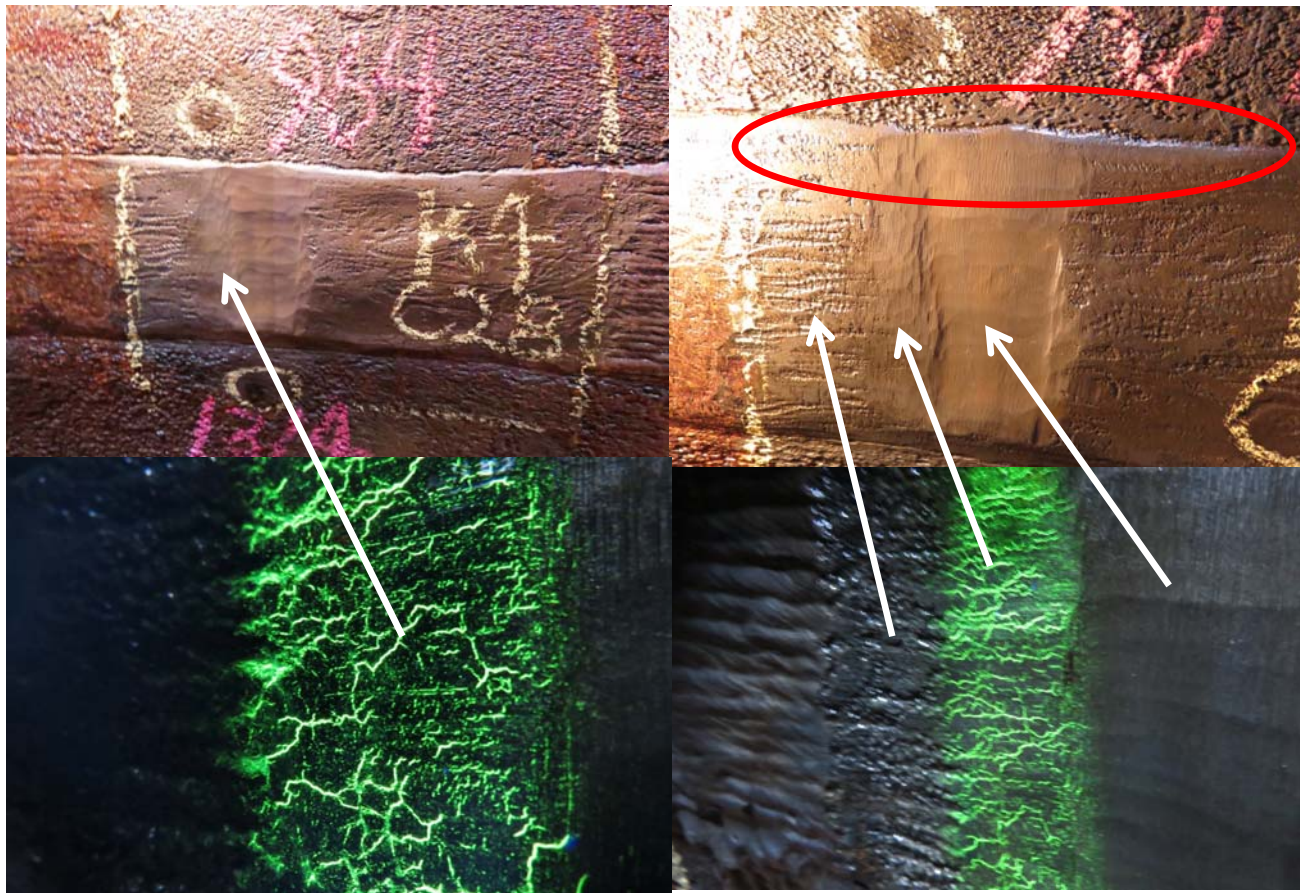
## Digester “A” case study – C28 previous inspection technique

2019 – “C28 Showing #4 monitor point with shallow new emerging issues in 24 months. Not removed.”

Four (4) spot inspection points  
~ 5% of weld circumference.  
Vertical welds were not inspected.

**Note** – weld toe not ground to base metal for inspection.

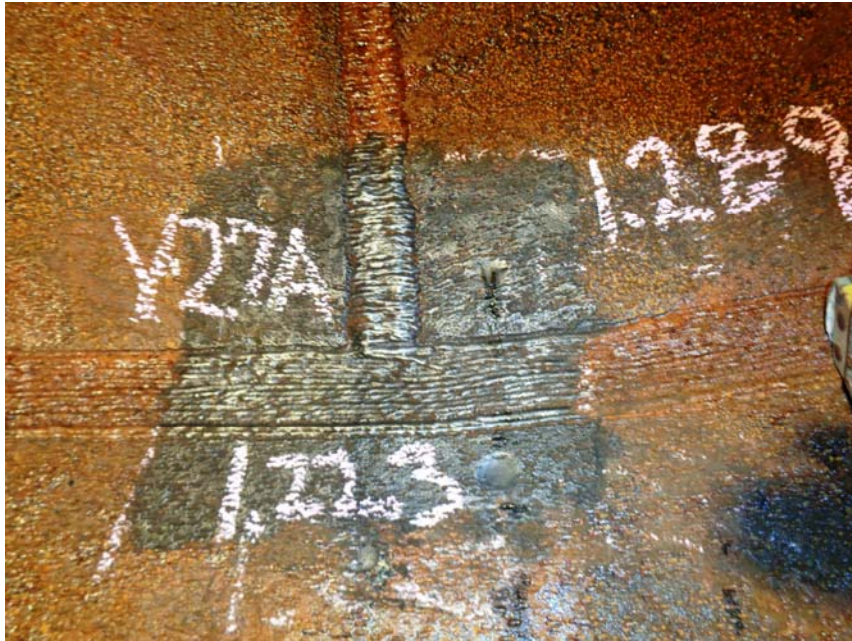
**2019 C27/V27 inspection – typical wire brush weld NDE inspection preparation**

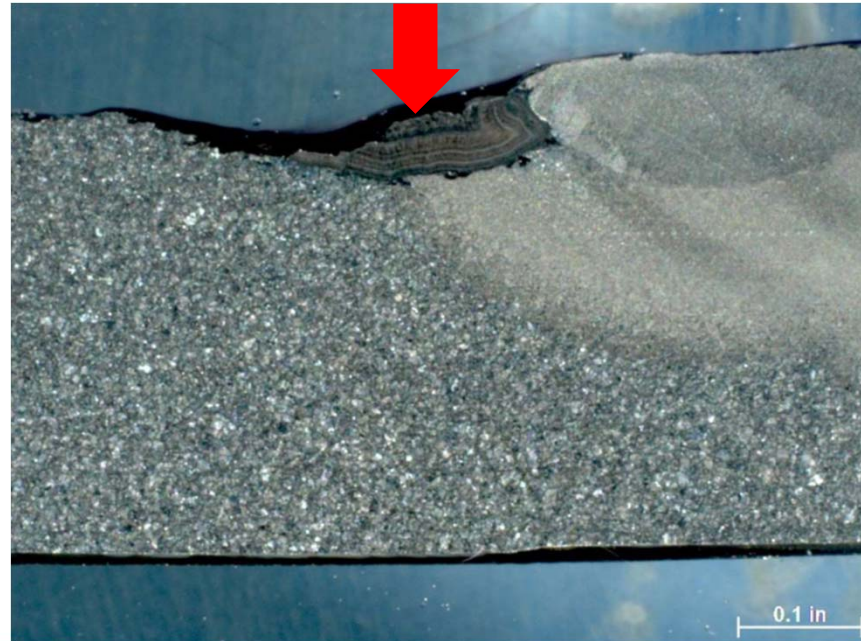
**2021 weld boat sample analysis showing weld and base metal not completely cleaned**

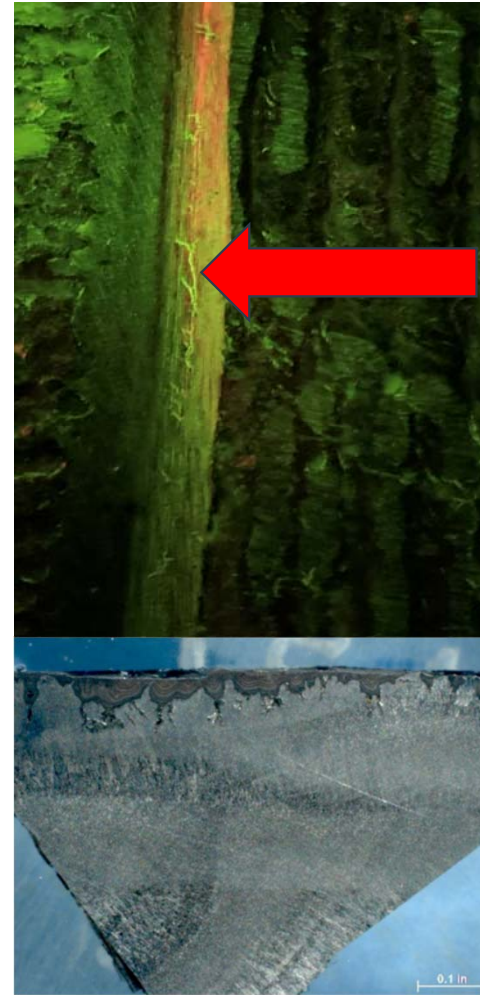
- Previous inspection method is flawed since weld toe was not completely cleaned prior to testing
  - Failure of Wet Fluorescent Magnetic Particles (WFMT) to reveal cracks on the test surface
  - Likely not detectable by WFMT with crack initiation behind “finger-nailing” of weld toe
- Inspection technique change – grind weld toes to shiny base metal
  - Welds now show SCC
  - Wire-brush cleaning was inadequate surface preparation

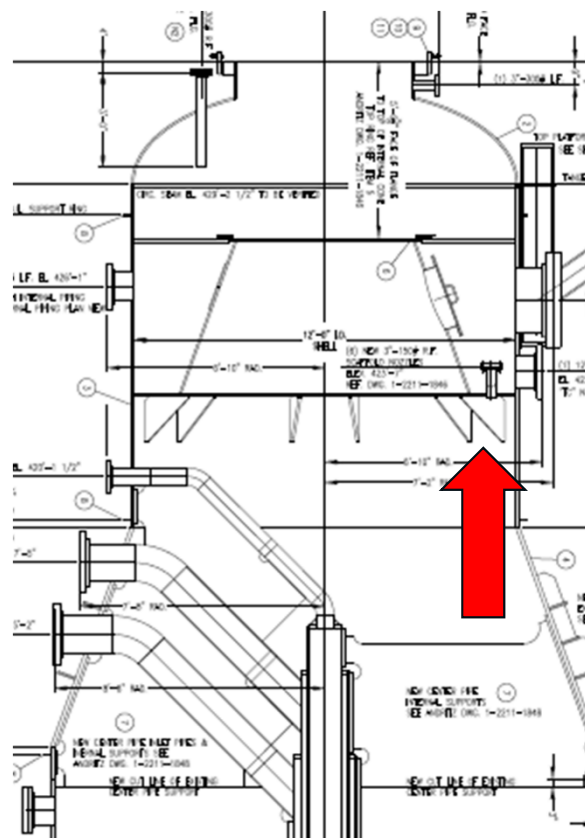
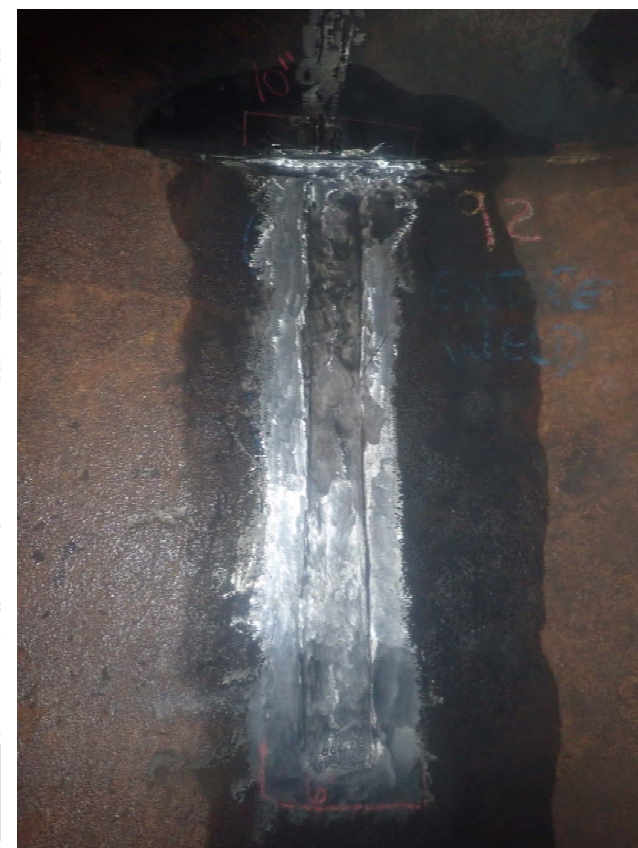
- SCC was not just found on vertical and circumferential seam welds
- Inner cone bottom ring stitch and gusset welds (13 total gussets, located above C28) had SCC detected - removal and repairs took longer than planned
  - Stitch weld SCC propagated behind the ring into the shell
  - Plan 309L weld overlay in these areas
  - **Difficult area to access** for inspection (not accessible from sky-climber scaffolding)

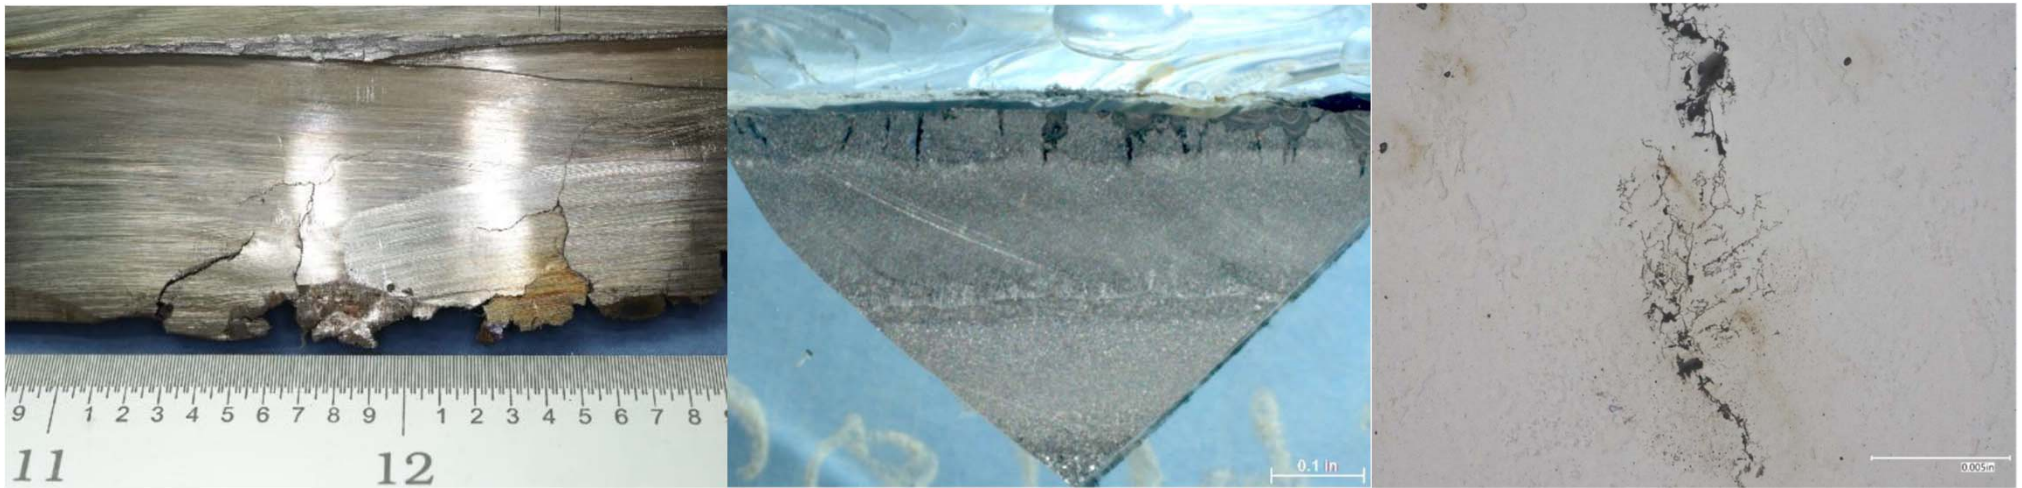
## Digester “A” Case Study – Weld Boat Sample Analysis photos

- “Cracking propagated out of the bottom of the pits and was consistent with caustic stress corrosion cracking (SCC).”
  - “Deposits within cracks had sodium and sulfur ...Significant amounts of sulfur were noted.”
- “...it is also notable that no chloride were noted.”

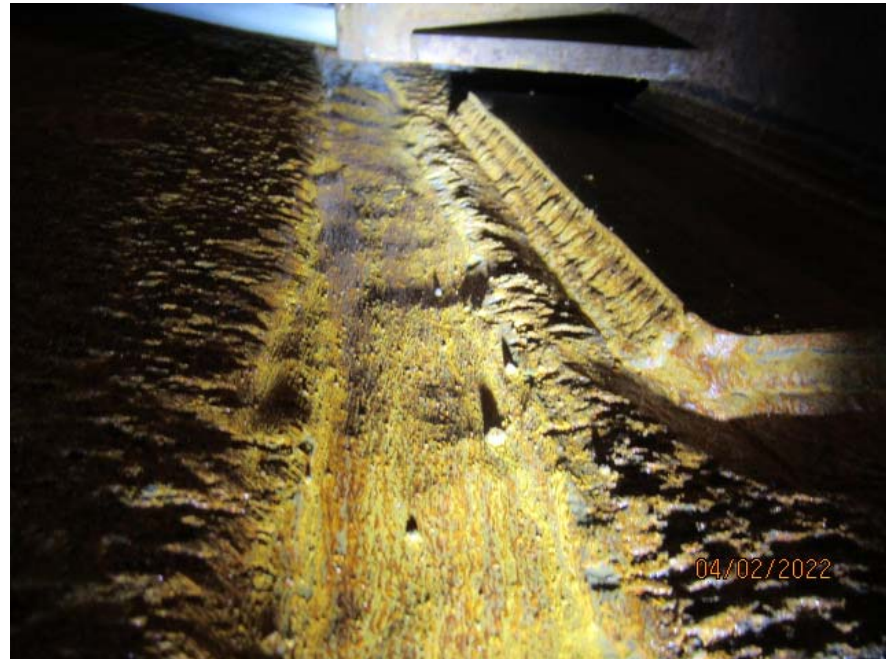
- 100% Inspection found SCC on C12, V12, and C13
  - TAPPI recommendation is spot inspection
- SCC was completely removed from these welds
- Anodic protection system is working well and mitigates SCC and generalized thinning
- Do not have history of generalized thinning, expected corrosion rate is  $<0.005''$  per year
