MINUTES
of the
YANKEE DRYER SAFETY COMMITTEE
April 26, 2006
8:11 AM EDT
Marriott Hotel
Atlanta, GA

Yankee Dryers for High Press Loads

Two Recent Yankee Incidents in Europe

Virtual Reference Grinding

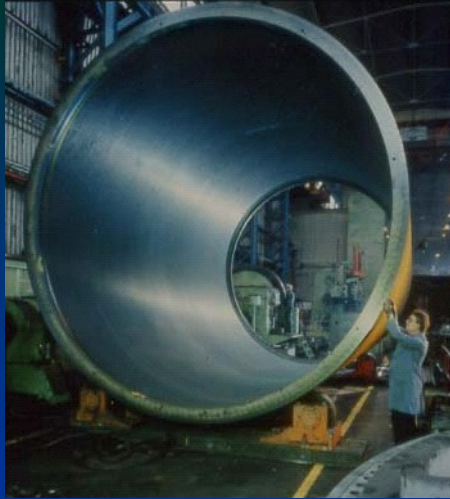
Modern Yankee Dryers

Today's Yankee Dryers are bigger, wider, faster and because they are ribbed and higher pressure, more productive

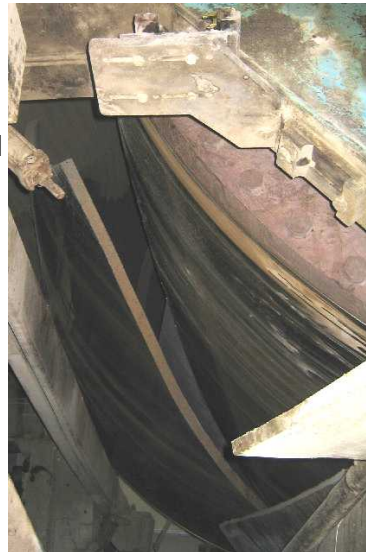
September, 2005 - Failure at Warm-Up

- No personal injuries
- Low steam pressure and crawl speed -> "limited" explosion and consequential surrounding damages
- Yankee dryer completely failed with shell and heads broken into pieces.

- Pre-heating without rotating the Yankee dryer (not confirmed)
 - with a stationary condensate puddle in the bottom of the dryer significant - and possible - critical temperature differences ($T1 \gg T2$) may occur in the dryer structure, especially when it is finally rotated
- (Low cycle) Fatigue failure due to warm-up and cooling-down induced stresses
 - depending on design and warm-up and shut-down procedures "higher than normal" stresses are created in the Yankee dryer. Stresses that may be well below the yield/burst strength but exceed the fatigue strength, resulting in a fatigue failure after more than 40 years of warming-up and cooling-down.

- (Infamous) Shell overhung design
 - reason for several Yankee dryer incidents. A high stressed section of the Yankee with significant increased risk for crevice corrosion. However in this particular case - a Yankee dryer used for glazing board paper - there were no corrosion jacking and due to the relative low machine speed (300 m/min / 985 fpm) there were less contribution to the nominal stress level by cooling. But...
- Bolted rope groove
 - threaded bolt holes in an already high stressed section may lead (and have led) to critical stress concentrations and the introduction of cracks

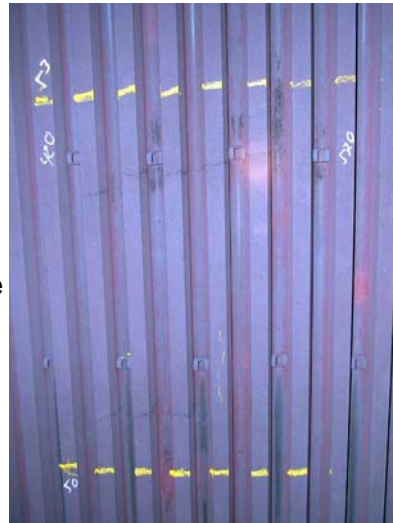
November 2005 - Shell Cracking due to Press Roll Cover Failure

- No personal injuries
- Roll cover failure during normal operation
- At first glance from outside the Yankee dryer looked OK - no steam leaking
- More thorough internal inspection revealed a massive cracking of the shell
- Yankee dryer immediately taken out of service

- Roll covers fails all the time without damage the Yankee dryer. In this particular case most of the cover went off with the exception for a section where cover residues not only stuck to the roll but folded double and repeatedly went through the nip until the machine could be stopped.
- The resultant nip load became very high damaging not only the Yankee but also the press roll.

- If a single stress shock would not have been enough the shell was exposed to an extreme form of low cycle fatigue until the machine was stopped.

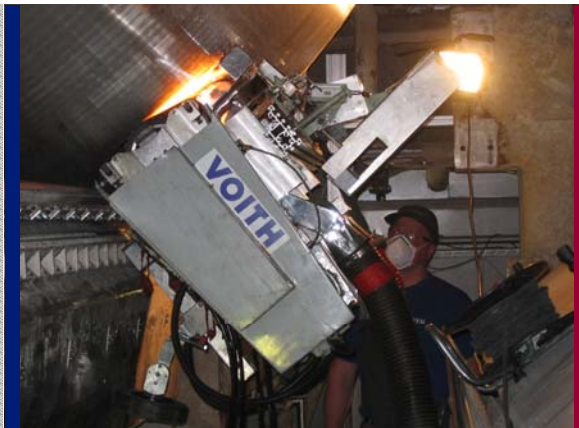
A Revolutionary
Approach to
Yankee Profile
Maintenance

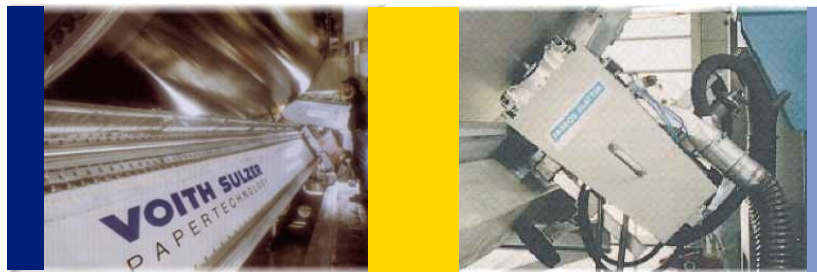
Previous Mobile Grinding Technology

Doctor Mounted Grinder (DMG)
Weight: 0.5 tons

'Tangential' Yankee Grinder
Weight: 5 tons
