# Advancements in Composite Cover Technology for Calender Applications

Bob Carney  
Stowe Weavexx

May 1-4  
**PaperCon 2011**  
Northern Kentucky Convention Center

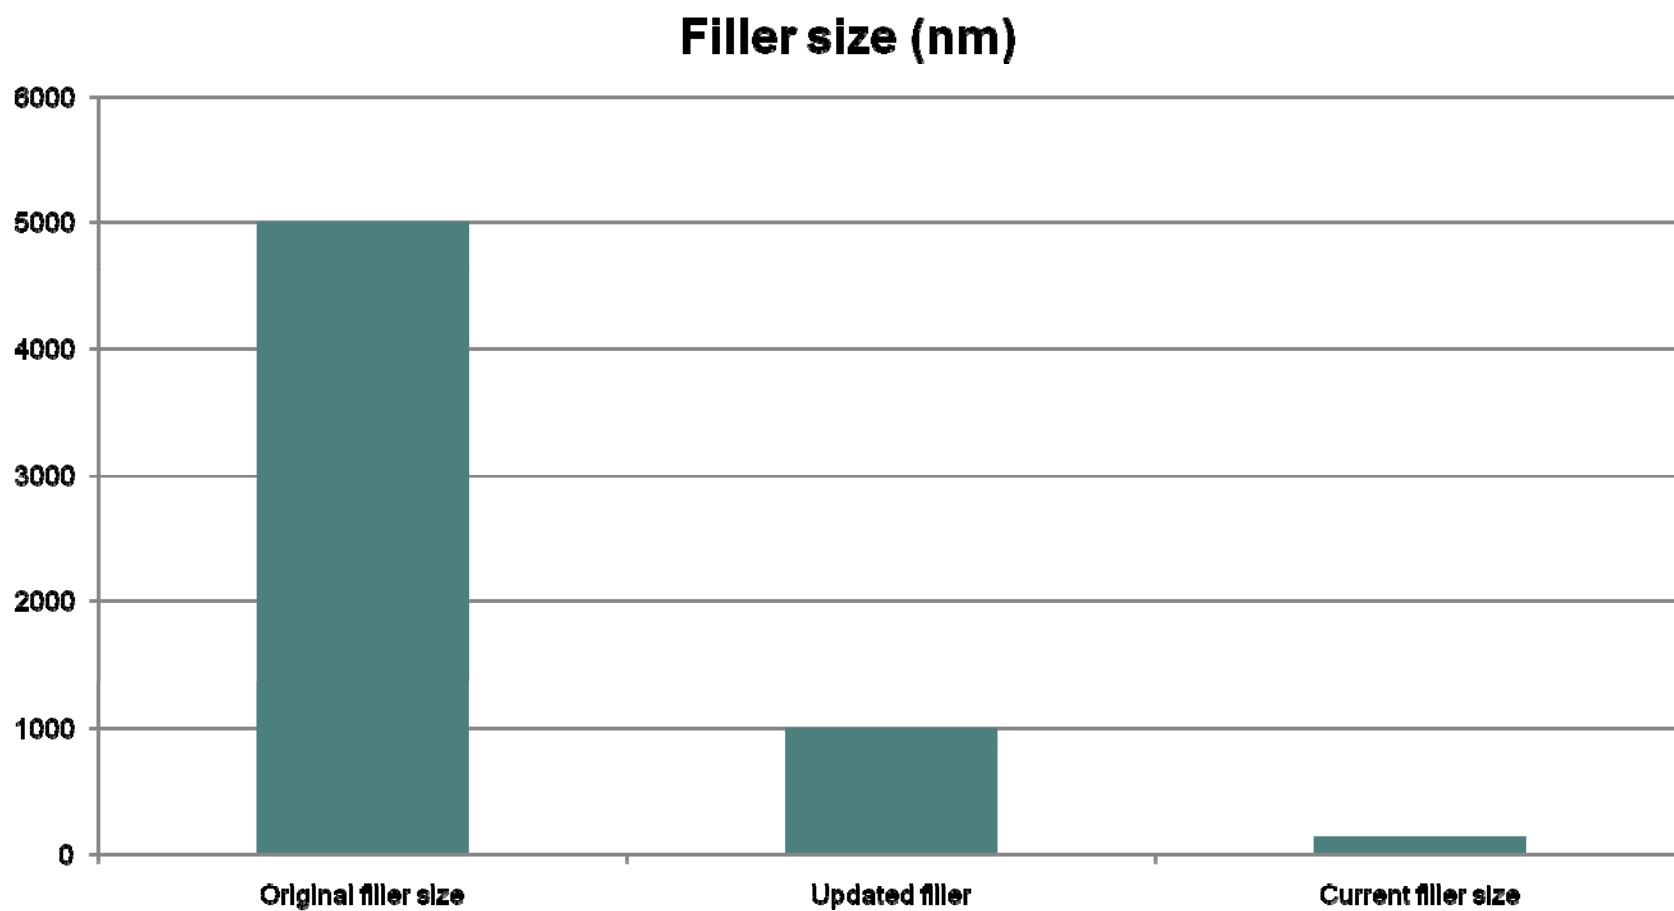
# Filler Size Reduction

- Silicon Carbide and Titanium Dioxide replace clay based fillers
- These fillers have a Mohs Hardness value of 7-9 and clay has a value of 2-3
- These fillers are also available in smaller sizes

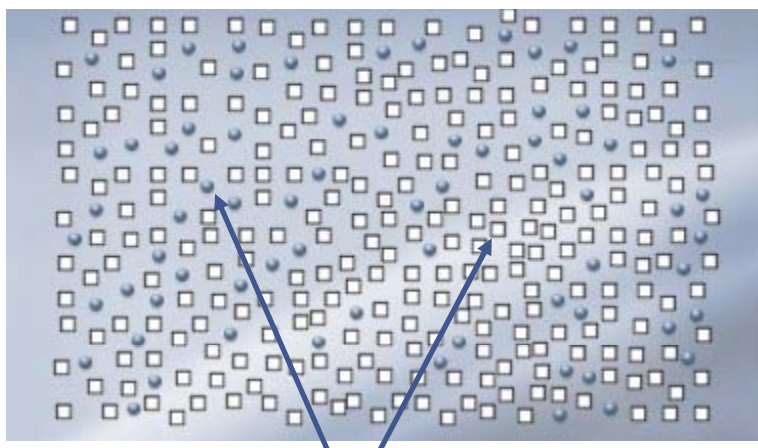
## Conventional Cover Matrix

**Large flake, spherical, and block particles allow more pockets of pure matrix with poor resistance to wear as the matrix wears the filler falls out leaving large voids.**

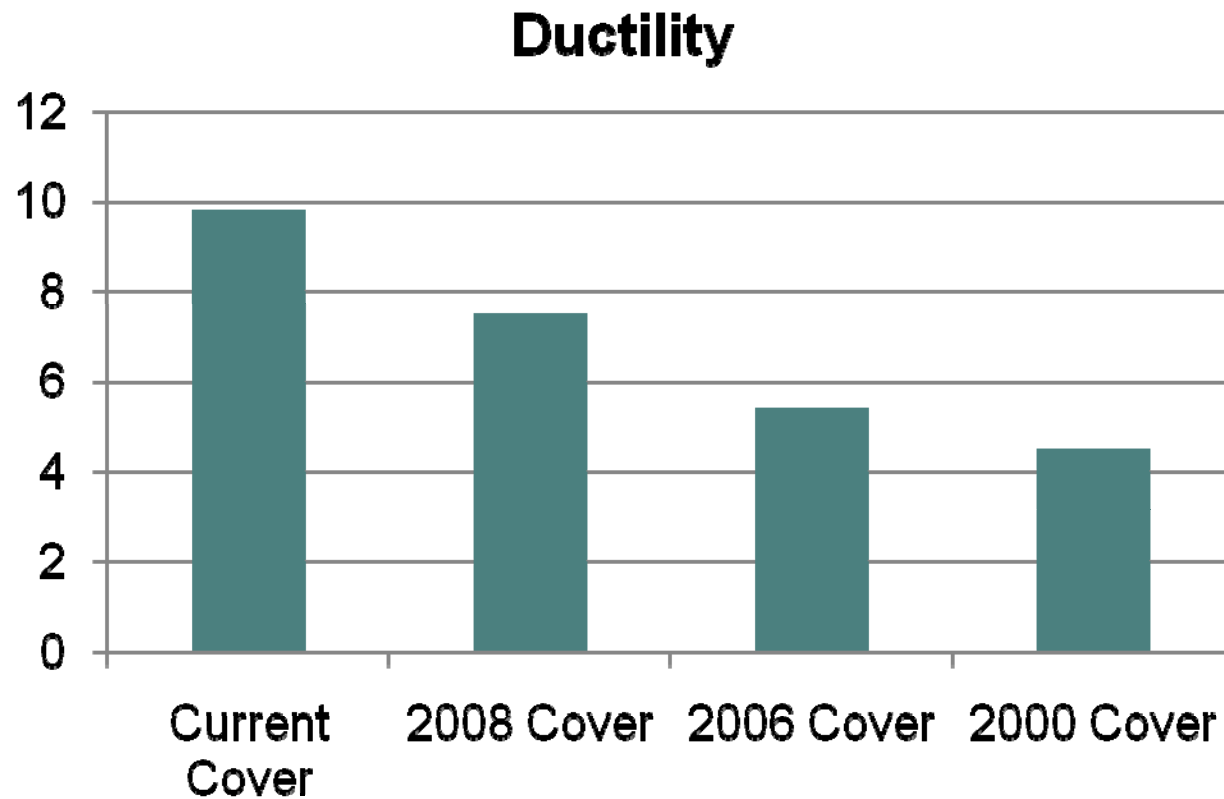
# Ductility Index

- Ductility allows the cover to come back after an impact
- Improvements increase damage resistance

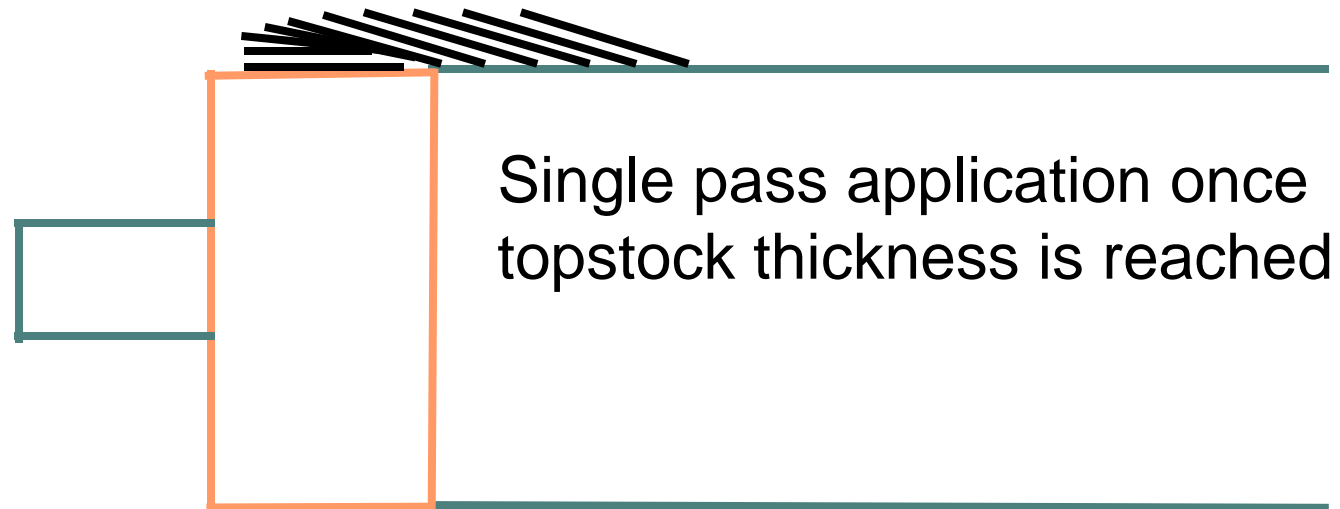
### Angle Wrap Application Method

- Higher fiber fraction
- Virtual elimination of defects
- Eliminates resin rich areas

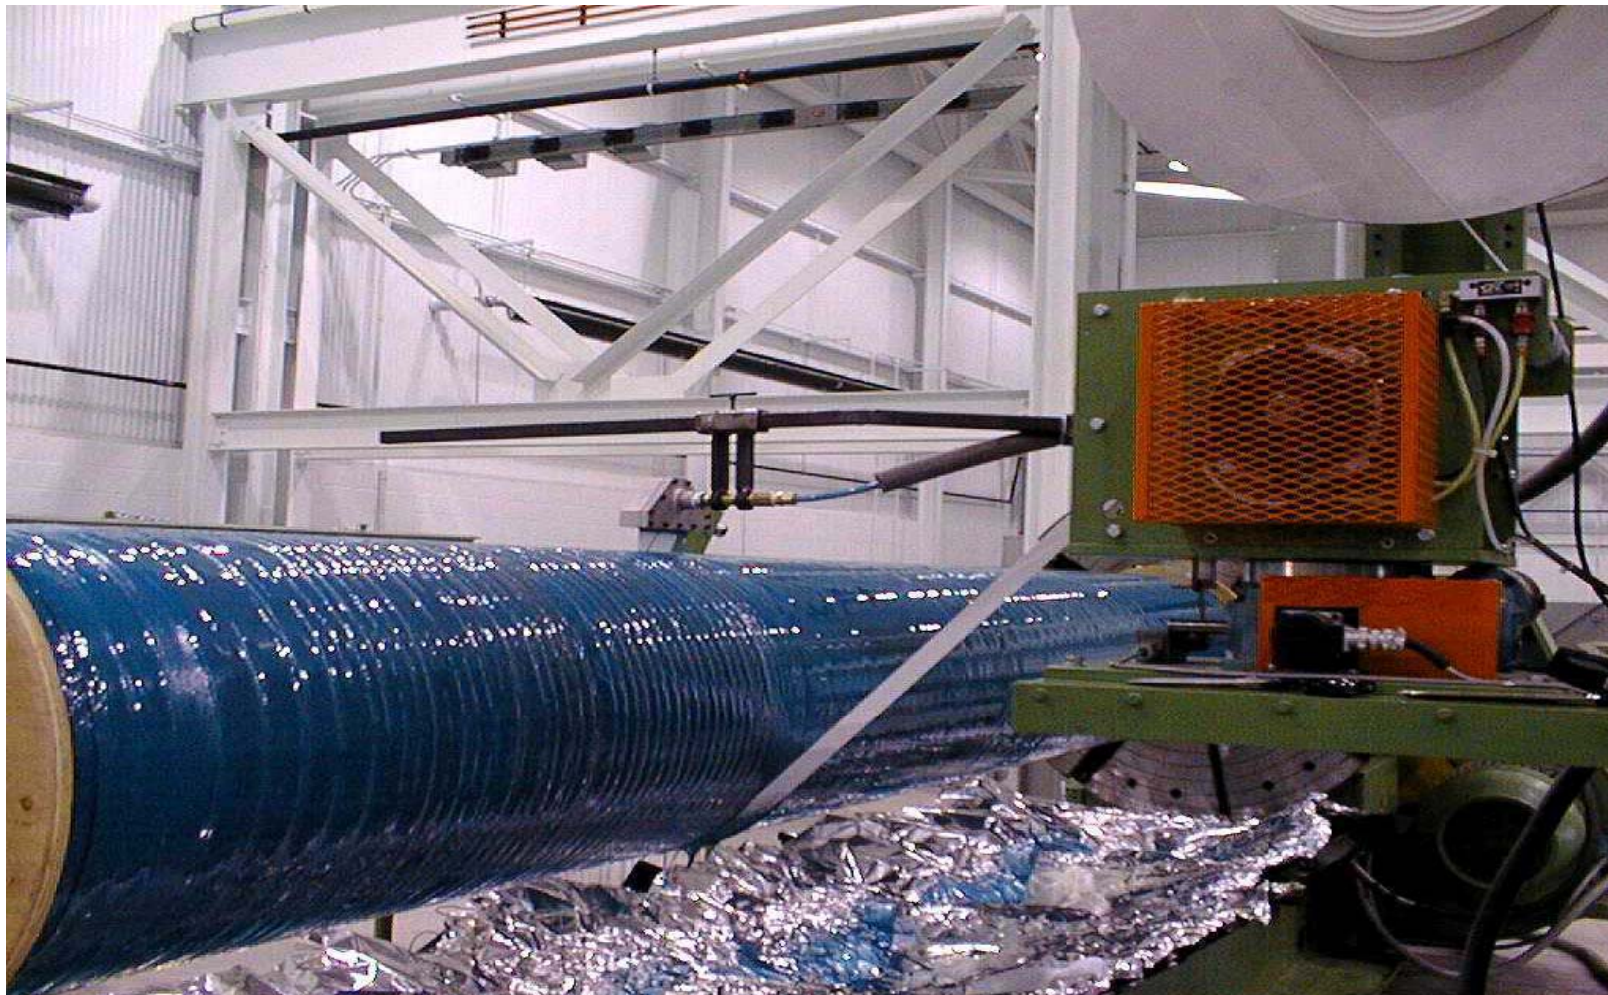
# Manufacturing The Wrapping Process

- Kevlar tension control
  - Computerized control
  - Improved Kevlar consistency
- Improved resin flow control
  - Computerized flow monitoring
  - Improved pumps
- Improved resin mixture systems
