# Continuous Digester Rapid Thinning

Margaret Gorog  
Houghton Cascade Holdings LLC  
November 2023

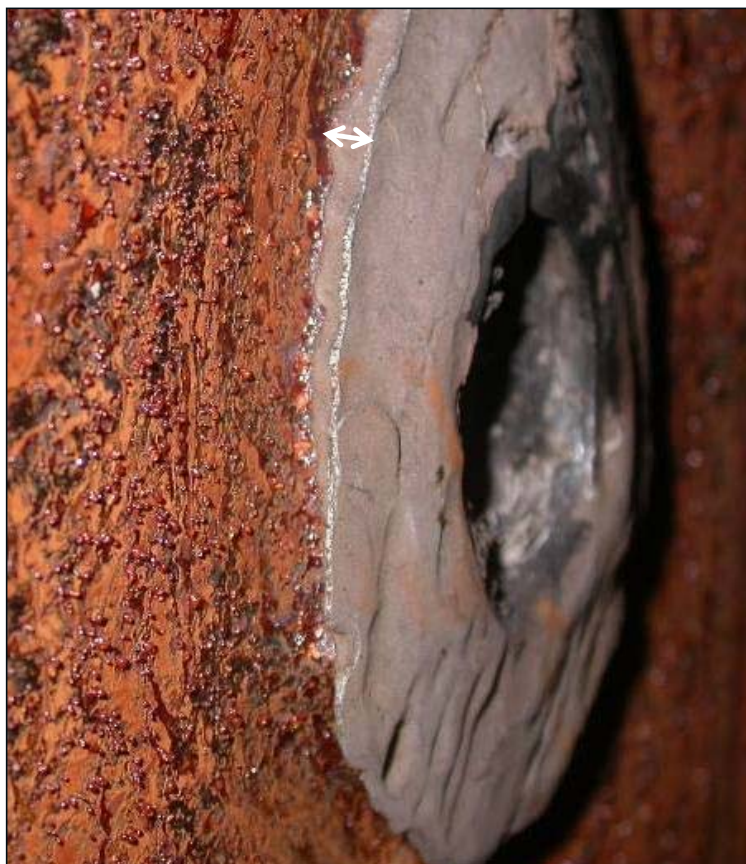
# The Shell has Receded from the Stainless Nozzle

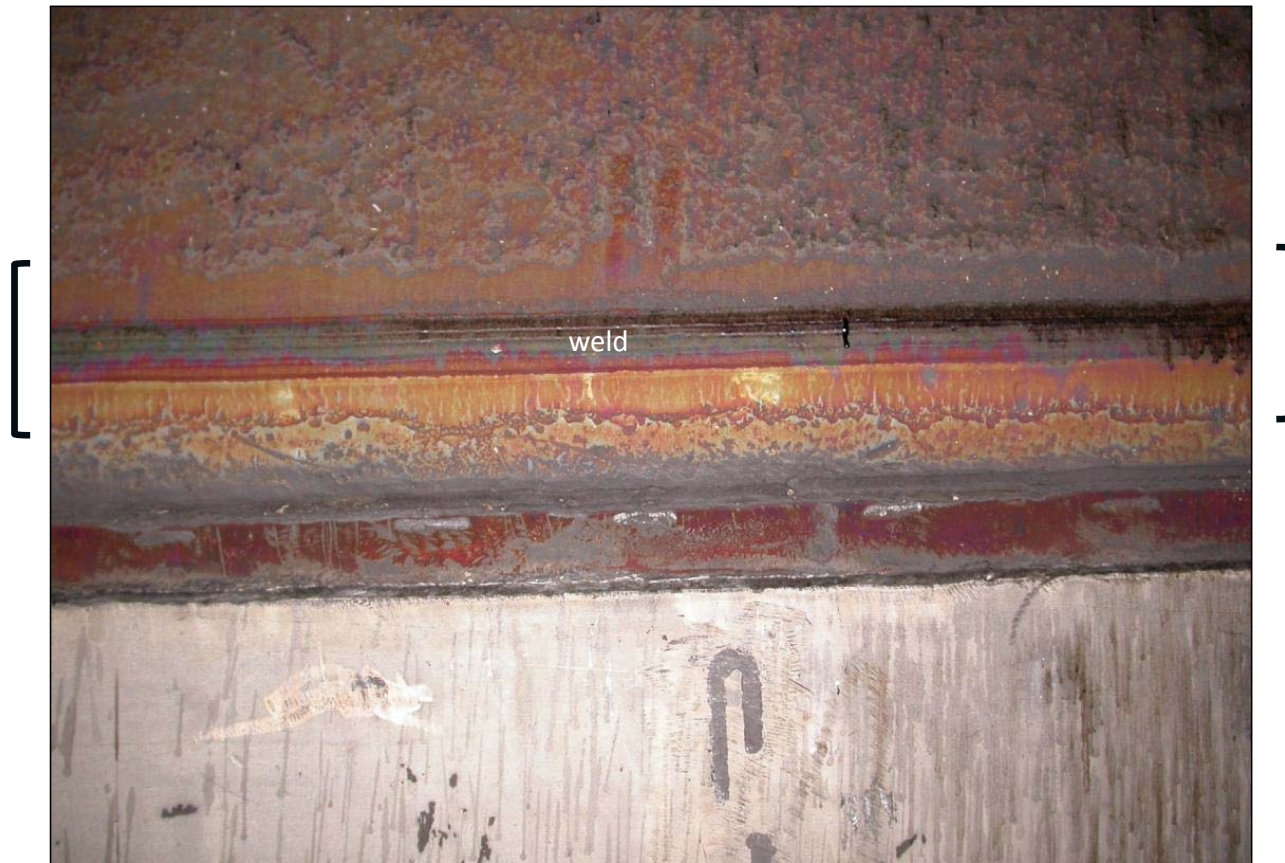
# Preferential Weld Corrosion

- Preferential corrosion
  - Welds, heat affected zones
  - Grinding, scratches
  - Disruption of mill scale
- “Ocean-Island”
- “Polishing” that produces a pit-free surface

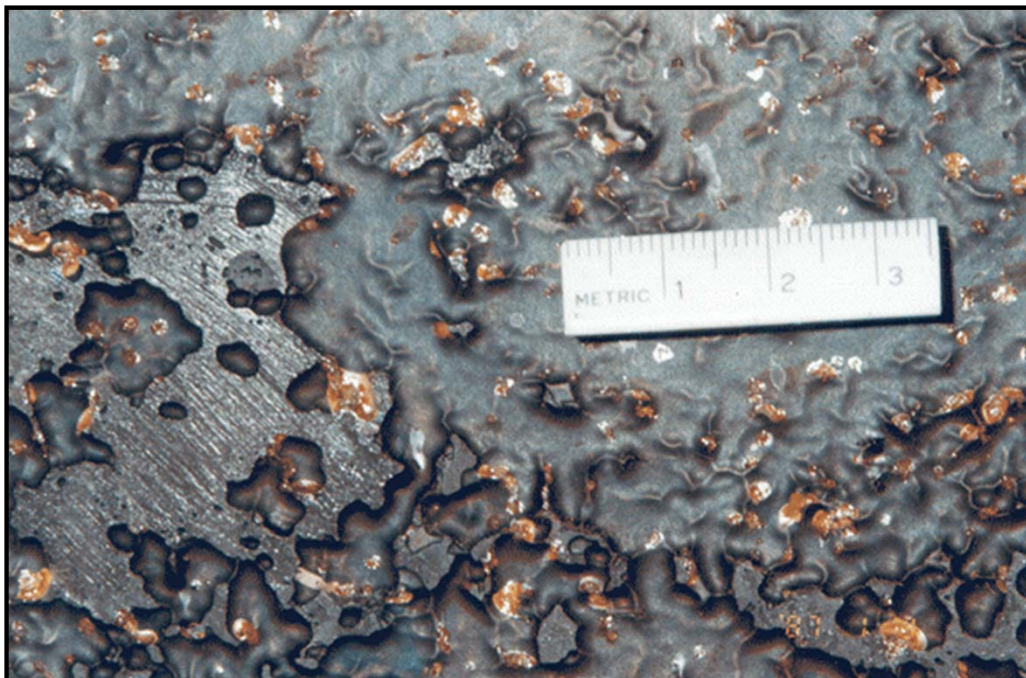
# “Ocean-Island” Corrosion

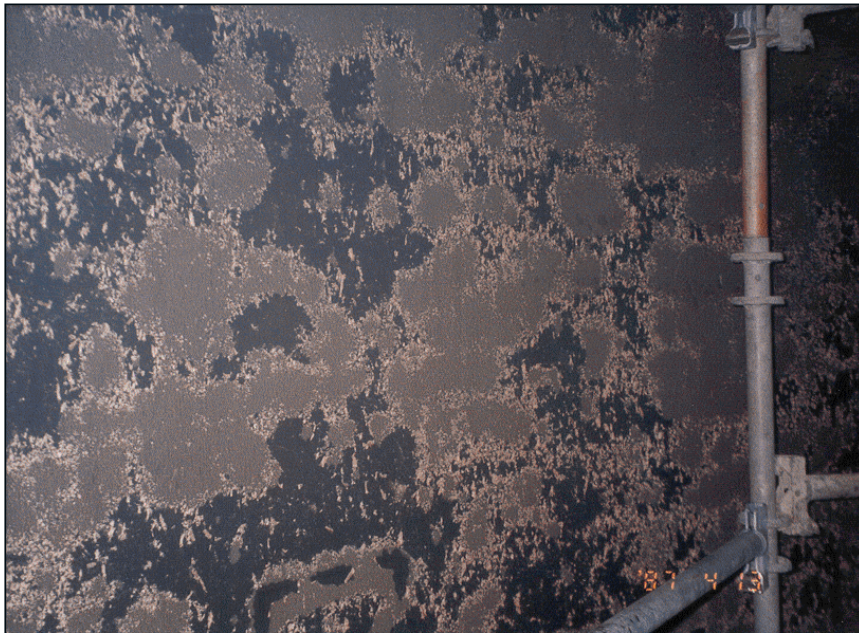
# More Ocean-Island Corrosion

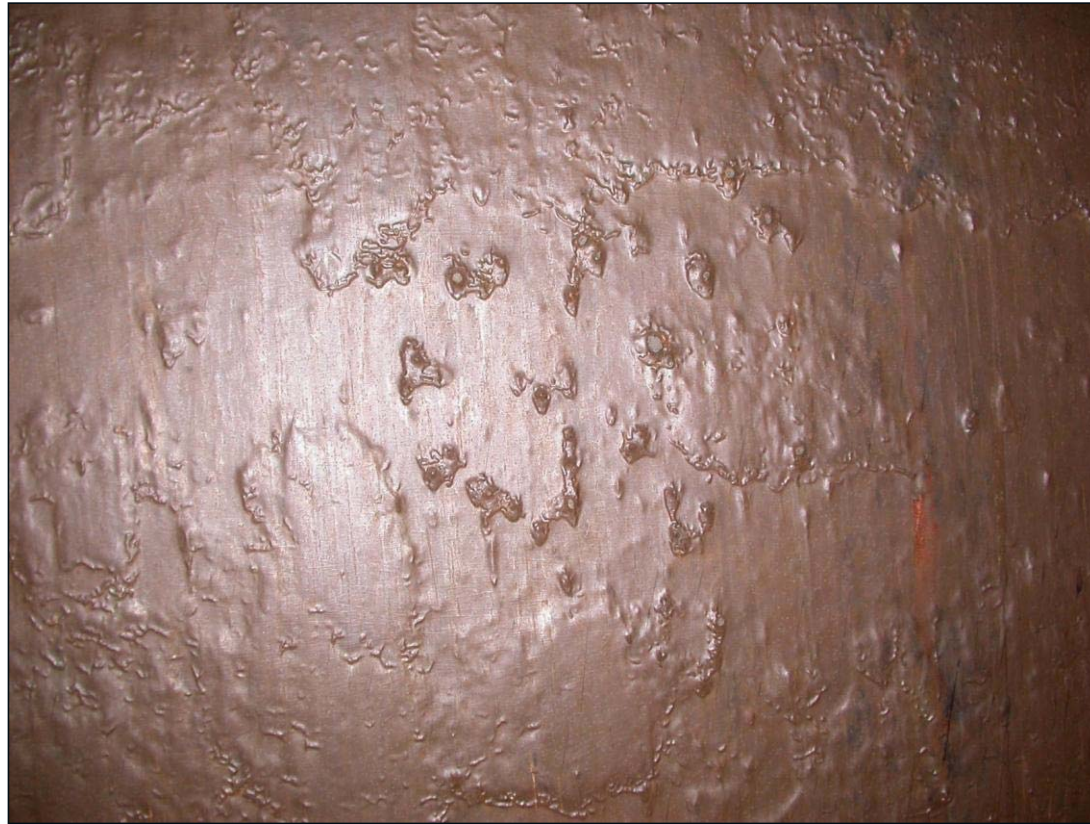
# Same Ring 8 Years Later

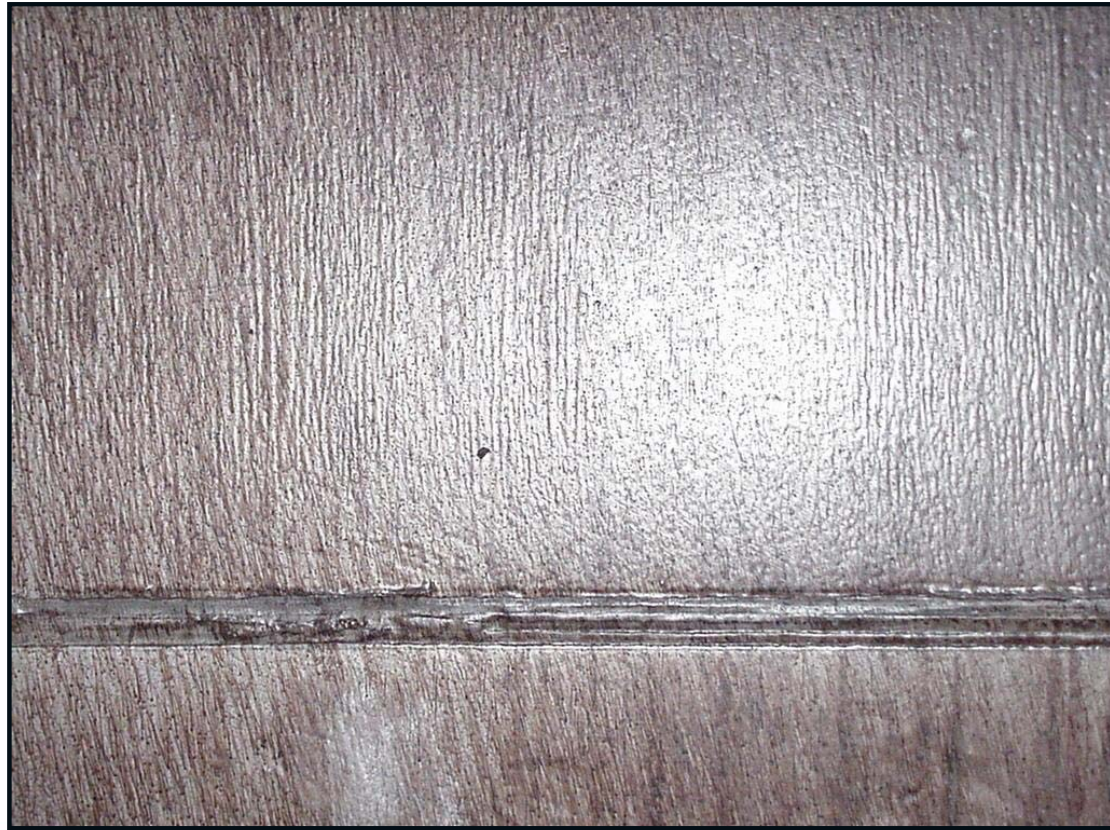
# Grooving, Smoothing and Weld Washout

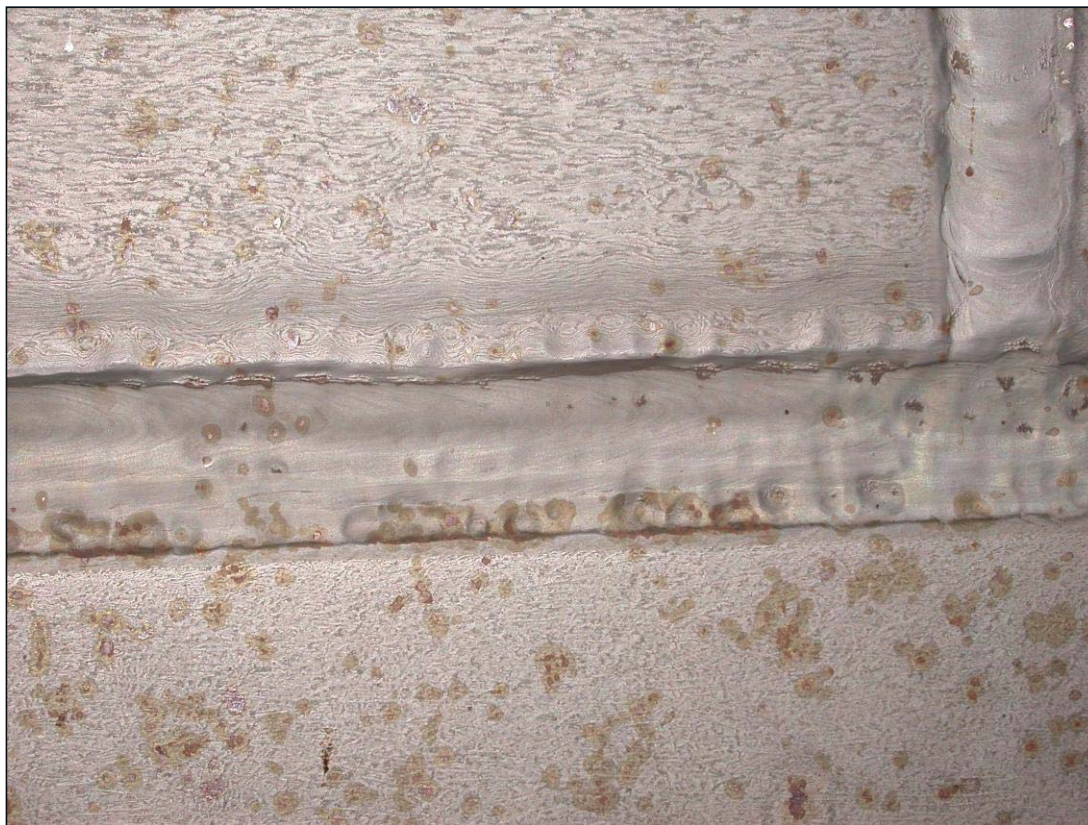
# Weld Close-Up Shows Polishing Effect

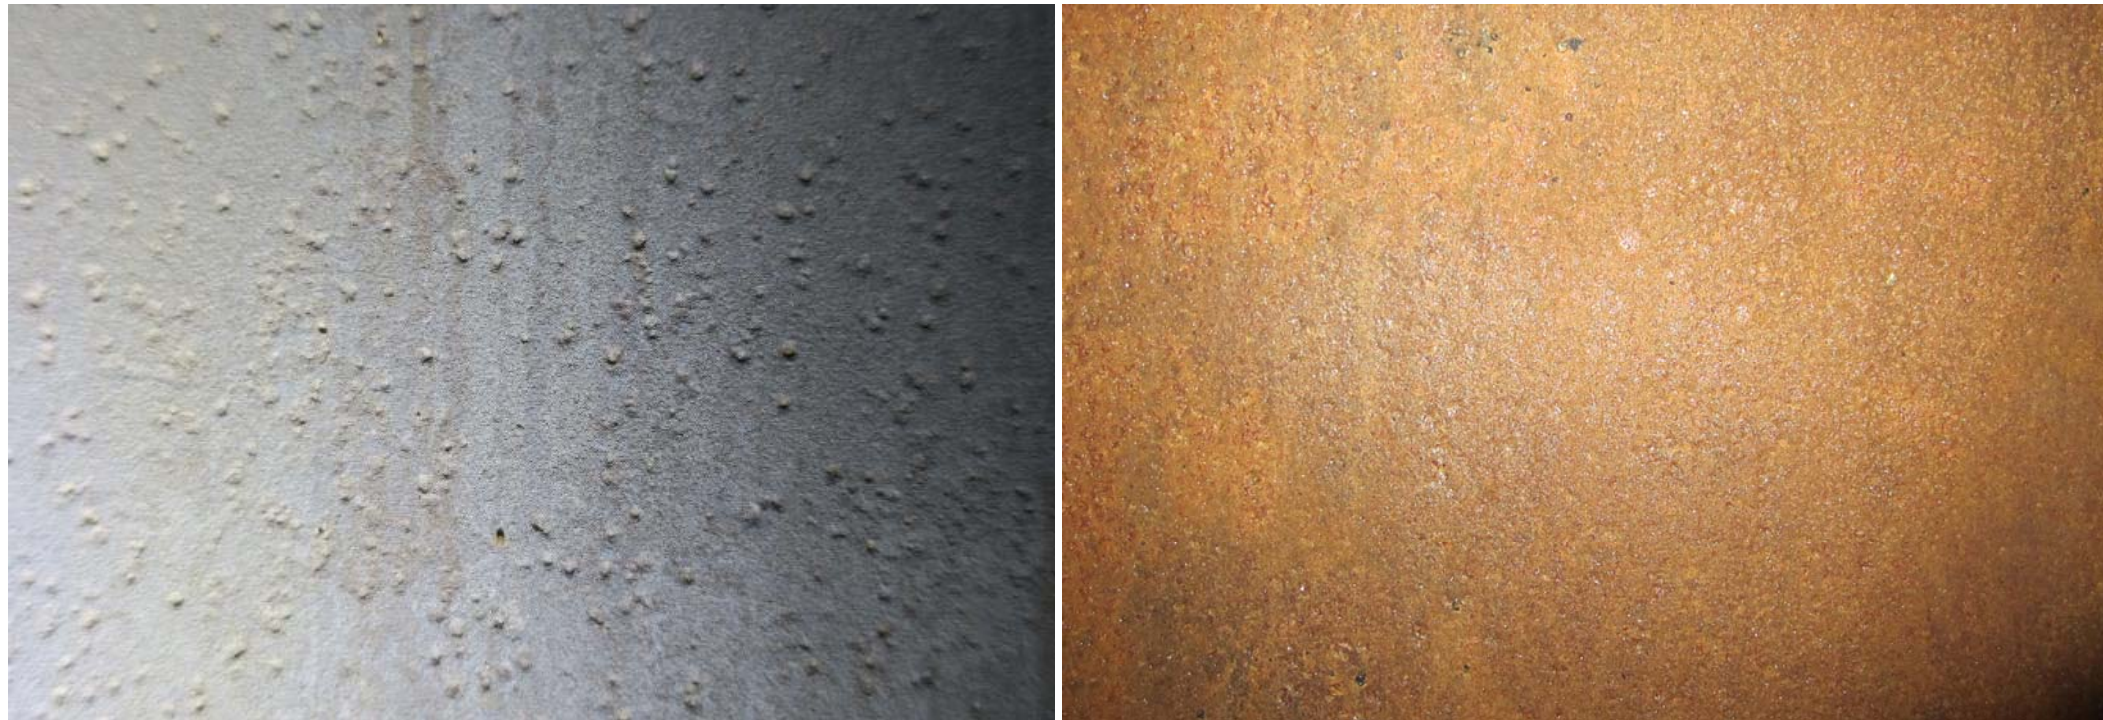
# Contrast With Upper Digester Pitting

Shallow, round, dispersed pits, rough surface

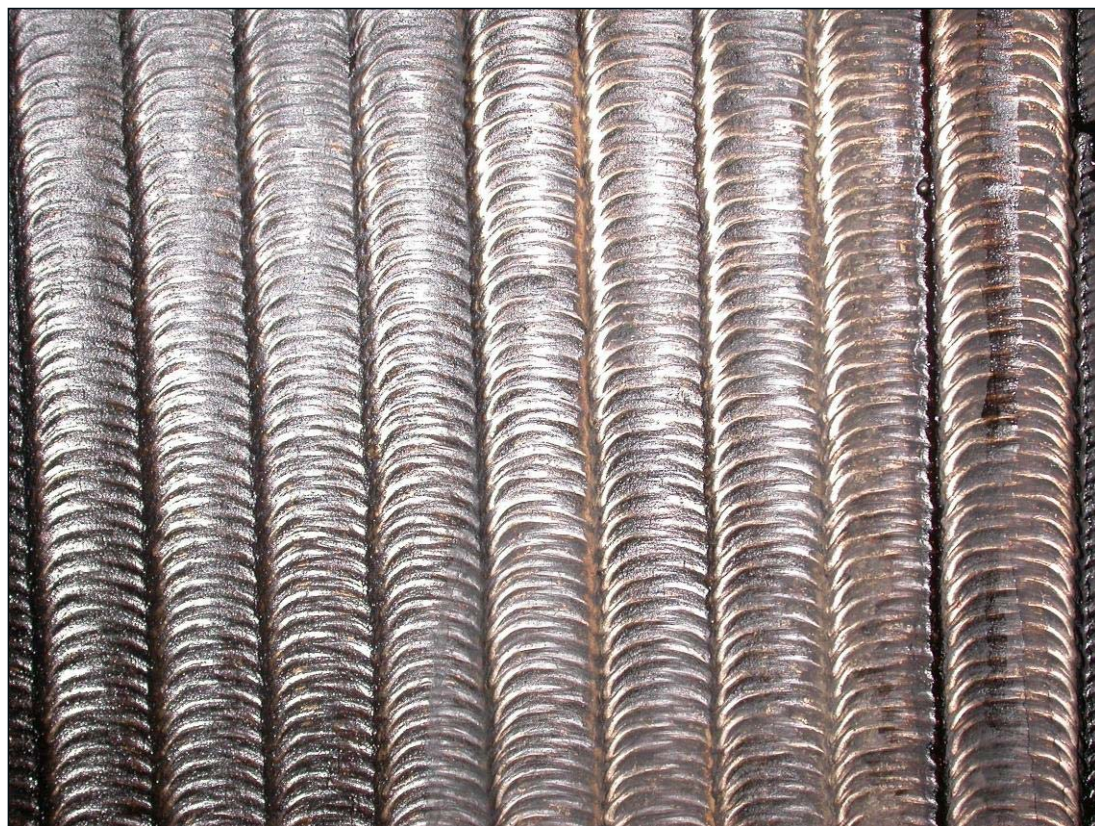
# Vertical Down

- Use TAPPI TIP 0402-03 for guidance
  - Consider applying overlay when the average remaining corrosion allowance is around 100 mils
- 309L with 18% chromium has enough corrosion resistance
- 312L duplex stainless steel, is not required, but its strength may be used if the shell is below ASME Tmin
- Establish quality requirements to prevent hot cracking i.e., control ferrite in stainless steel
- Vertical or horizontal overlay
- May require an extended shutdown
- Long lasting with little maintenance

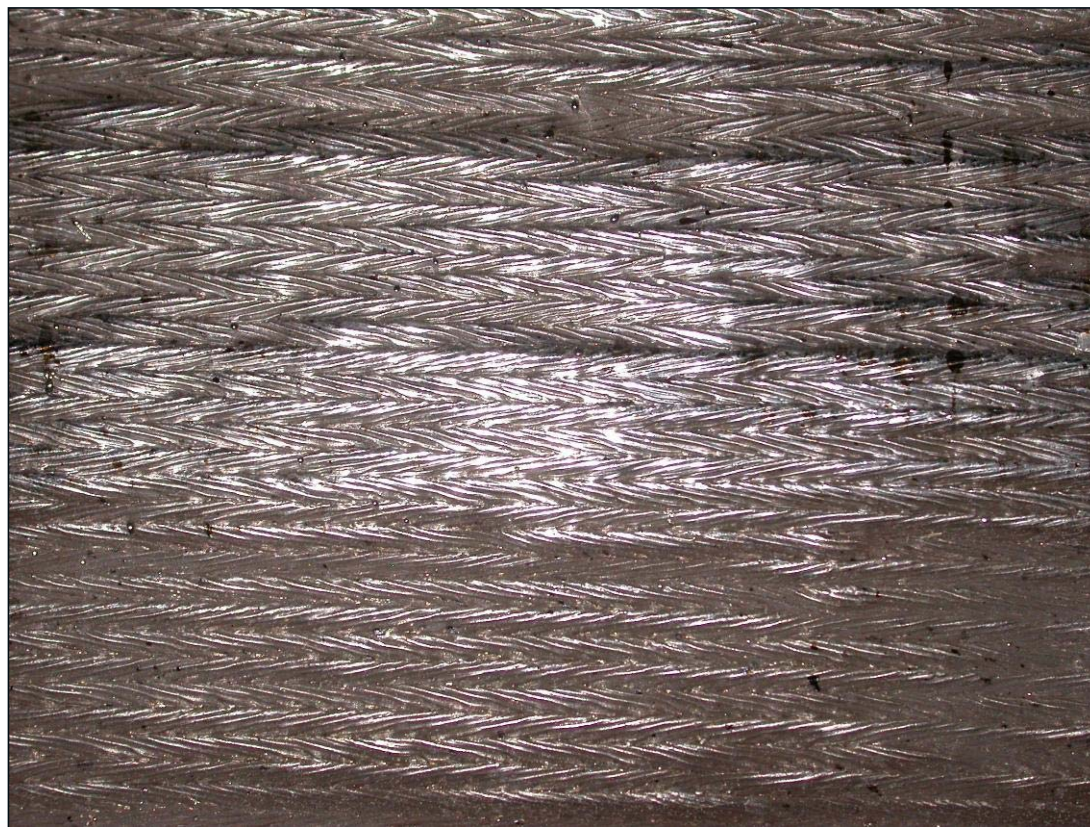
# 309L Overlay After 15 Years

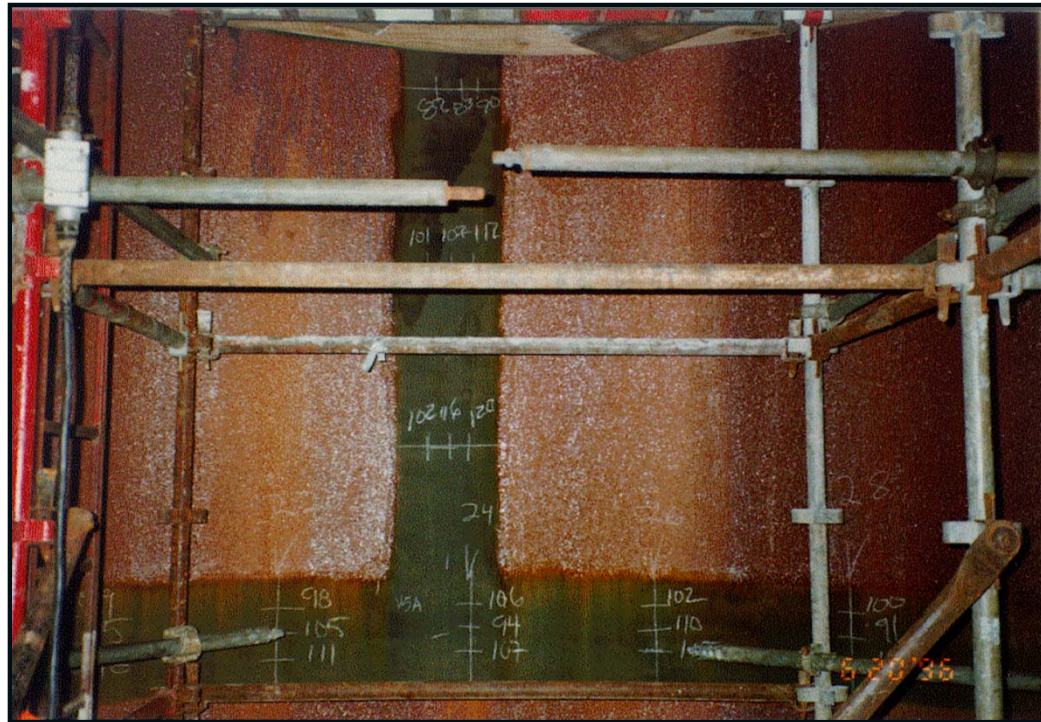
# Protecting welds from Stress Corrosion Cracking

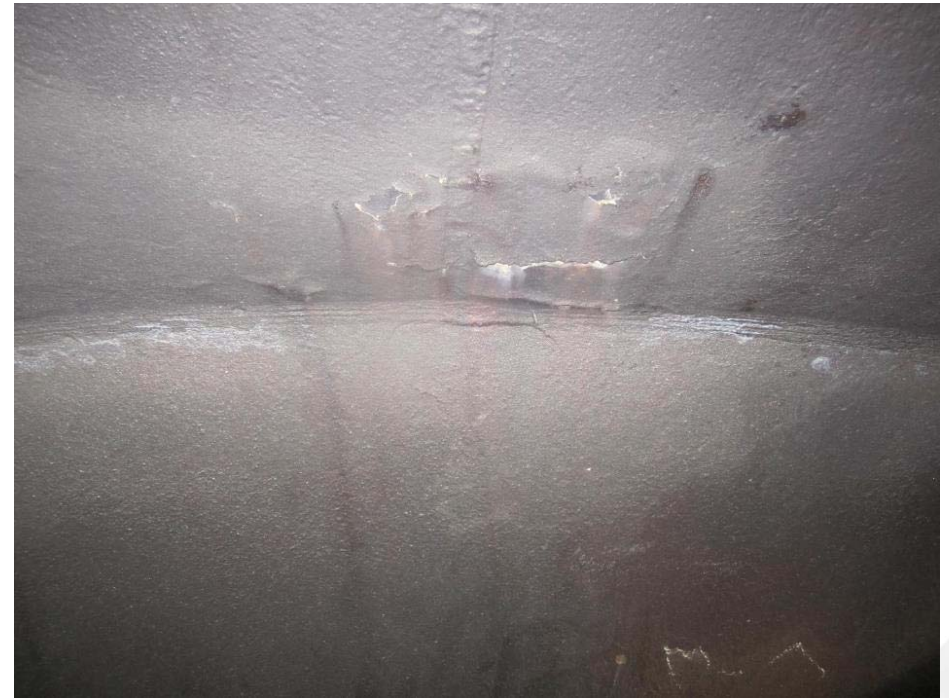
# Blistering and Spalling in a Flash Tank

- Use TAPPI TIP 0402-32 for guidance
- No heat affected zone
- May require an extended shutdown
- Limited access while the coating is applied
- Denser, thinner coatings are more likely to blister and spall
- For large areas, thermal spray requires more maintenance than weld overlay
