## **Continuous Digester – A Story of Shell Corrosion Under Insulation (CUI)**

**By Kyle Lindsay (Georgia-Pacific LLC)**

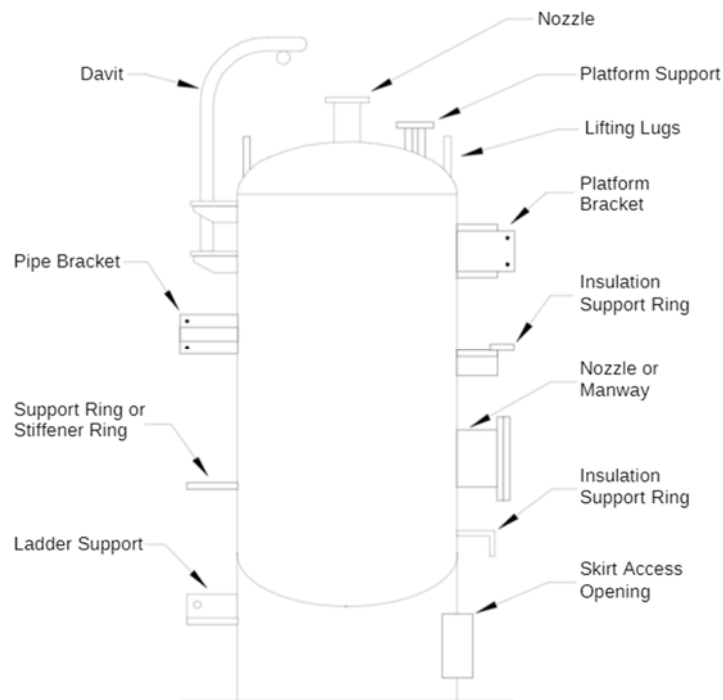
1. Developed Standard Operating Procedure for walking down vessels during hydro/testing of overpressurization protection interlocks.
  - o Leak checks to be done while vessel is held standard operating pressure.
    - Digester A's leak was not present unless pressure was brought up above operating pressure to test the first over pressurization interlock trip.
  - o Callouts specifically in walkdown procedures to check for leaks around suspected areas of concern for CUI. Areas of concern include those mentioned in SP0198 [1] best practice document (figure 6).

*Figure 6 Vessel Attachment types where water intrusion or debris buildup may occur reproduced from SP0198 [1]*

3. Performed visual inspection of areas where grating supports, insulation, lagging, etc., can cause a collection of seal water, liquor, or other liquid sources (Figure 6).

2. Design of new and existing insulation systems was scrutinized to pay attention to ensuring intended drains for attachments are not covered by insulation.

- o Support beam attachments which create cavities for collection of debris such as what caused the penetration of Digester B's shell have been modified to where they are free draining and will not collect debris or retain moisture.

- o If attachments cannot be engineered to prevent CUI then proper administrative controls such as routine visual inspections and thickness testing should be performed in suspected areas where CUI is observed.
