# Continuous Digester Process Safety Improvements

# Continuous Digester Stress Corrosion Cracking (SCC) Case Studies

## Digester “A” SCC case study information

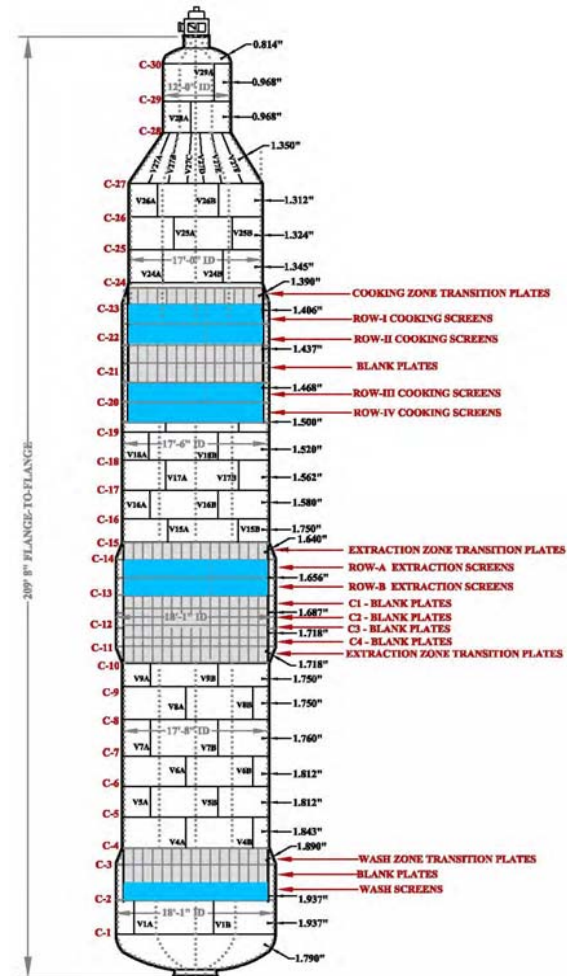
- 1966 Kamyr single vessel hydraulic continuous digester
- MAWP: 165 psi @ 350F, original corrosion allowance 0.250"
- Overall dimensions: roughly 17' diameter X 209'-8" high (with top neck down to 12' dia., step outs at screens)
- 30 circumferential weld seams – noted as “C1-C30” with higher elevation
- 2 to 6 vertical seams per course, labeled with prefix “V” and suffix “A-F” based on position clockwise from lower manway.

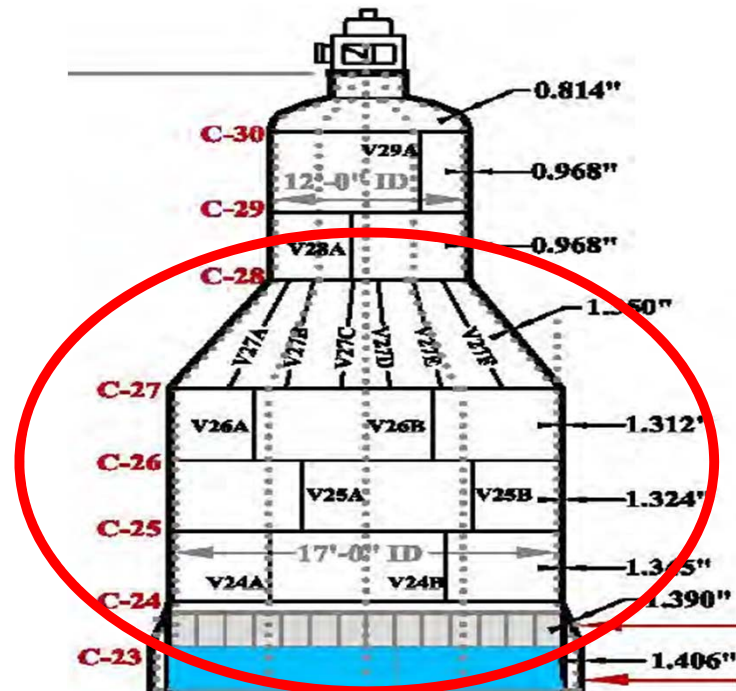
- Materials of construction
  - SA212 Gr B FBX with PWHT to C19
  - SA516 Gr 70 FBX above C19, no PWHT
  - SA264 304L cladding on top and bottom heads
- No other shell weld overlay or corrosion protection (no anodic protection)
- Previous inspections found SCC cracking in the impregnation zone circumferential welds (C24 thru C28)
- Major weld restoration executed in 2021 with transverse weld boat samples sent for analysis
- Leak detected during 2021 post outage hydro on top dome – undetected atmospheric corrosion forced unplanned flush plate repair (separate presentation)

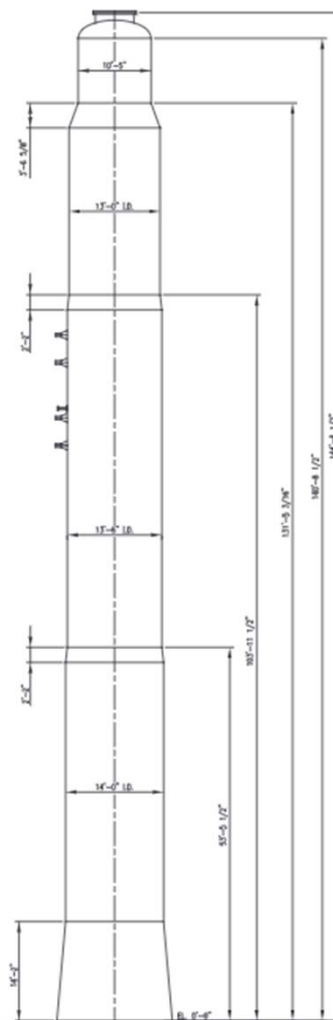
- 1964 Kamyr single vessel hydraulic continuous digester
- MAWP: 165 psi @ 350F, original corrosion allowance 0.250”
- Overall dimensions: roughly 14’ diameter X 144’-5” high (with top neck down to 13’ dia., step outs at screens)

- 17 circumferential weld seams – noted as “C1-C17” with higher elevation
- Materials of construction
  - SA285 Gr C FBX with PWHT to C7
  - SA264 304L cladding on top and bottom heads

- 2 to 4 vertical seams per course, labeled with prefix “V” and suffix “A-D” based on position clockwise from lower manway.
- An anodic protection system installed in the 1980’s (no record of exact year when it was installed), and it was rebuilt in 1996. After several years of issues, it was removed and replaced in 2021.

- C14 had thermal spray coating added in 2004 and C17 (penthouse) has Inconel weld overlay.
- Previous inspections found SCC cracking in the impregnation zone circumferential and vertical welds

- Major weld restoration and corrosion resistant weld overlay completed in 2023
