Troubleshooting Corona Treatment Issues

Rory A. Wolf

Enercon Industries Corporation

Abstract

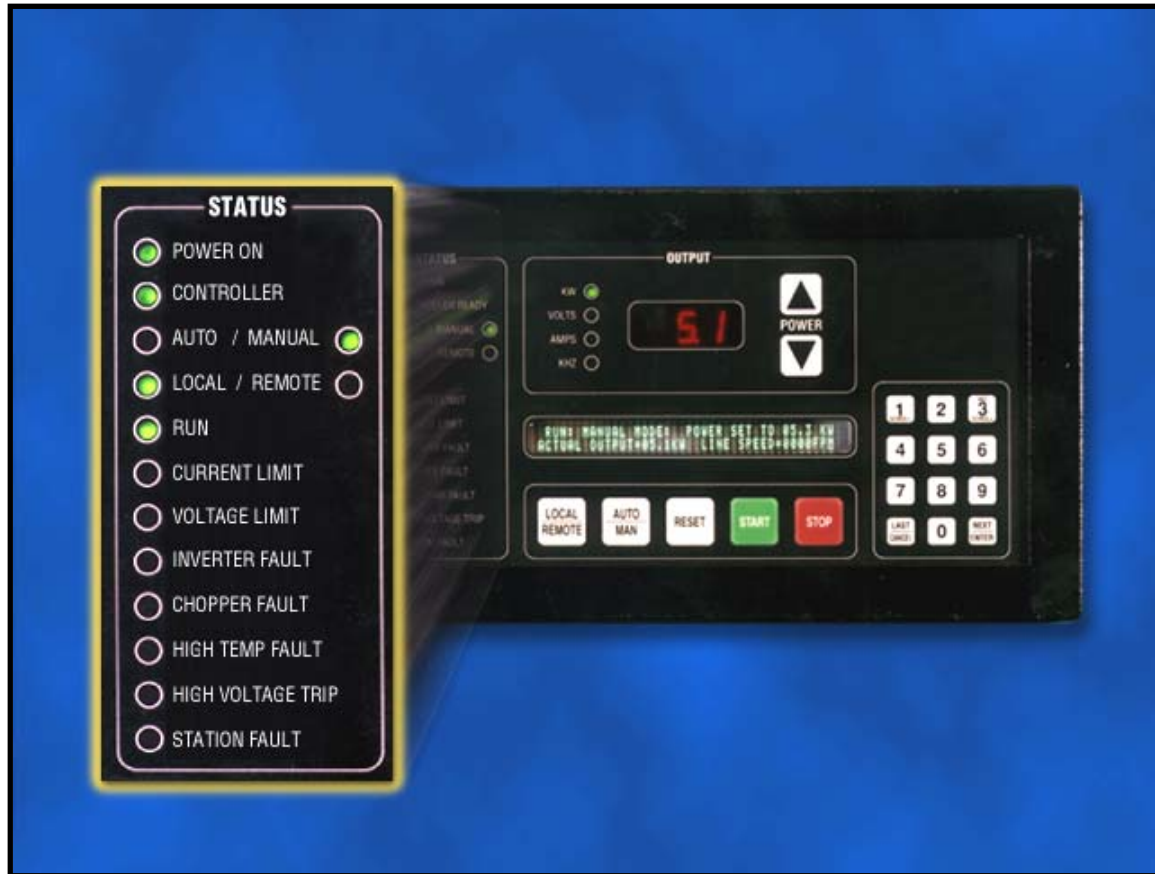
Power Supply Control Panel

- **2. At time of LINE DOWN incident**
 - **Check diagnostic indicators on Power Supply**
 - **Have instruction manual available**
 - **Have supplier service number available**
 - **Determine if internet on-line assistance is available**

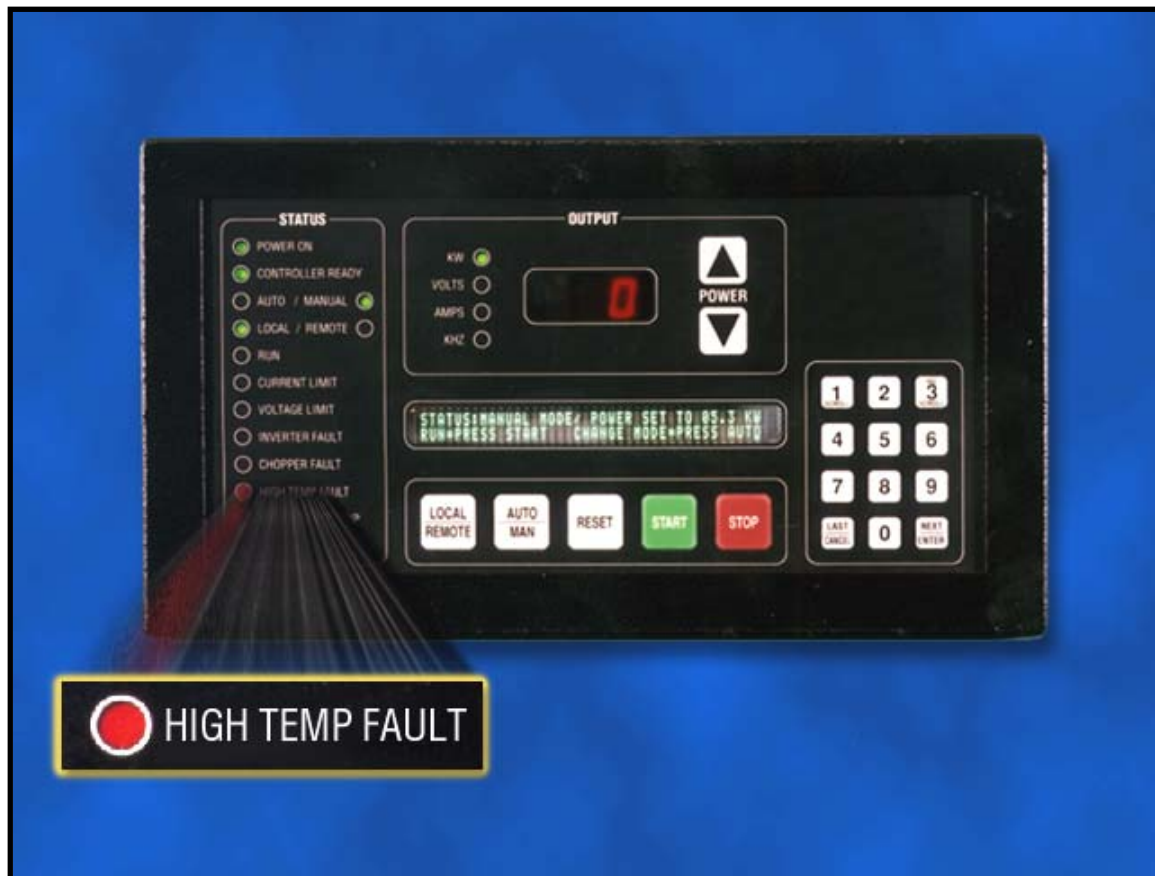
High Temp Fault Indication

High Temp Fault Checks

- **Heat Sink Fans operating?**
- **Heat Sink Fans clean?**
- **Thermal Switch normally closed?**

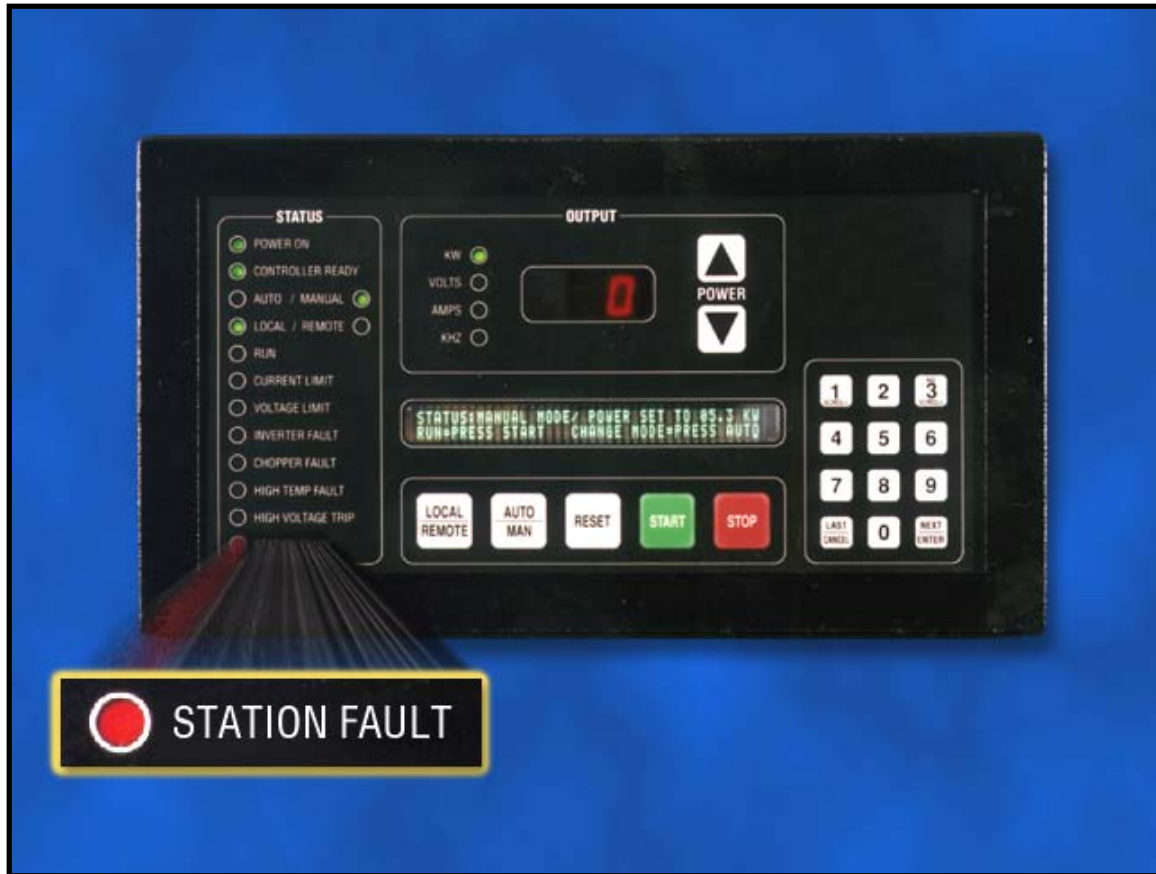
Station Fault Indication

Station Fault Checks

- **Air Flow: Is blower operating?**
- **Electrode Interlock: Is electrode in treat position?**
- **Zero Speed: Has line stopped or treater roll stopped rotating?**

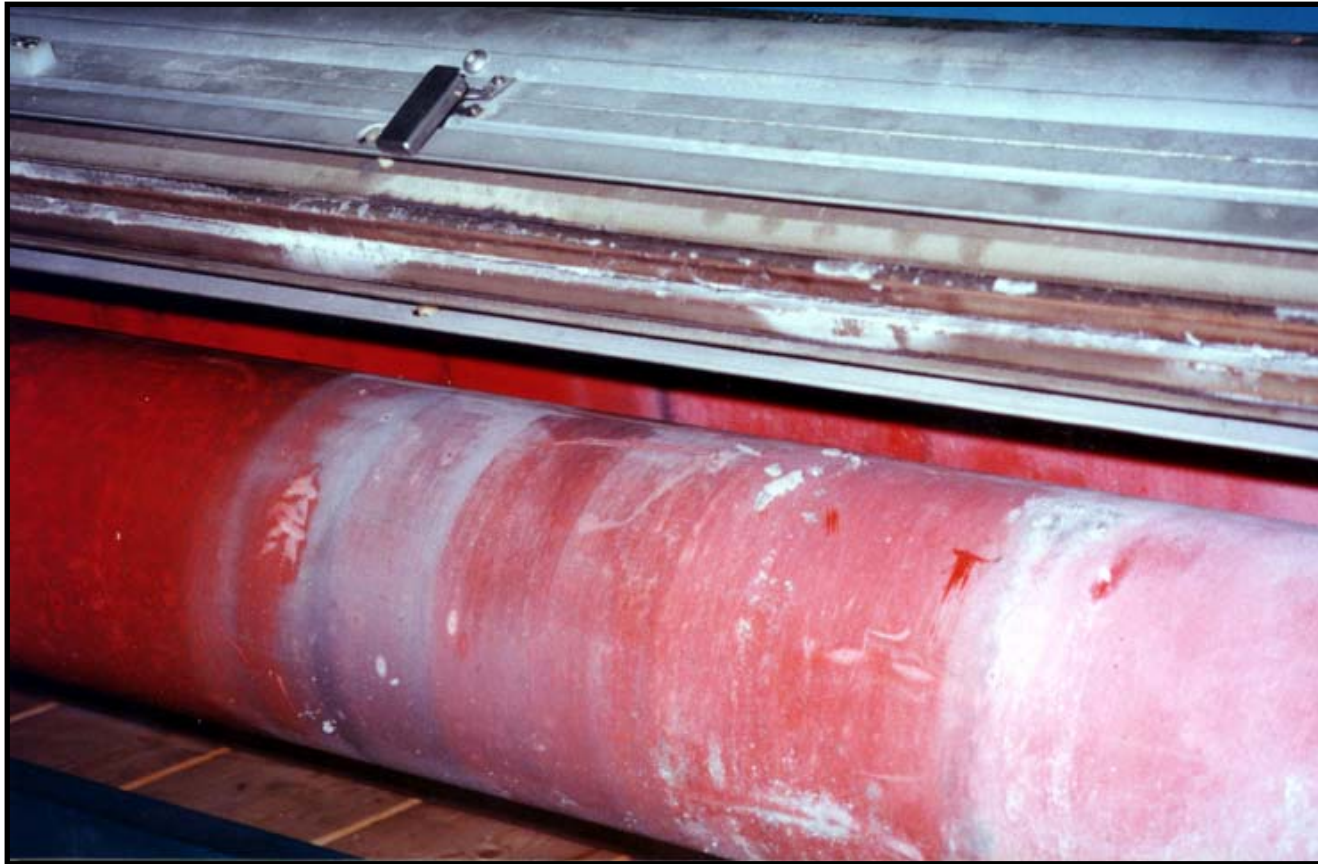
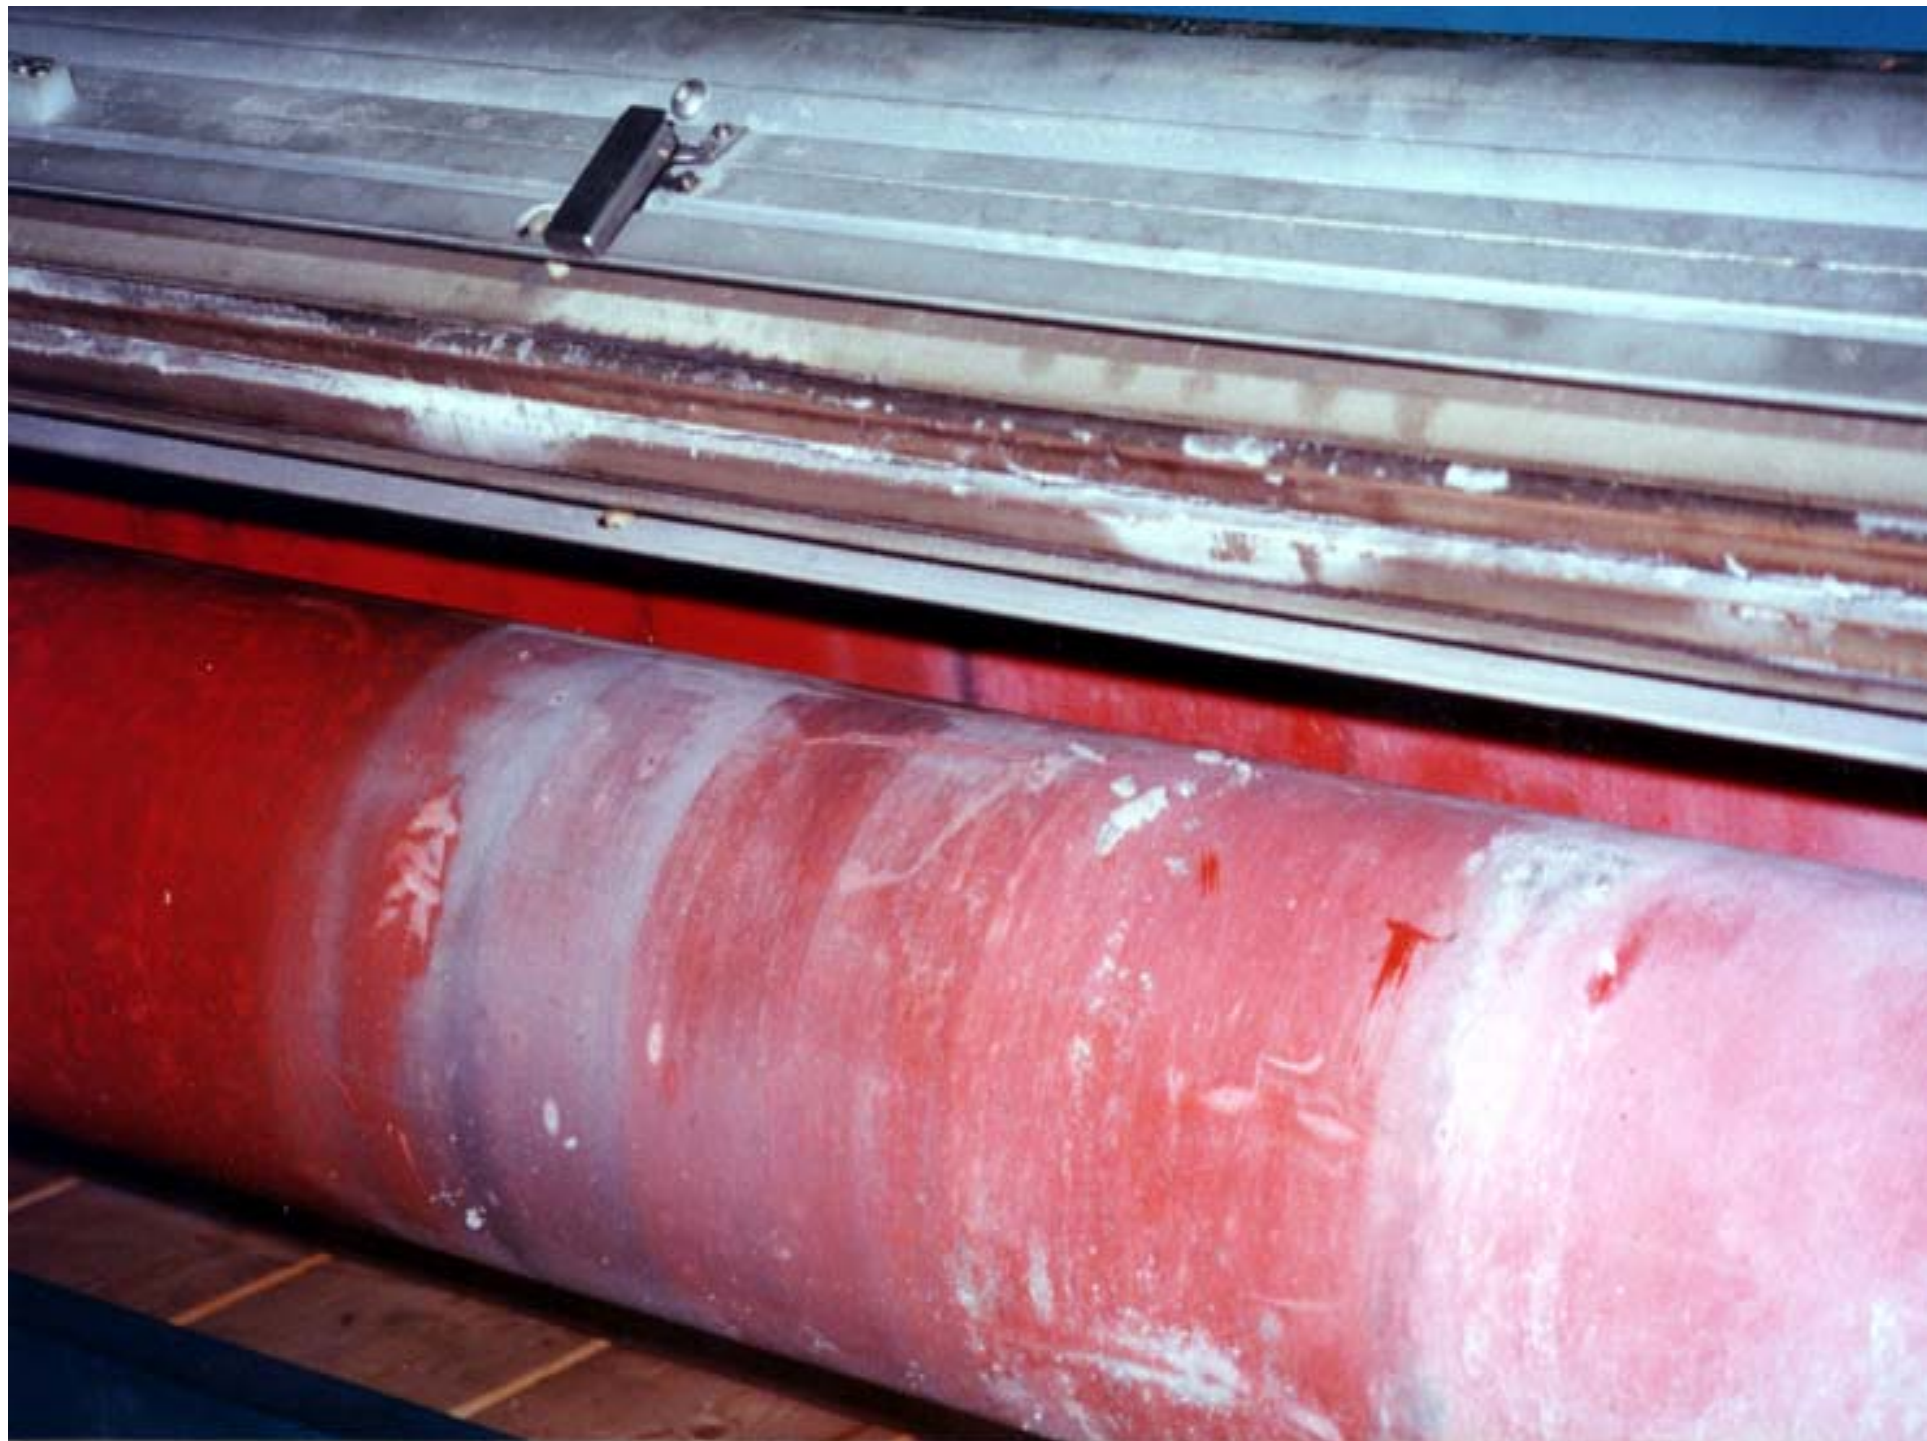
Dirty Roll

Roll Maintenance

- Bare – Roll
- Covered - Roll

number of causes for backside treatment, all of which are a result of air being entrained under the web being treated. One of the most common causes for backside treatment is dirt build-up on the roll. Another cause of backside treatment is due to the increase in line speeds. As webs exceed 600 fpm production speeds, boundary layers of air traveling with the web develop. These boundary layers of air can cause the web to float over the ground roll, resulting in air underneath the web. This air ionizes in the gap, producing backside treatment. The use of nip rolls at low nip tension tends to break up any boundary layer air traveling with the web. The use of treater roll coverings made from organic materials such as epoxy or rubber can also cause backside treatment as the covering begins to deteriorate from the heat, ozone and UV exposure produced in the corona process. This problem can manifest itself when running different web widths as a visible pattern of the different webs begins to appear on the roll. Wrinkles are also another cause of backside treatment. The most common method of eliminating wrinkles is with spreader or stretcher rolls. Roll realignment, readjusting web tension, extending the web wrap, improving gauge control and managing static are also key approaches to wrinkling problems which emerge.

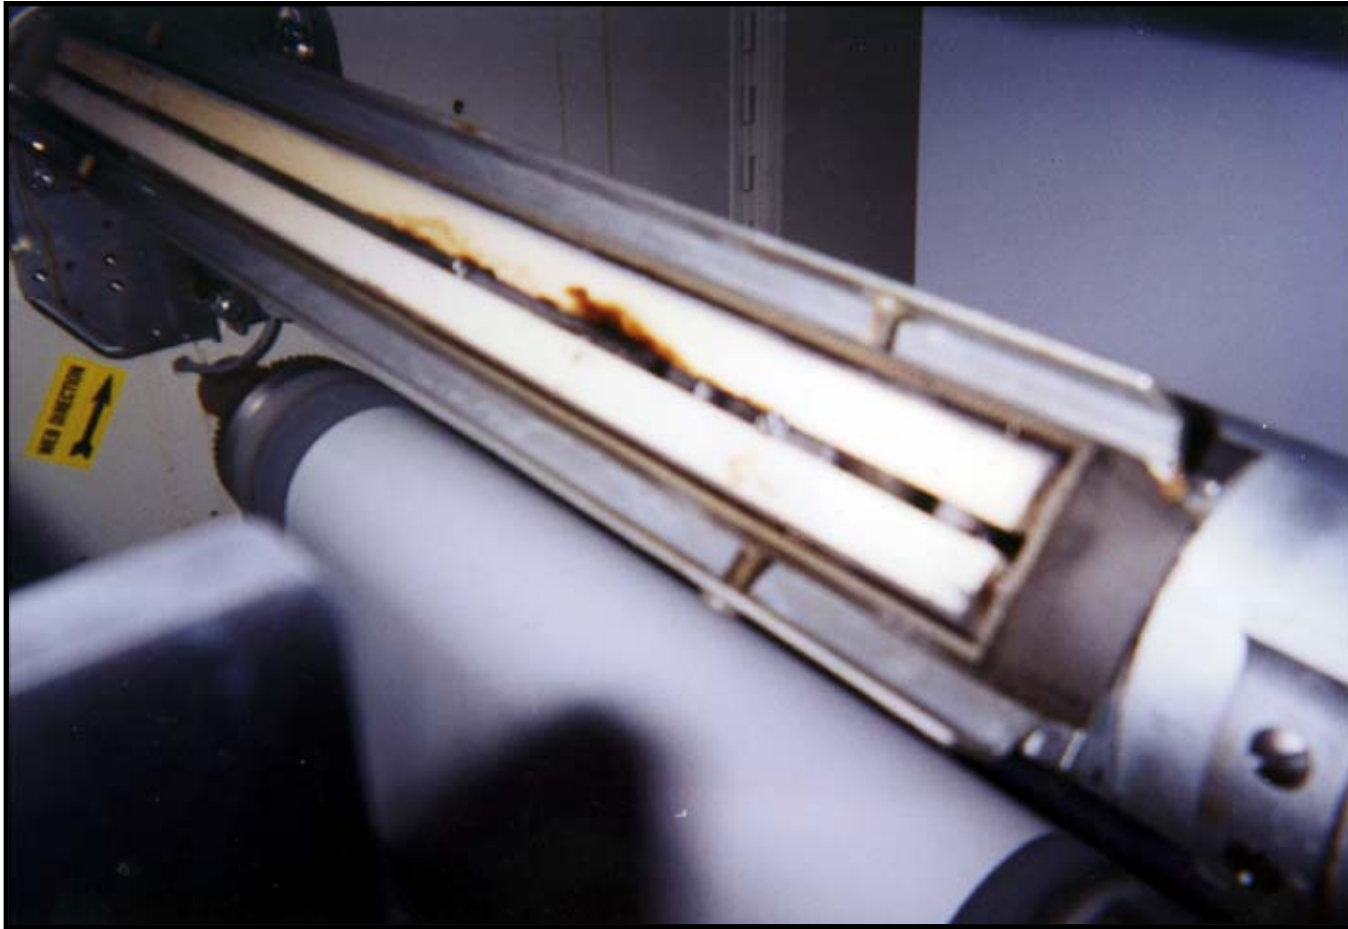
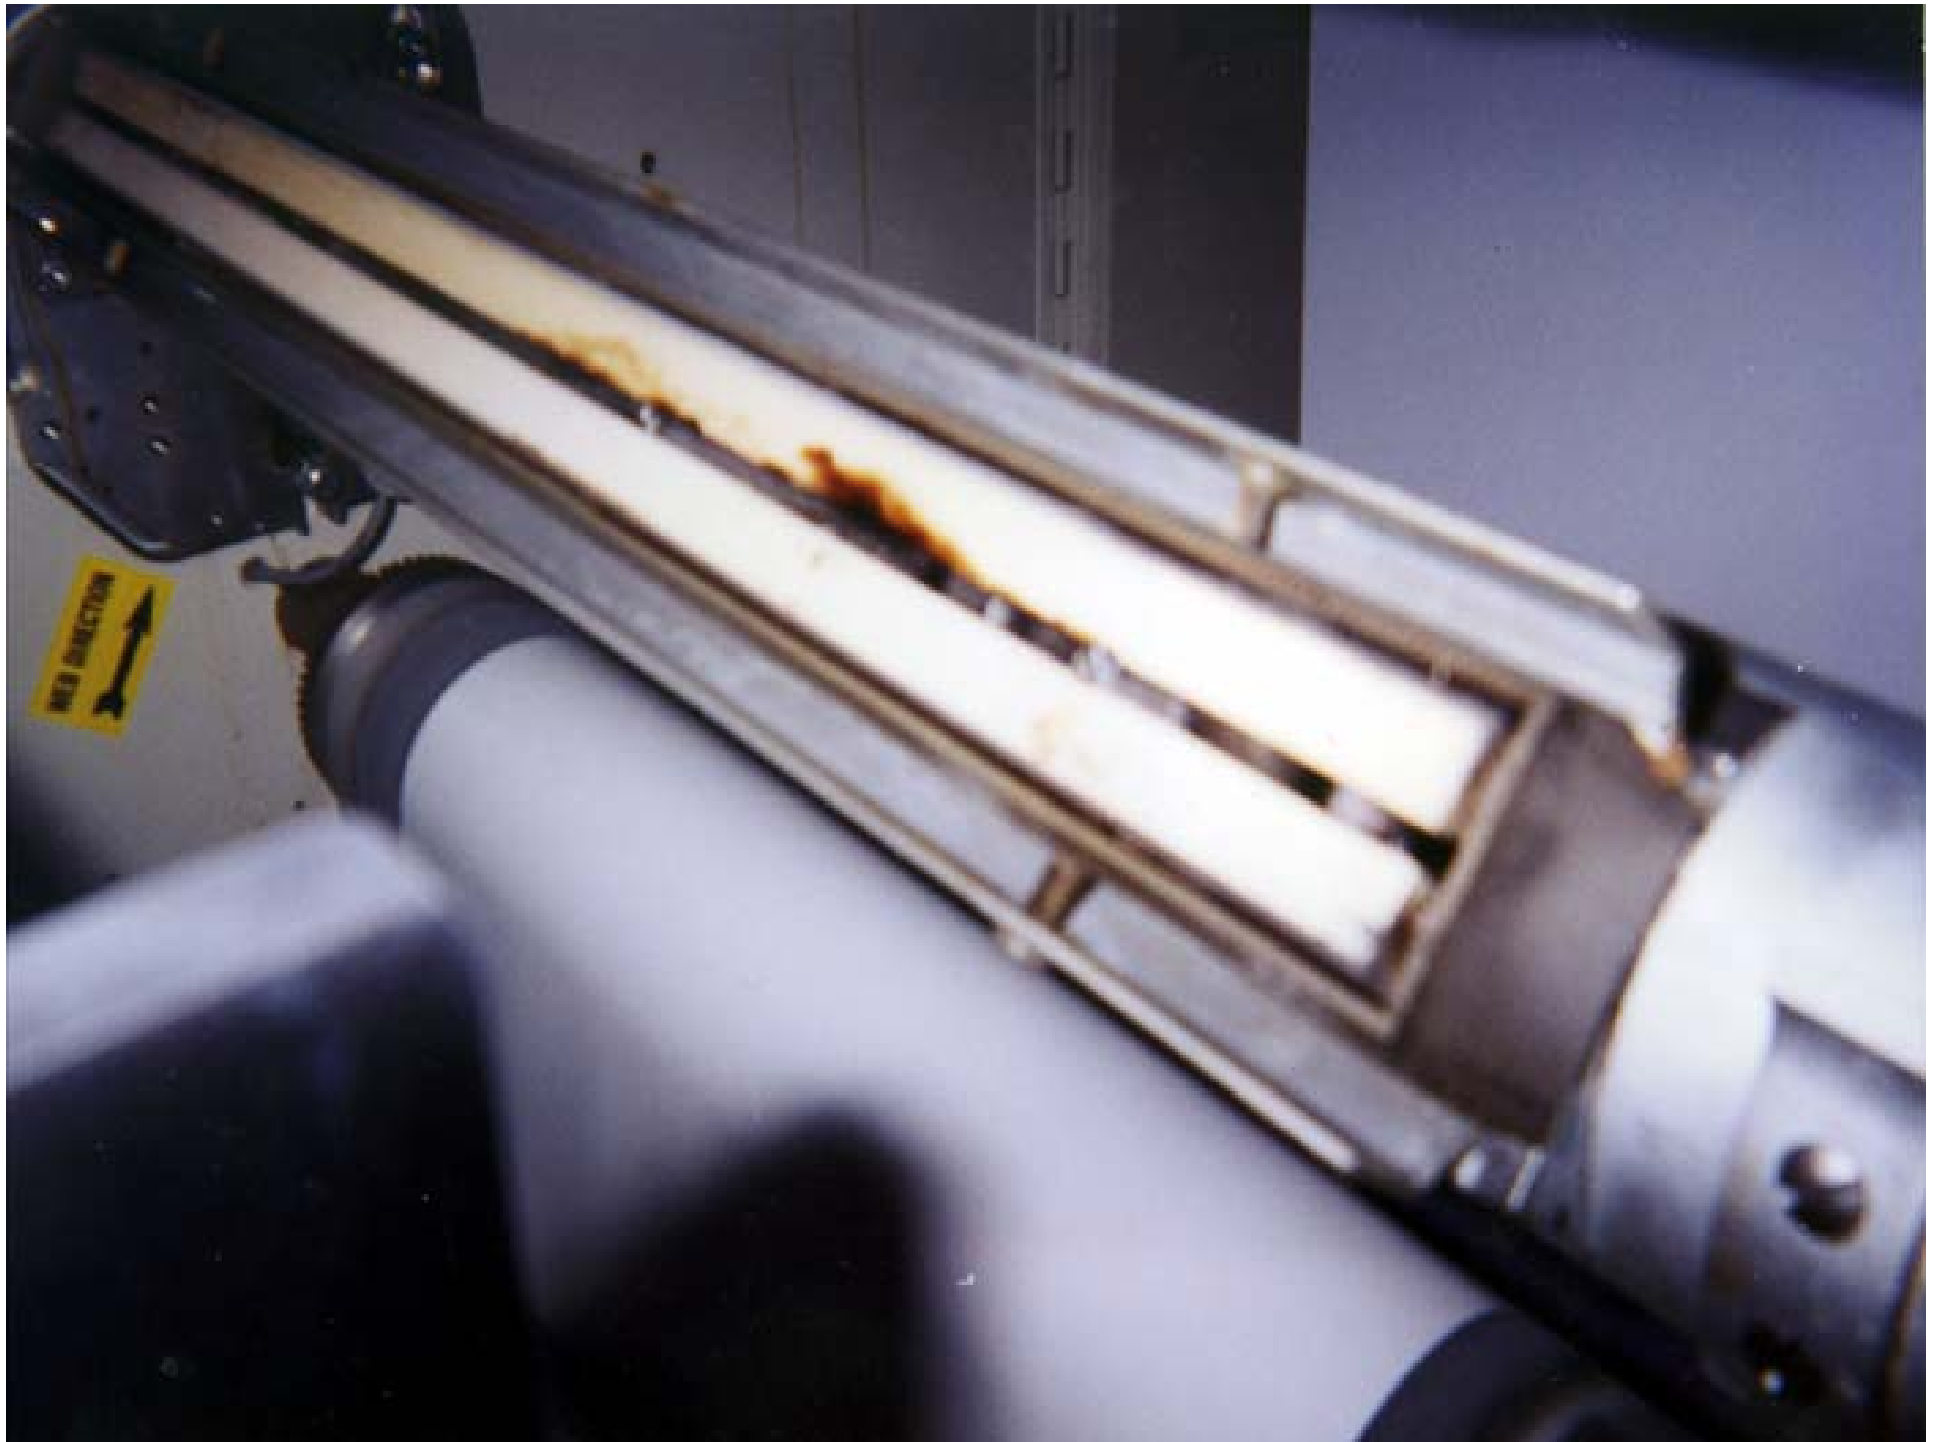
Dirty Electrode

Electrode Maintenance

- **Assembly**
- **Air Flow**
- **Air Gap Adjustment**

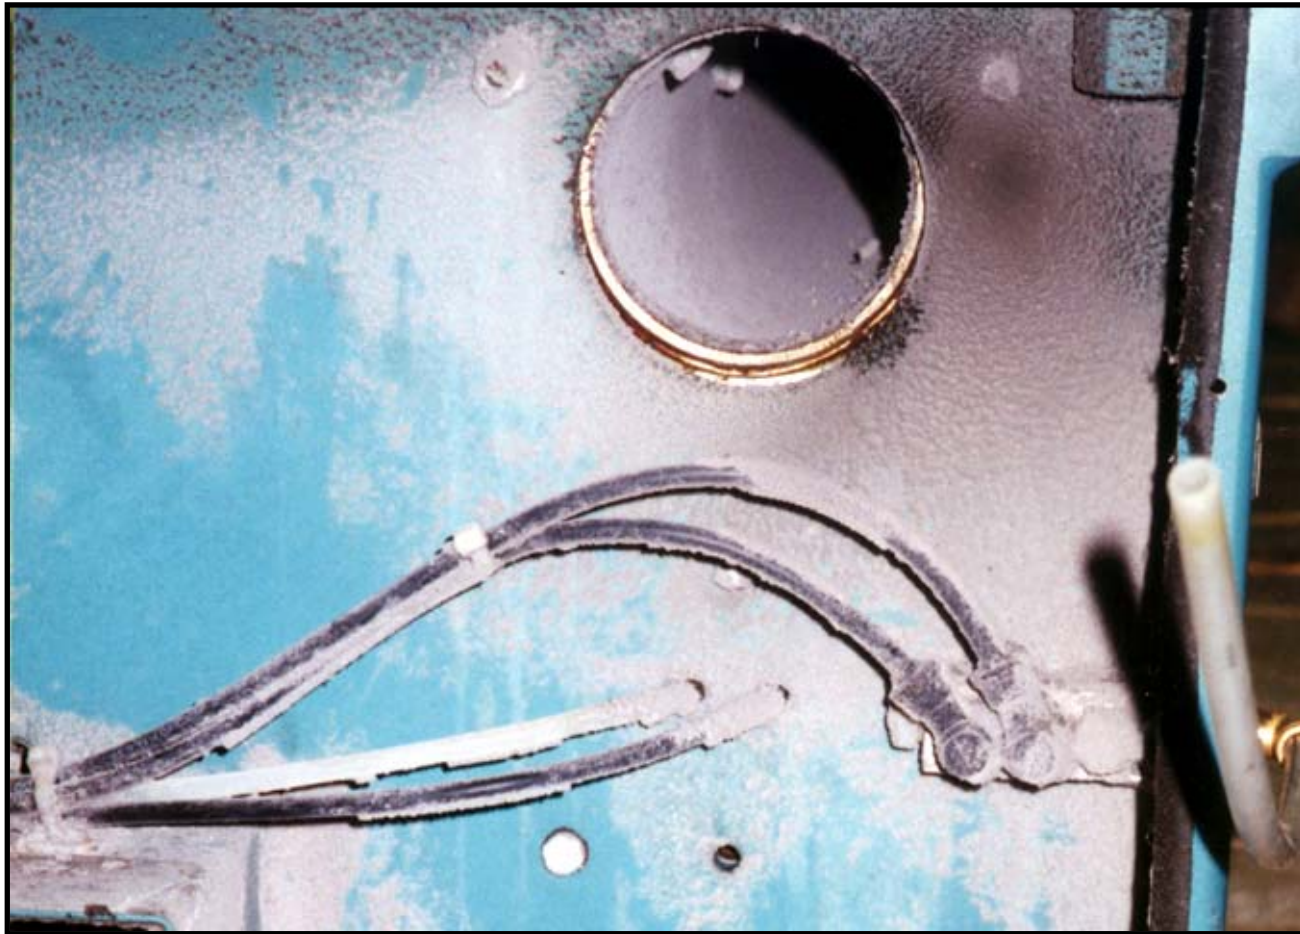
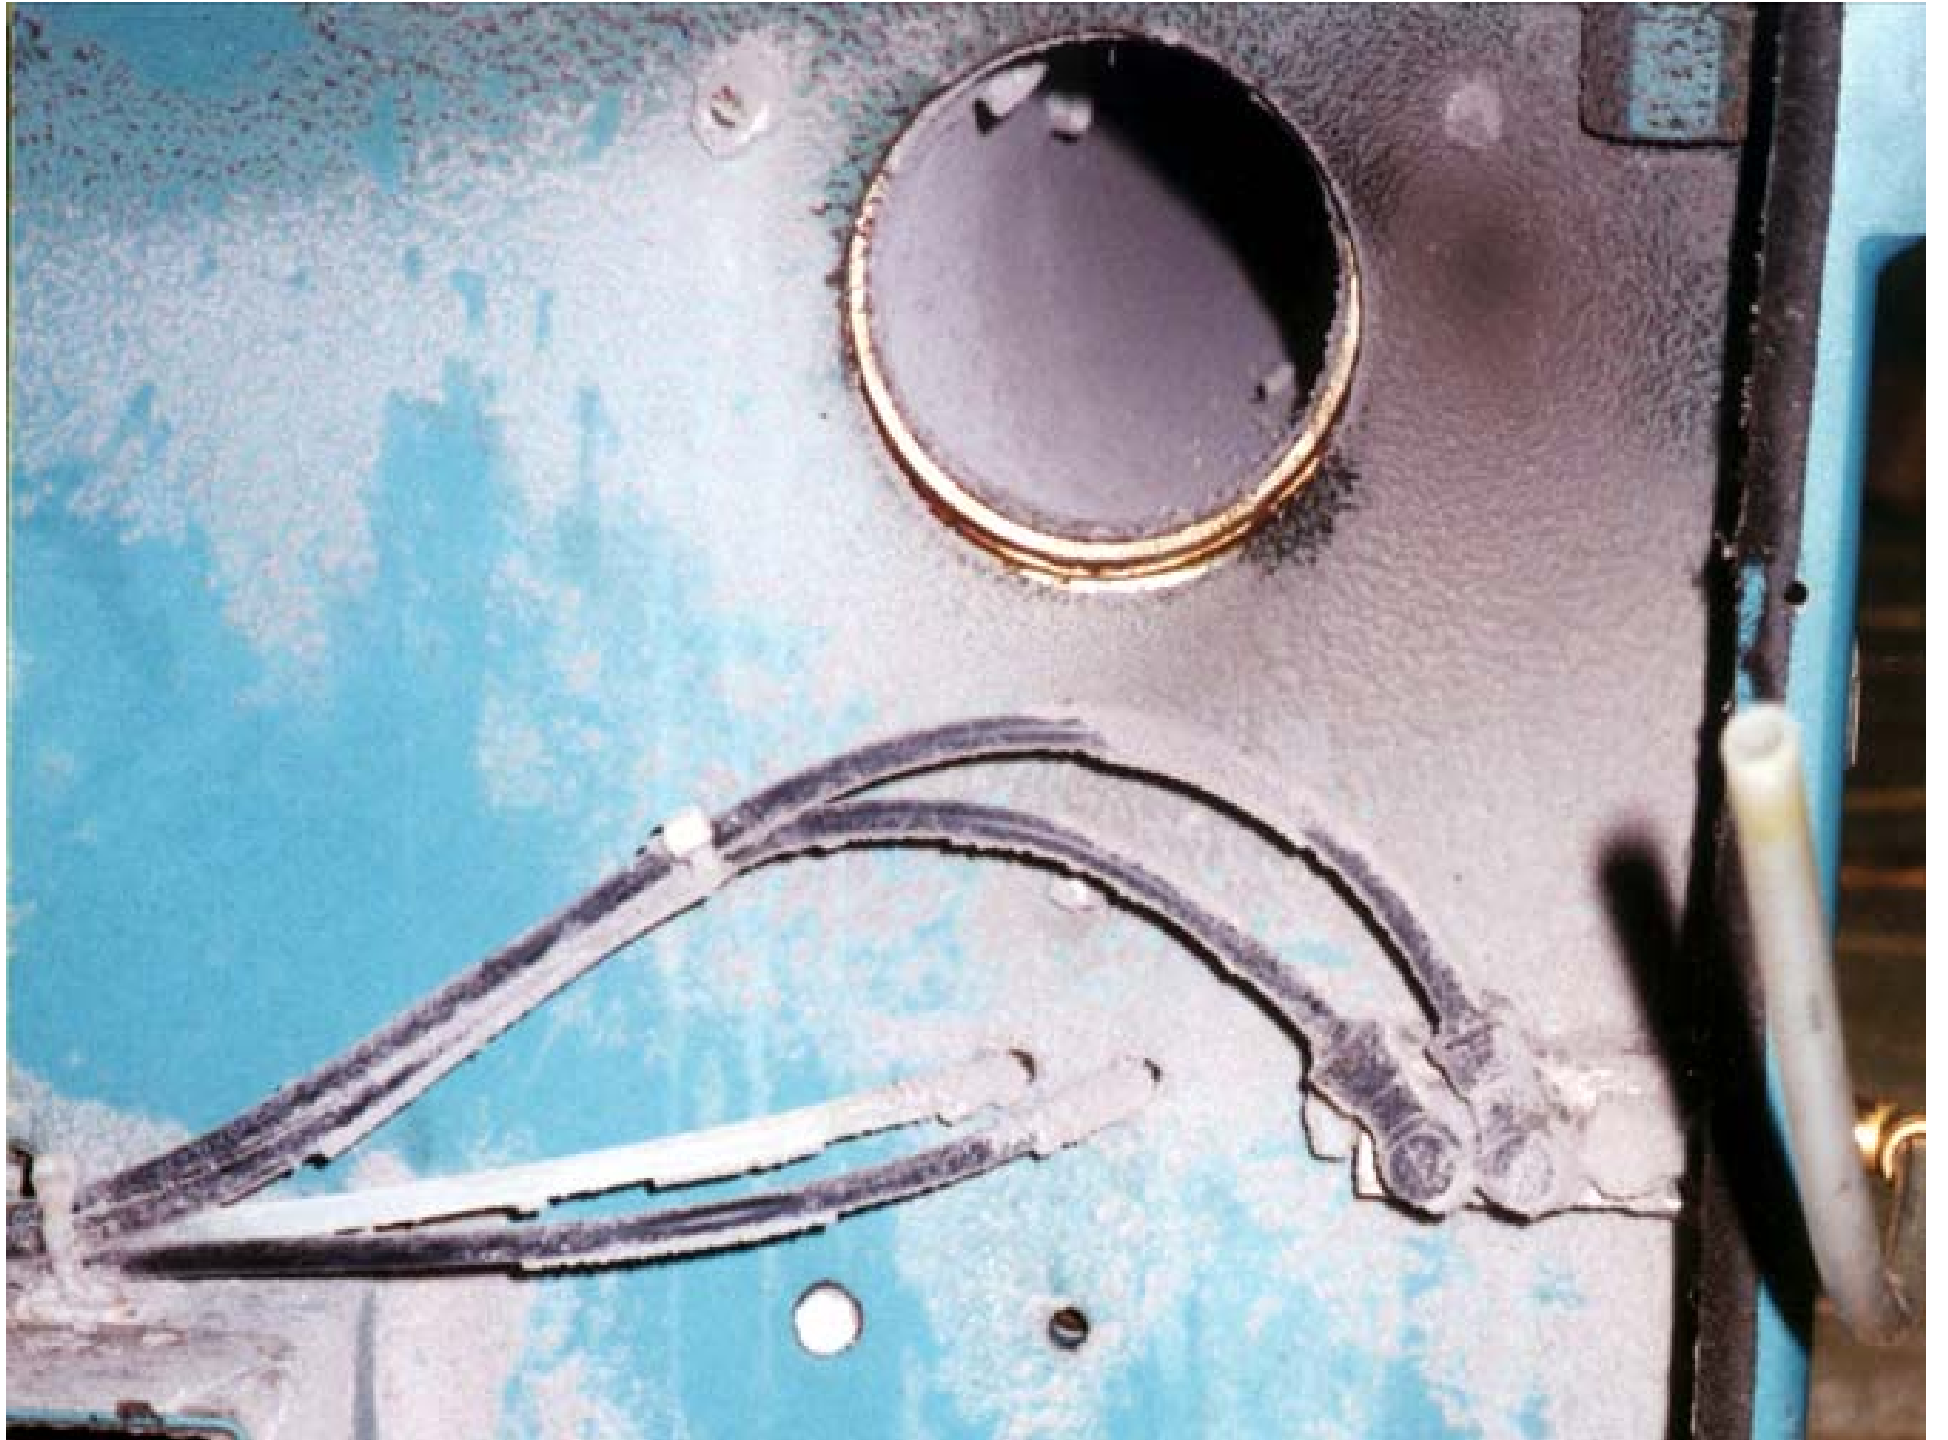
Dirty Exhaust Plenum (view 1)

- Rolls
- Electrodes
- **Exhaust System**

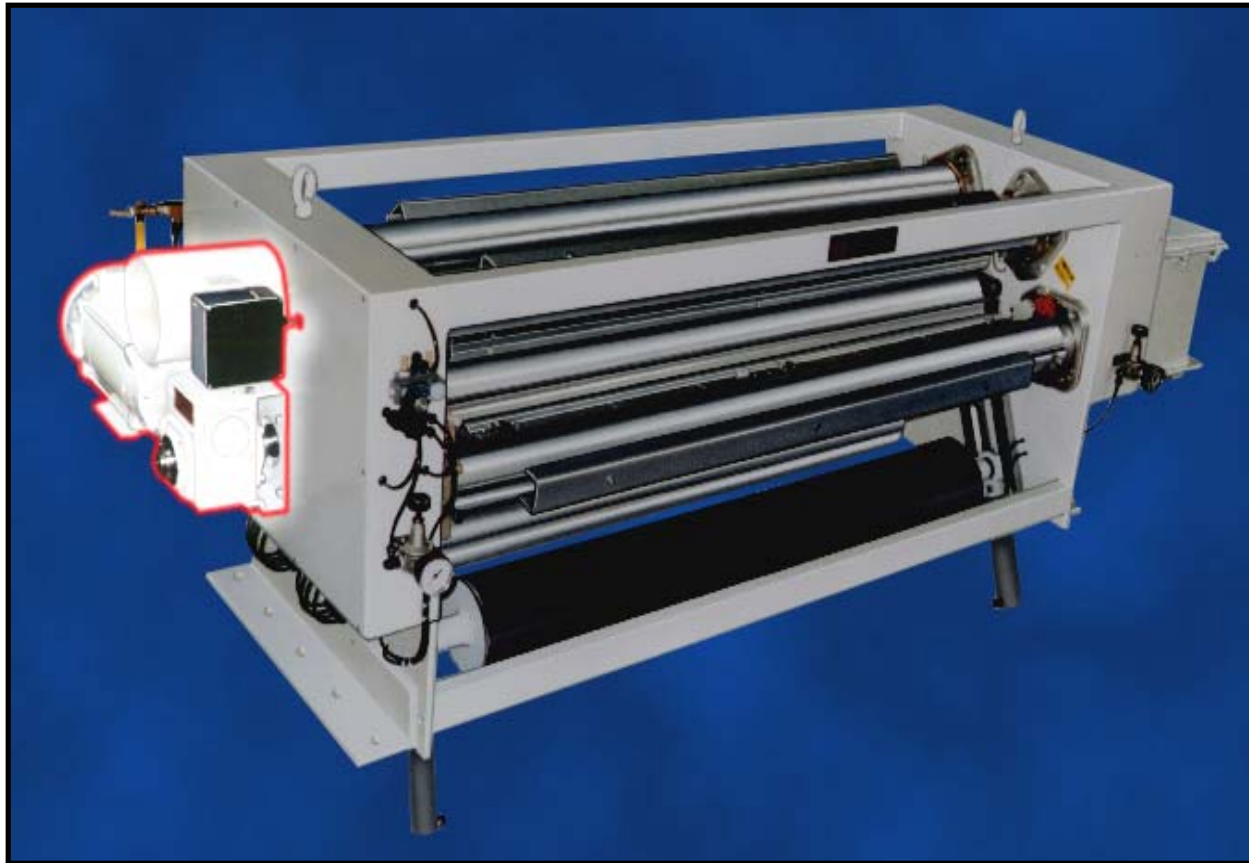
Driving Roll

Reduce wrinkling by:

- **Driving Roll**
- **Extend Web Wrap**
- **Increase Web Tension**
- **Add Entry Nip Roll**

Roll Drive Option

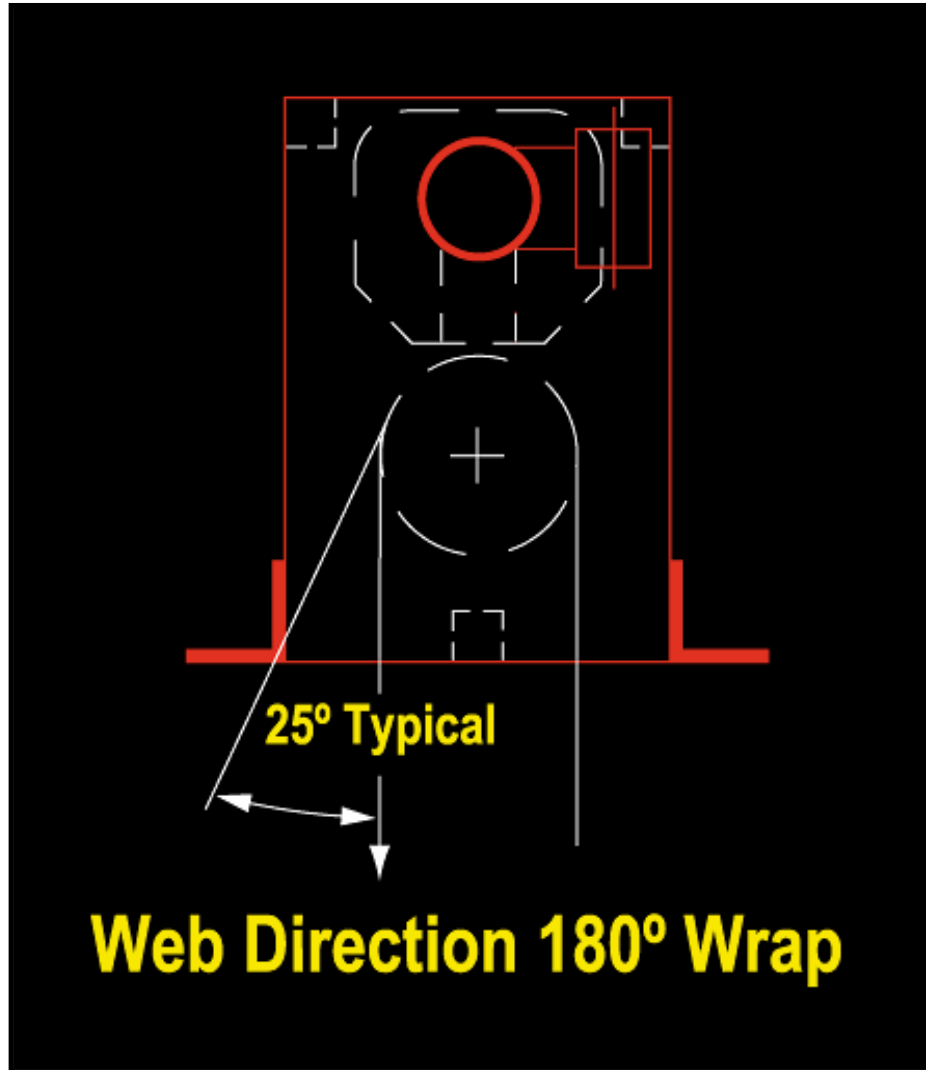
Extended Web Wrap

**Standard
Configuration**

**One Electrode
Assembly**

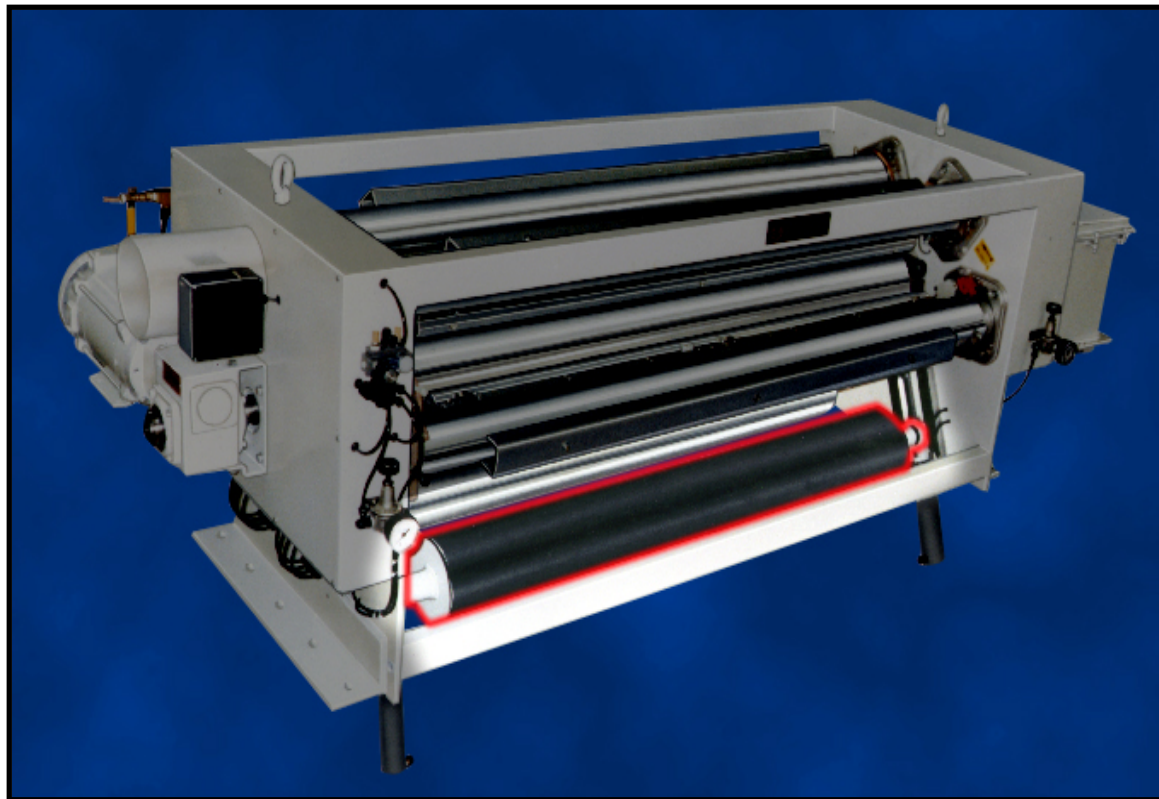
Early Nip Roll Option

- Driving Roll
- Extend Web Wrap
- Increase Web Tension
- **Add Entry Nip Roll**

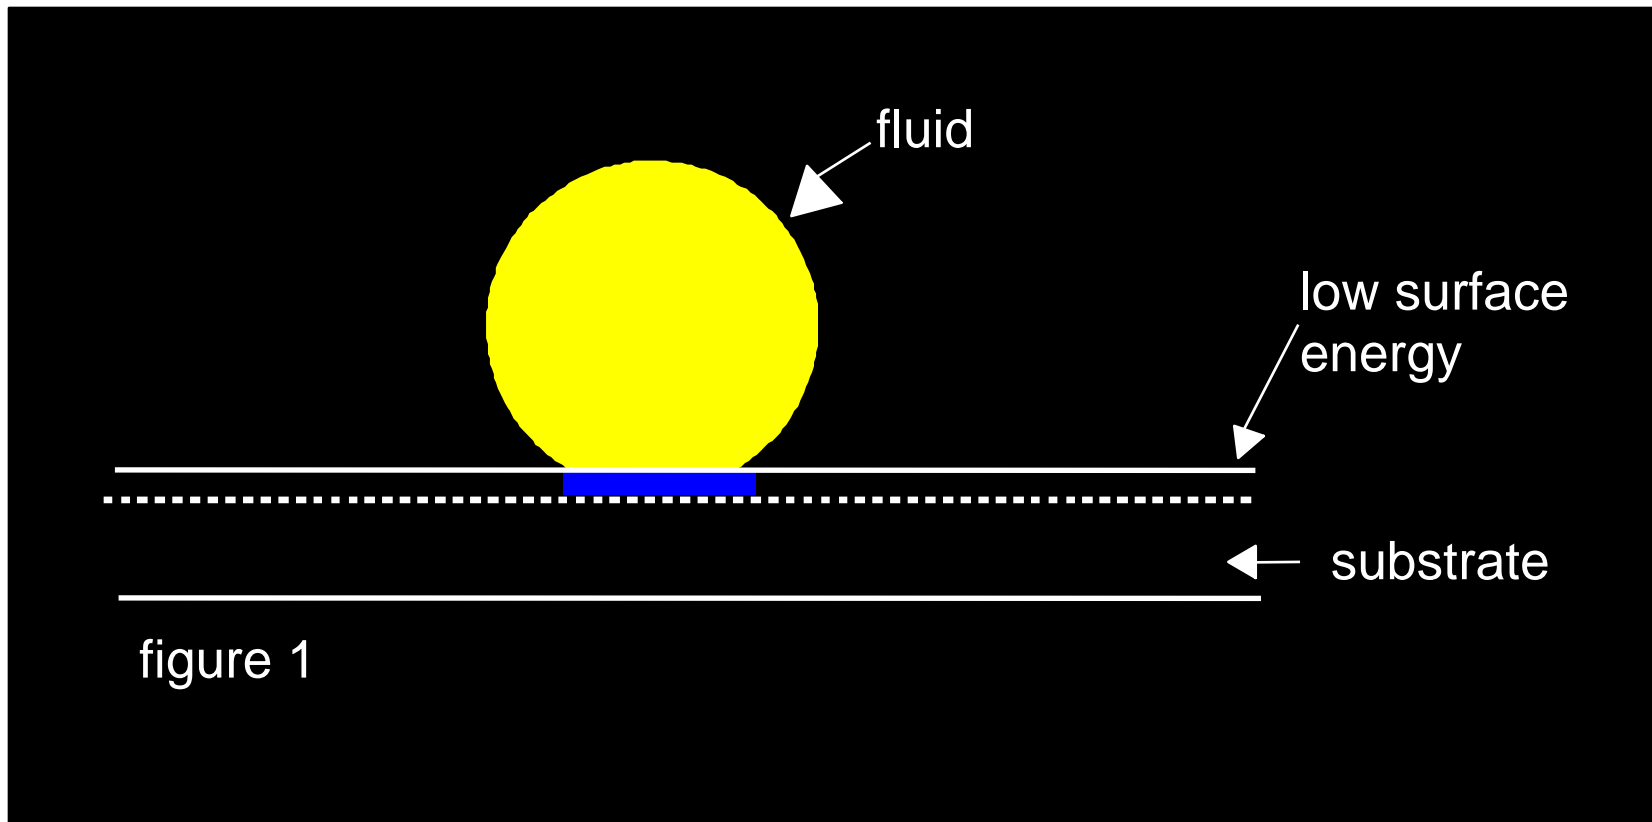
Untreated Film

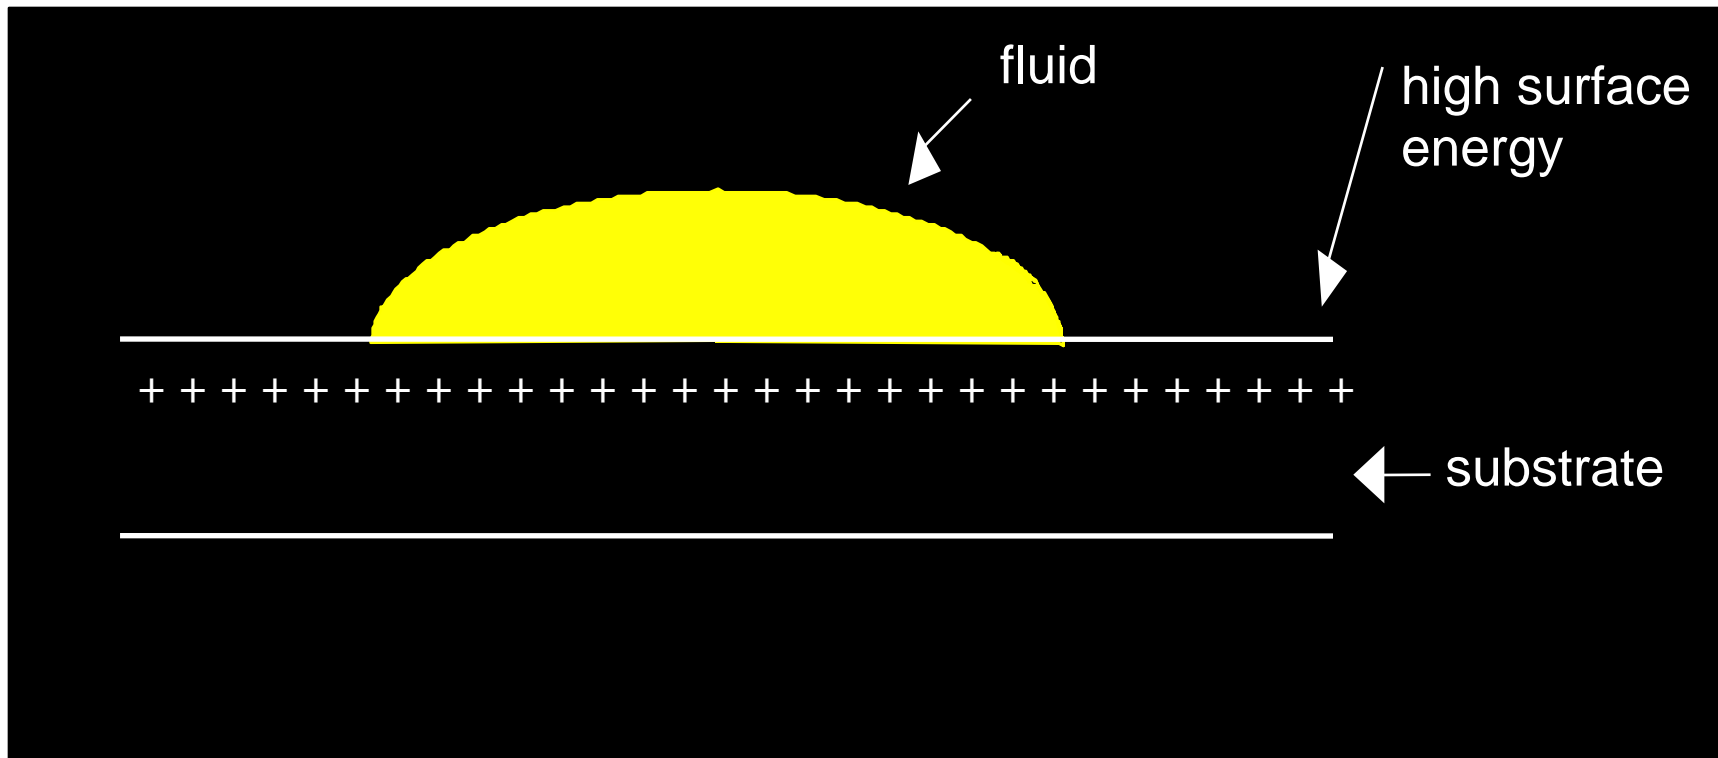
Normally Treated Film

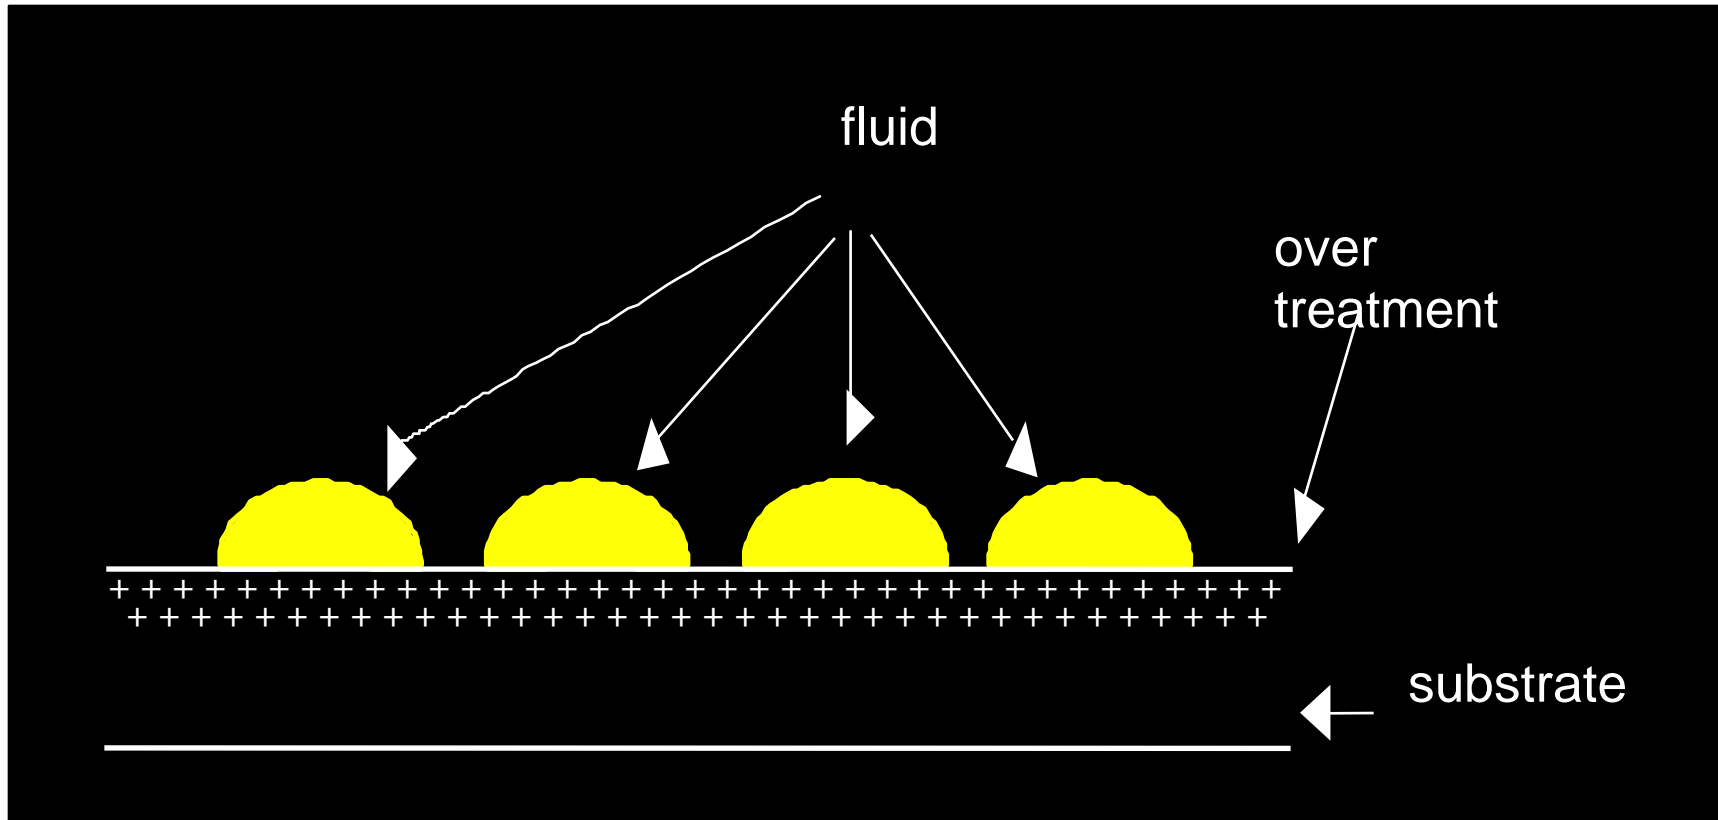
Over Treated Film
