Troubleshooting Corona Treatment Issues

Rory A. Wolf

Enercon Industries Corporation

Abstract

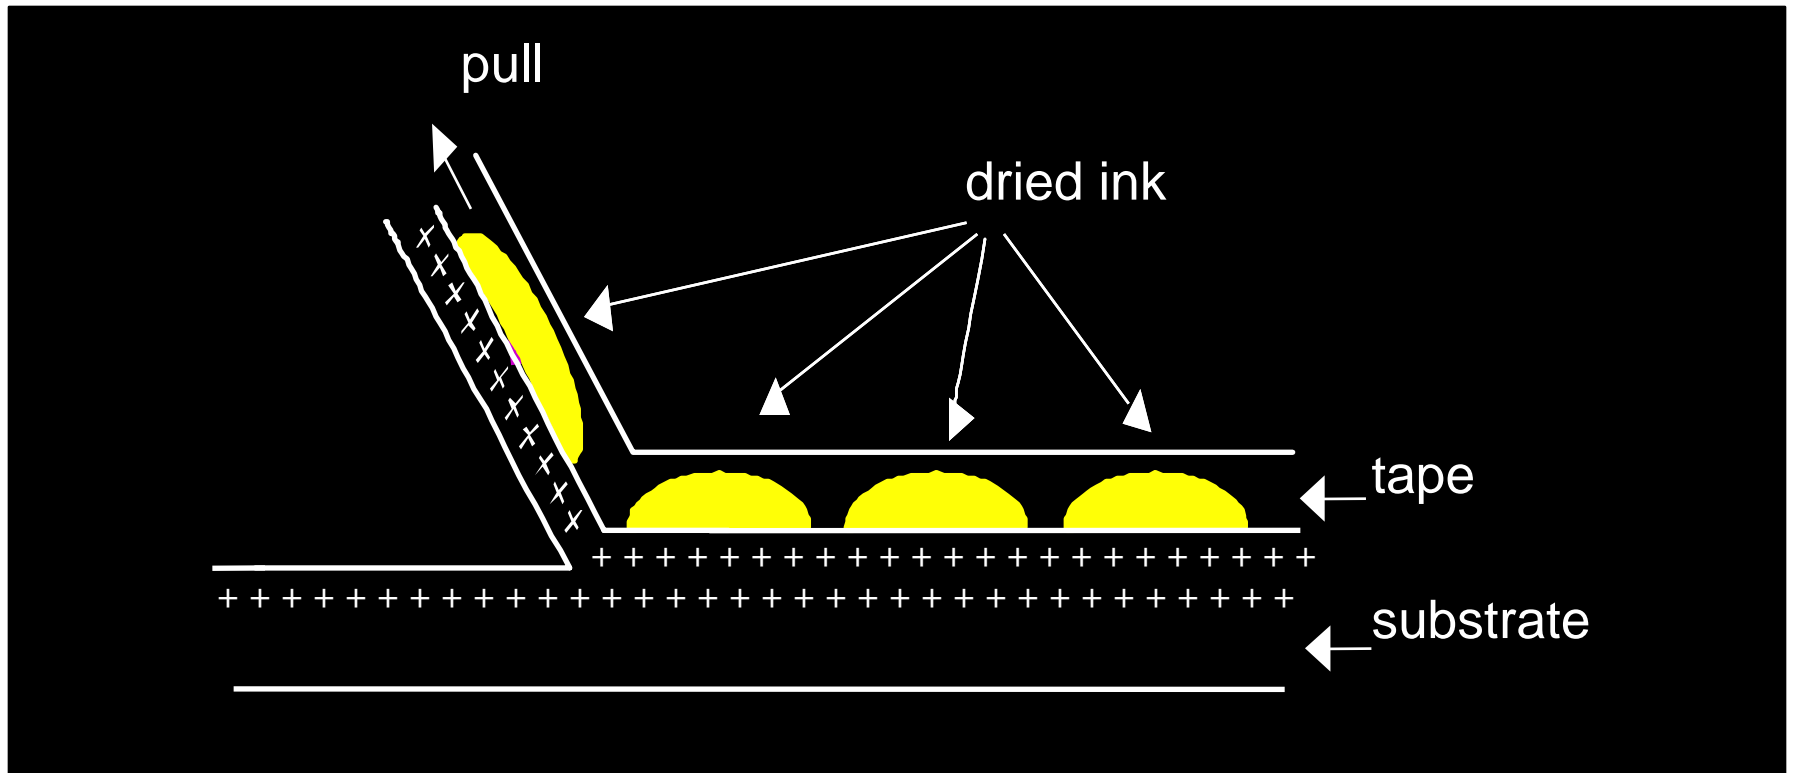
**Results of Over Treatment:
Surface Delamination**
