FLOW SURGING IN SINGLE-SCREW, PLASTICATING EXTRUDERS

Mark A. Spalding, Joseph R. Powers, Phillip A. Wagner, and Kun Sup Hyun
The Dow Chemical Company
Midland, MI 48667

*Flow Surging in
Single-Screw, Plasticating
Extruders*

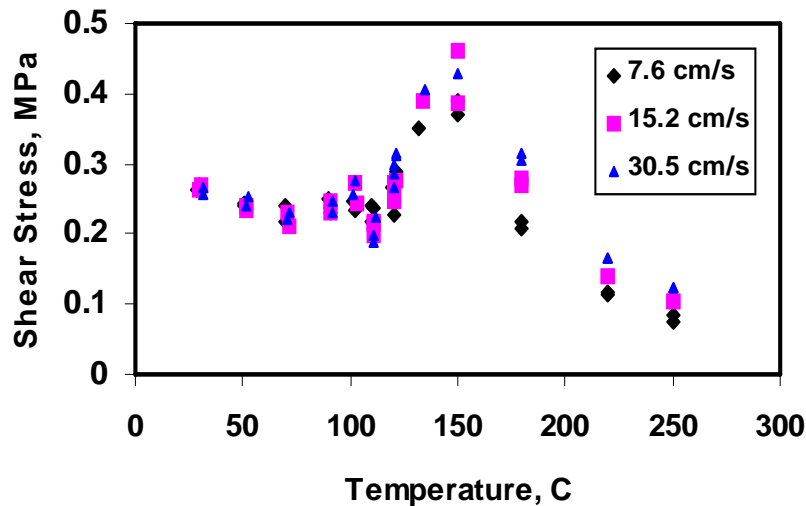
Figure 1. Shear stress between HIPS resin and a metal surface at 0.7 MPa and as a function of sliding velocity.

Rheology, bulk density, coefficient of dynamic friction, and the shear stress at the polymer metal interface were measured for the HIPS resin. The rheology and bulk density of the resin were essentially the same as that previously reported for a slightly different HIPS resin (10,11). The shear stress at the polymer-metal interface is reported here rather than the dynamic friction since friction is only defined for solid-state processes, while the stress can be described from ambient temperatures up to processing temperatures. The shear stress at the interface (12) for HIPS resin is shown by Figure 1 at a pressure of 0.7 MPa. As indicated by this figure, the shear stress was nearly constant from ambient temperature up to about 110°C, increased to a maximum stress near 150°C, and then decreased as the temperature was increased further. Optimal performance of the solids conveying section for this resin would be such that the forwarding forces are maximized with metal surface temperatures near 150°C where the stress is a maximum, and the retarding forces minimized with metal surface temperatures of 110°C or lower. Thus, optimal solids conveying for HIPS resin would occur with a feed zone barrel inner surface temperature near 150°C and a screw surface temperature in the feed section no higher than 110°C. In practice, screw temperatures less than 90 or 100°C are preferred such that melting of the resin does not occur if an emergency shutdown should occur. For the solid state temperature region, the shear stress at the interface can be converted to the coefficient of dynamic friction by the following (12):

where f is the coefficient of dynamic friction, τ is the shear stress at the polymer metal interface, and P is the pressure (0.7 MPa).

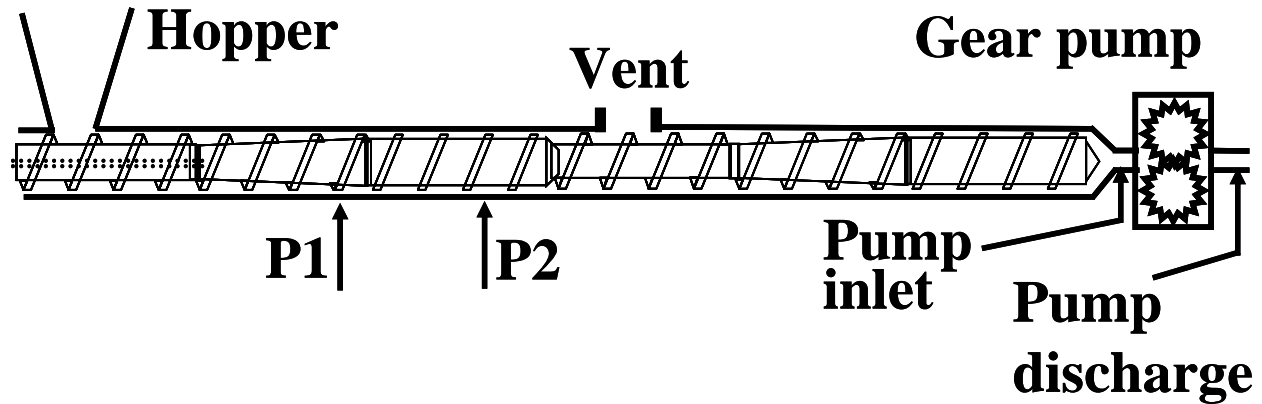
Figure 2. Schematic of the extrusion process.

A severe and random flow surging problem limited the production rate for a large-diameter, two-stage, vented extruder. If it were not for a gear pump positioned between the extruder and die, this extrusion line would not be operable. A schematic for the extruder and gear pump are shown by Figure 2. The surging did, however, limit the output of the line to about 60% of its potential rate. The maximum potential rate is the rate that the extruder can run at high screw speed and with proper operation. In order to diagnose the problem, a data acquisition system was

temporarily connected to the extrusion panel. The screw was single-flighted and typical of what is used for HIPS resins. Screw temperature control was accomplished by flowing cooling water through a rotary union into and out of a hole cut into the feed end of the screw (13). This hole extended to about 4 diameters into the feed section. Pressure sensors were positioned in the barrel wall at the end of the first-stage transition section (P1), at the end of the first-stage metering section just before the vent (P2), and at the discharge. An additional pressure sensor was positioned at the inlet (suction side) to the gear pump. A temperature sensor was positioned in the transfer line upstream of the gear pump to measure extrudate temperature. A commercial control scheme adjusted the screw speed to maintain a constant pressure of 9 MPa to the inlet of the gear pump. The gear pump was operated at constant speed in order to maintain a constant flow rate of material to the downstream equipment.

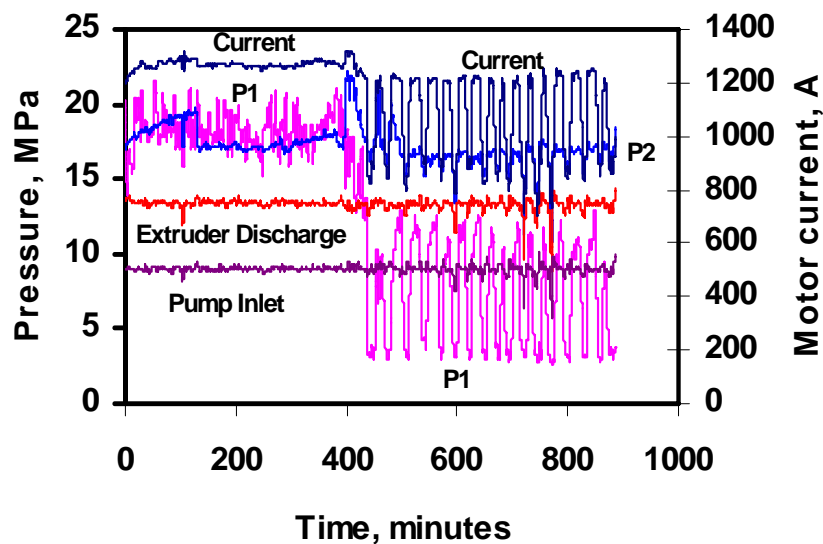
Figure 3. Barrel, discharge, and pump inlet pressures and motor current for stable and unstable extrusion for a large-diameter extruder running HIPS resin.

Steady-state operation of the extruder is shown by the first 400 minutes in Figures 3, 4, and 5. The data for these figures were from the same experimental run. At these conditions, the extruder was operating at about 70% of its potential maximum rate and the screw speed varied only about ± 2 rpm. The barrel pressure at the end of the first-stage transition section, P1, had variations of about ± 3 MPa about the average pressure. This pressure variation was considerably higher than was expected and suggests that the extruder, although running stable, was on the verge of unstable operation. Some of the variation was due to the movement of the flight tip past the sensor. Barrel zone temperatures tracked the set point values and were stable. Calculations indicated that the first stage was full of resin.

At about 410 minutes into the run, the extruder started to operate unstably, as indicated by Figures 3, 4, and 5. The processing change that caused the extruder to go from a stable operation to an unstable one is not known, but it could have been due to minor changes in the bulk density of the feedstock or cooling water fluctuations. As indicated by these figures, the event started when the P1 pressure decreased slightly, causing the rate and the P2 pressure to decrease. This decreased pressure transmitted down the extrusion system, eventually decreasing the pressure at the inlet to the gear pump. To correct for the lower pressure, the controller on the gear pump increased

As indicated by Figure 3, the P1 pressure was considerably lower during the period of unstable operation. This result indicates that the cause of the problem originated in the first stage of the screw before the metering section. At a screw speed of 160 rpm, the extruder was capable of a rate of at least 50% greater than the actual rate. This lower than expected rate indicated that the first-stage metering section was operating only partially filled. The most likely reason for a starved metering section was poor solids conveying from the feed section to the transition section. This poor solids conveying was likely due to improper temperature control of the metal surfaces in the feed section of the extruder and screw. Barrel feed zone heaters and controllers were examined and determined to be operating properly at set point temperatures typically used for HIPS resin. Based on this information, the investigation was focused on screw temperature control.

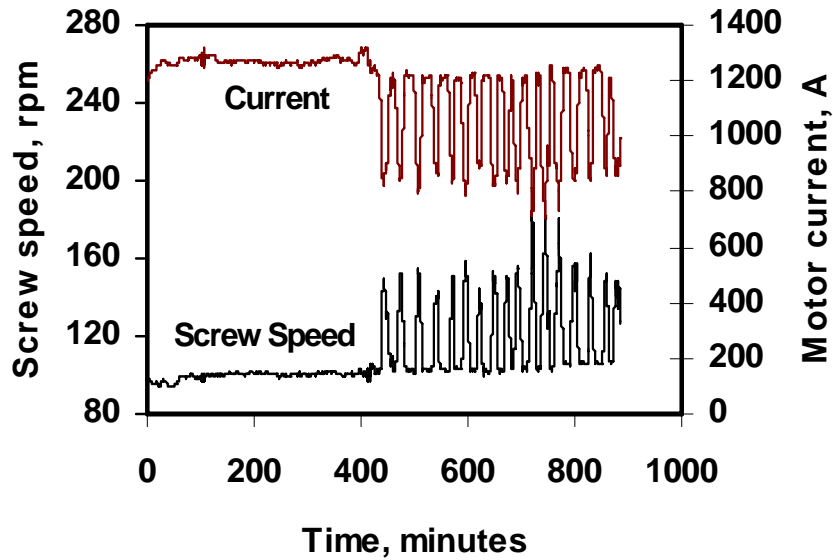
Figure 4. Screw speed and motor current for a large-diameter extruder running stable and unstable.

the speed of the screw from 100 to about 160 rpm. Next the P1 pressure increased due to the higher screw speed and higher flow rate, as indicated by Figure 4. As the pressure increased at the gear pump inlet, the gear pump controller decreased the screw speed back to 100 rpm, causing the extruder to flow surge. Flow surging caused the screw speed controller to oscillate about once every 25 minutes. As indicated by Figure 3, the screw speed controller was able to provide a relatively stable pressure to the pump inlet, allowing the process to run at reduced rates. The barrel zone temperatures, as indicated by Figure 5, were extremely oscillatory.

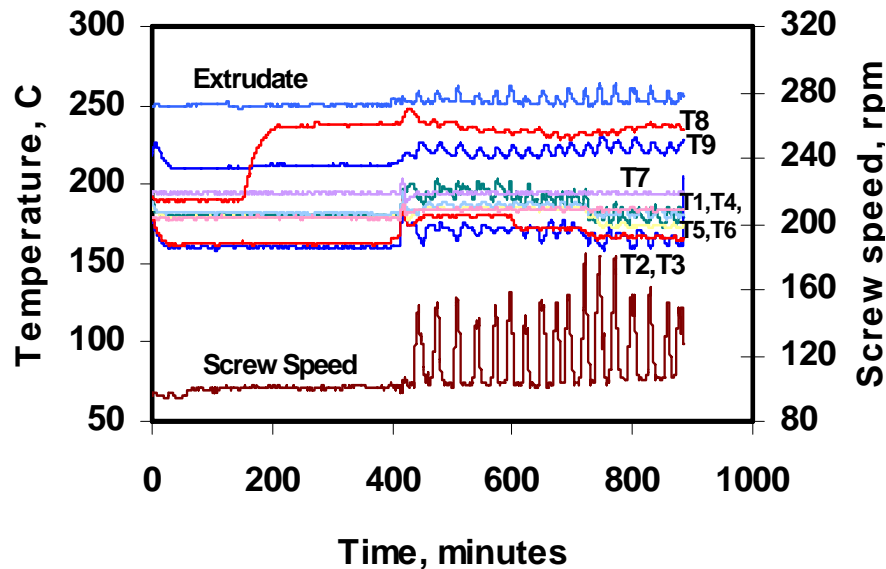
Figure 5. Screw speed, extrudate temperature, and barrel zone temperatures for a large-diameter extruder running stable and unstable.

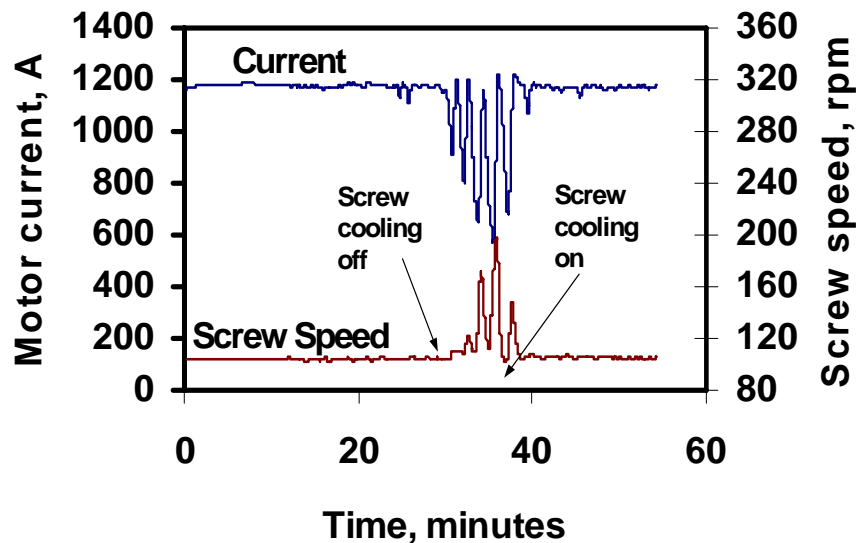
Figure 6. Screw speed and motor current for the screw cooling experiment.

The effect of internal screw cooling was determined during a period when the extruder was operating stably. For this stable extrusion period, cooling water was flowing to the screw-cooling lance and the extruder was operating stably and properly at a rate of 70% of its potential maximum. The metal surface temperatures of the pipes used to flow water into and out of the screw were measured at 29 and 37°C, respectively. At about 28 minutes into the run, the cooling water flow to the screw was turned off, as indicated by Figures 6 and 7. At about 30 minutes, the pressure at the end of the first-stage transition section, P1, started to decrease as shown by Figure 7, indicating that solids conveying was significantly reduced. Like before, the reduced solids flow caused the downstream pressures to decrease, and ultimately to cause the extruder to flow surge. At about 36 minutes into the run, cooling water flow was turned on and within about 4 minutes the extruder operation became stable, as indicated by the Figures 6 and 7. The surface temperature of the pipe for water flow out of the screw was measured at 81°C just after the cooling water was turned on; a temperature change of 44°C. Previous research on HIPS resin (14) has shown that solids conveying becomes difficult or unstable at screw temperature of about 160°C and higher. The temperature of the screw surface was unknown, but it likely increased by at least 44°C and possibly approached 160°C.

Based on the above data, the cause of the extrusion instability was identified as high screw surface temperatures in the feed section. These high surface temperatures caused the coefficients of dynamic friction to increase, increasing the retarding forces on the solids at the screw surface. Since solids conveying depends on a combination of forwarding forces at the barrel wall and pushing flight and retarding forces at the screw root and trailing flight, an increase in the retarding forces will cause a reduction in the solids conveying rate. The instability appeared to be random due to the complicated interactions of cooling water flow rate and temperature, and changes in bulk density of the feedstock.

To increase the operating window for stable extrusion, the cooling level to the feed section of the screw was increased by lengthening the cooling hole in the screw. The cooling hole length was increased from 4 diameters into the flighted section to 7 diameters; i.e., up to the end of the feed section. After the screw modification, the extruder has not experienced instabilities of this type and the rate was increased to 100% of its maximum potential rate.

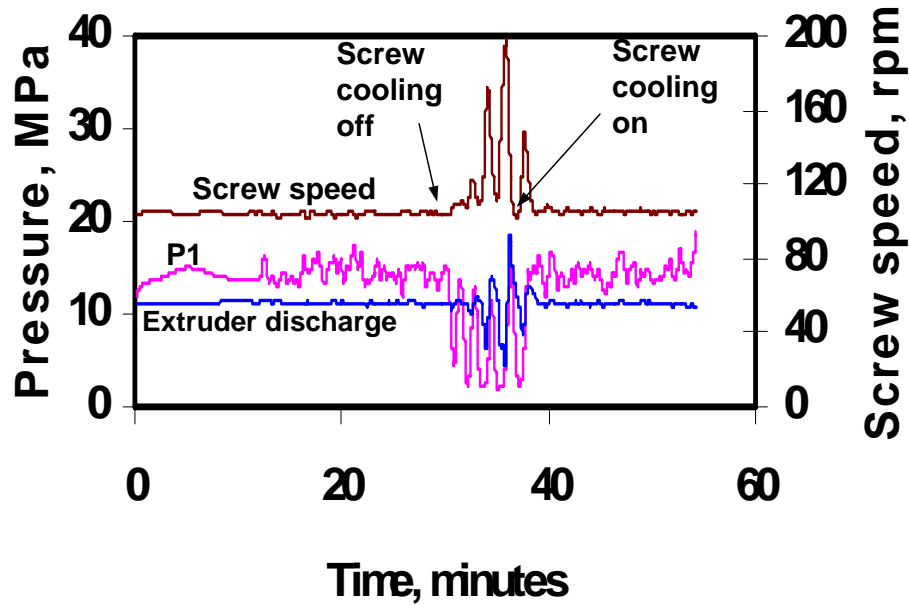
Figure 7. Screw speed, pressure at the entry to the first-stage meter (P1), and discharge pressure for the screw cooling experiment.

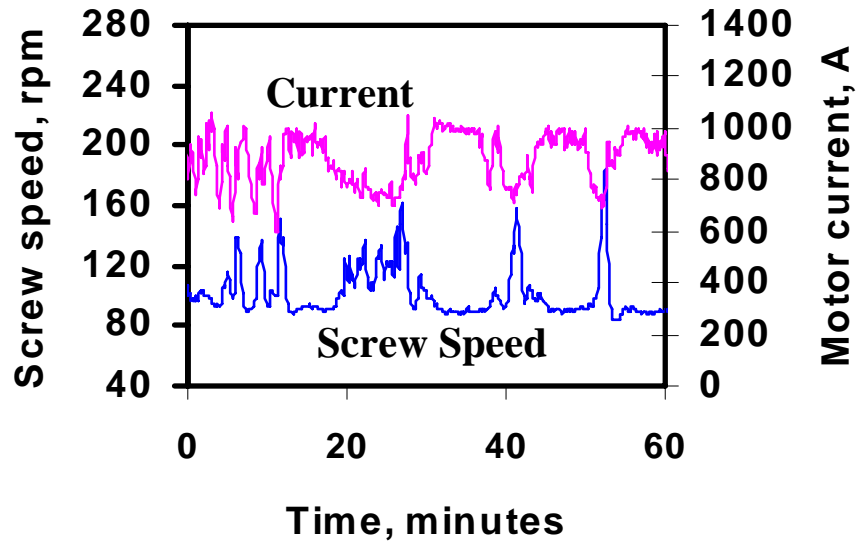
On a different occasion, the same extruder started to flow surge, but with a slightly different frequency, as shown by Figures 8 and 9. As indicated by these figures, there were short time periods when the discharge pressure and screw speed were stable and the motor current was high. During these periods, the extruder was operating well but at a reduced production rate. During periods of unstable operation, the motor current decreased by about 20%, the screw speed increased, and the discharge pressure became extremely oscillatory. Like the previous case, as the motor current decreased solids conveying decreased, causing the controller to increase the speed of the screw.

During the trial, the feed casing to the extruder had an outside surface temperature of about 80°C. Although not measured, the inside cylinder wall of the feed casing for first 1.5 diameters downstream of the feed opening was considerably hotter. These higher temperatures were caused by a combination of frictional heating of the solids on the wall and also by conduction from the first heated zone of the barrel. It is estimated that temperatures as high as 170°C occurred in the feed casing. Optimal solids conveying will occur when the stress at the polymer-metal interface at the barrel is a maximum. This maximum stress occurs for HIPS at a surface temperature near 150°C, as indicated by Figure 1. Surface temperatures higher than 150°C in the feed section will reduce conveying and lead to starving of the screw channels and ultimately flow surging. Corrosion inside of the cooling channels of the feed

Figure 7. Screw speed and motor current for a large-diameter extruder with a feed casing that was too hot.

casing prevented the flow of cooling water. Cleaning the cooling channels and adding a larger cooling water recirculation pump reduced the temperature of the feed casing and eliminated the flow surging problem.

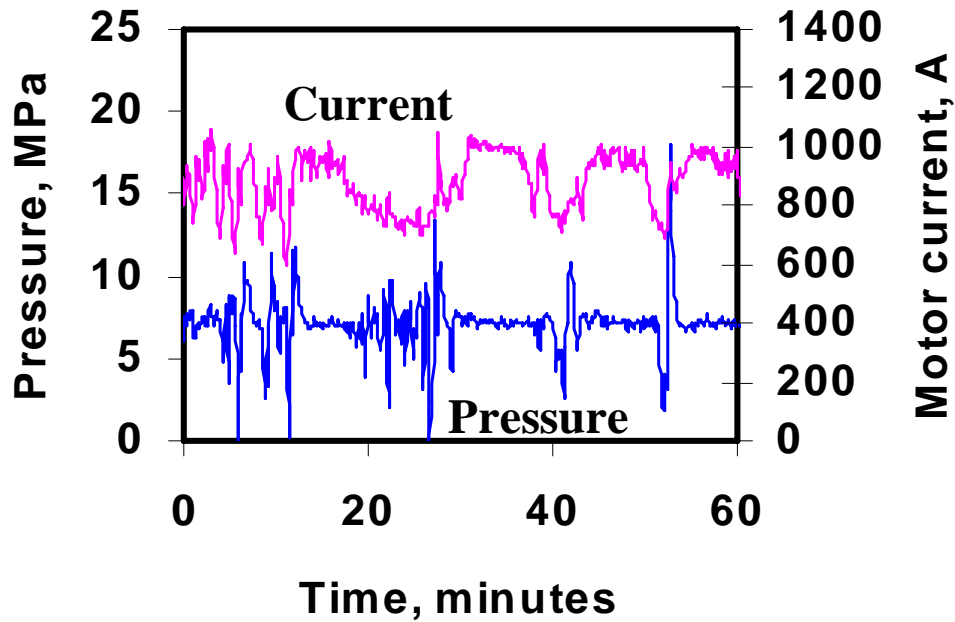
Figure 8. Discharge pressure and motor current for a large-diameter extruder with a feed casing that was too hot.

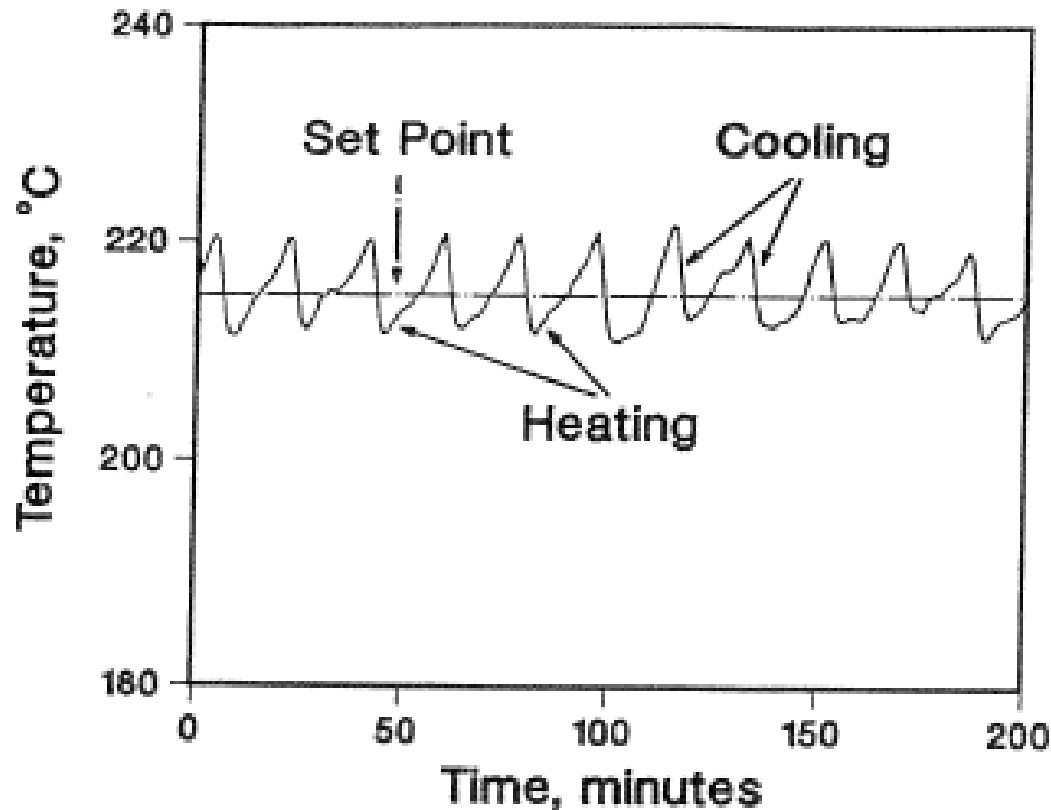
Poor Barrel Temperature Control

- A large diameter extruder had a relatively small and cyclic variation in rate with a frequency of one cycle every 20 minutes
- Rate variation caused a variation in sheet thickness

- Heaters were not turned on by the controllers
- Water cooling was determined to be too high
- Restrictor valves added to water lines

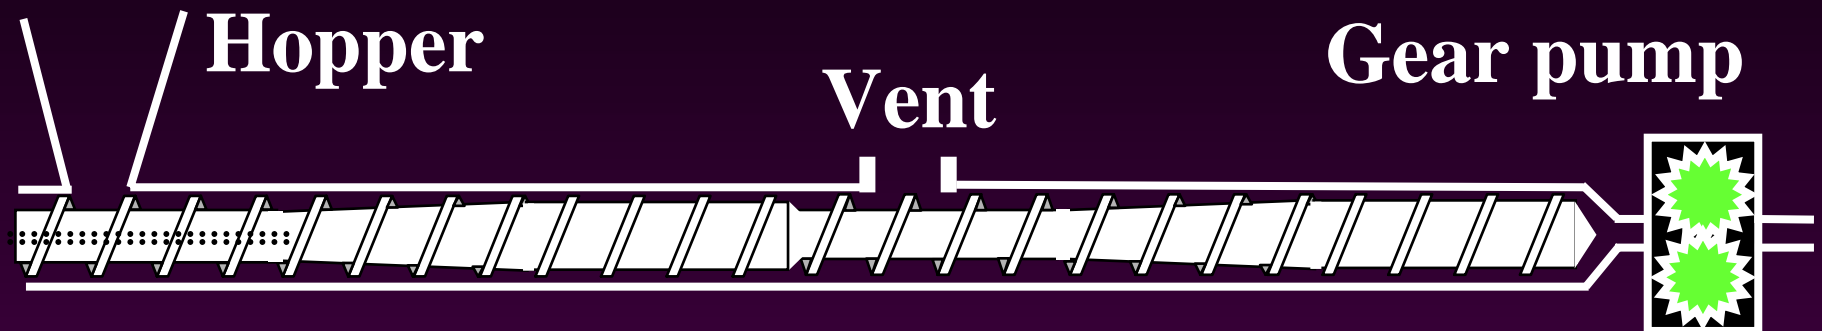
Extrusion Equipment

- 203 mm diameter extruder
- Two-stage, vented
- Gear pump assisted
- Screw cooling up to 4 diameters

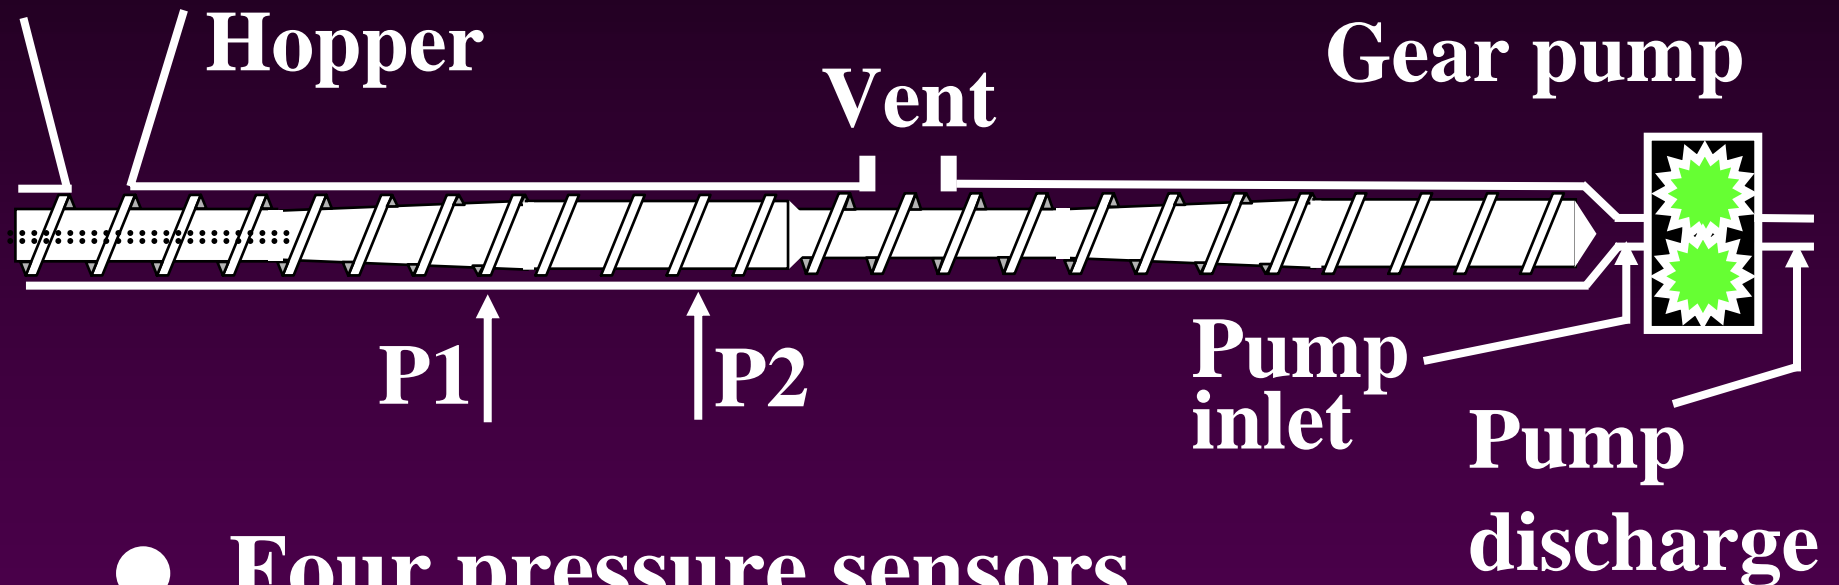
Extrusion Equipment

- **Four pressure sensors**
- **A data acquisition system was connected to the extruder panel**

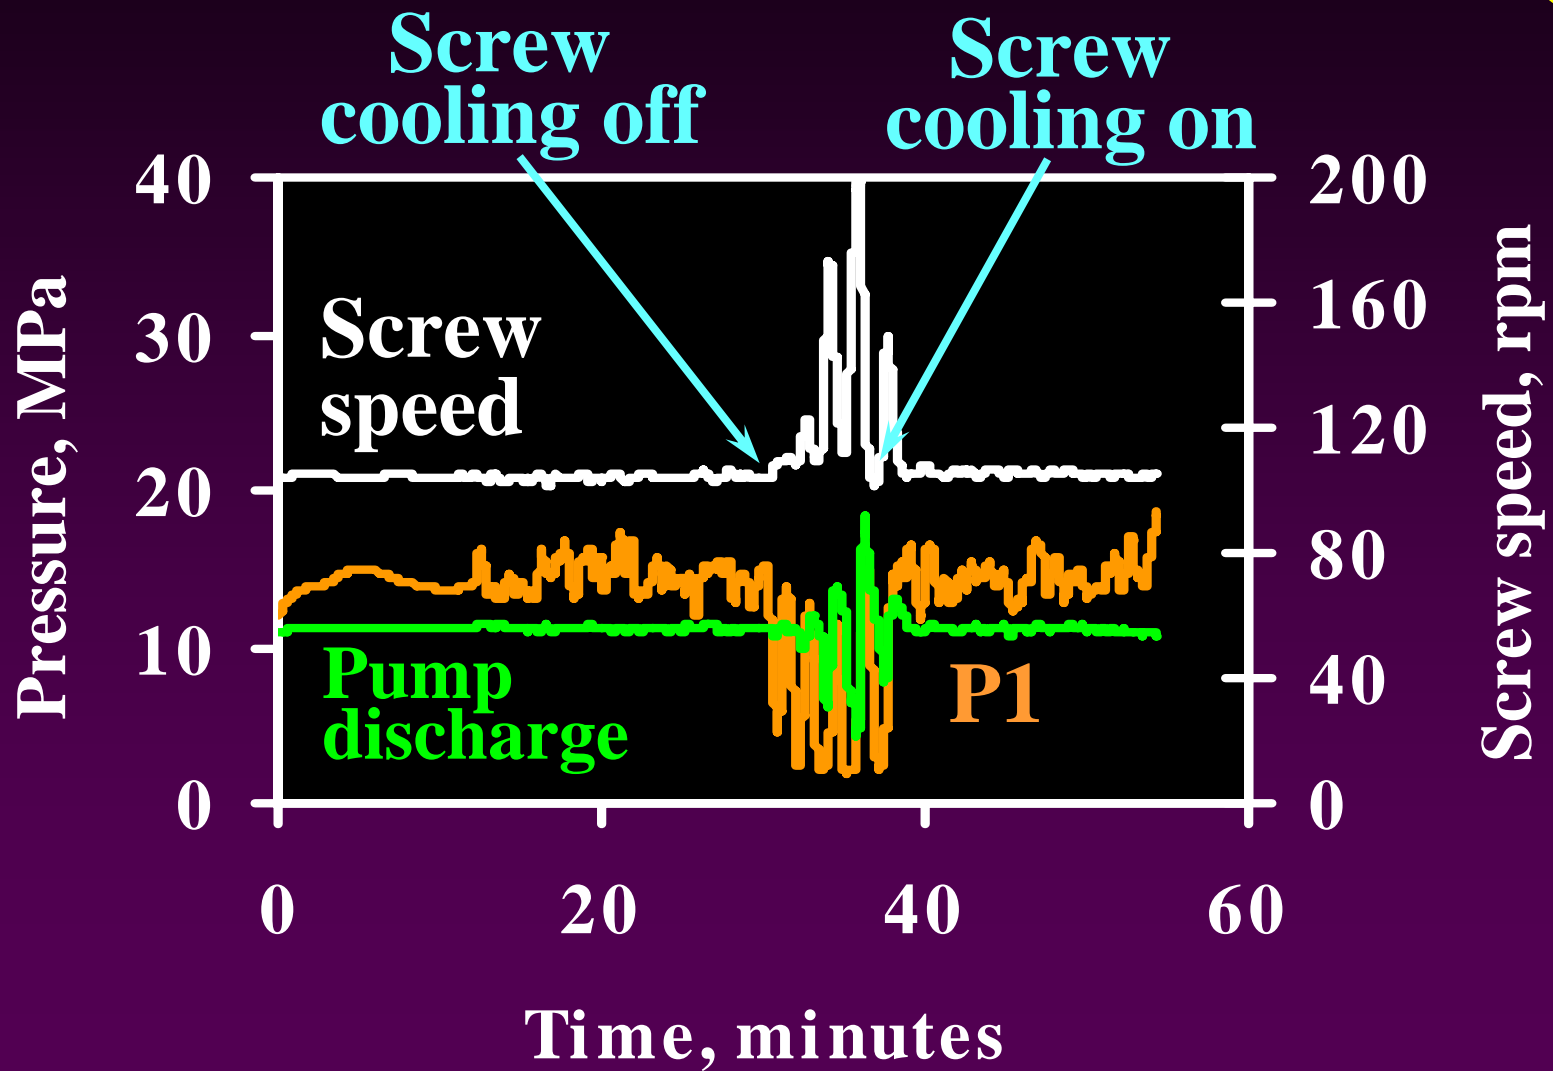
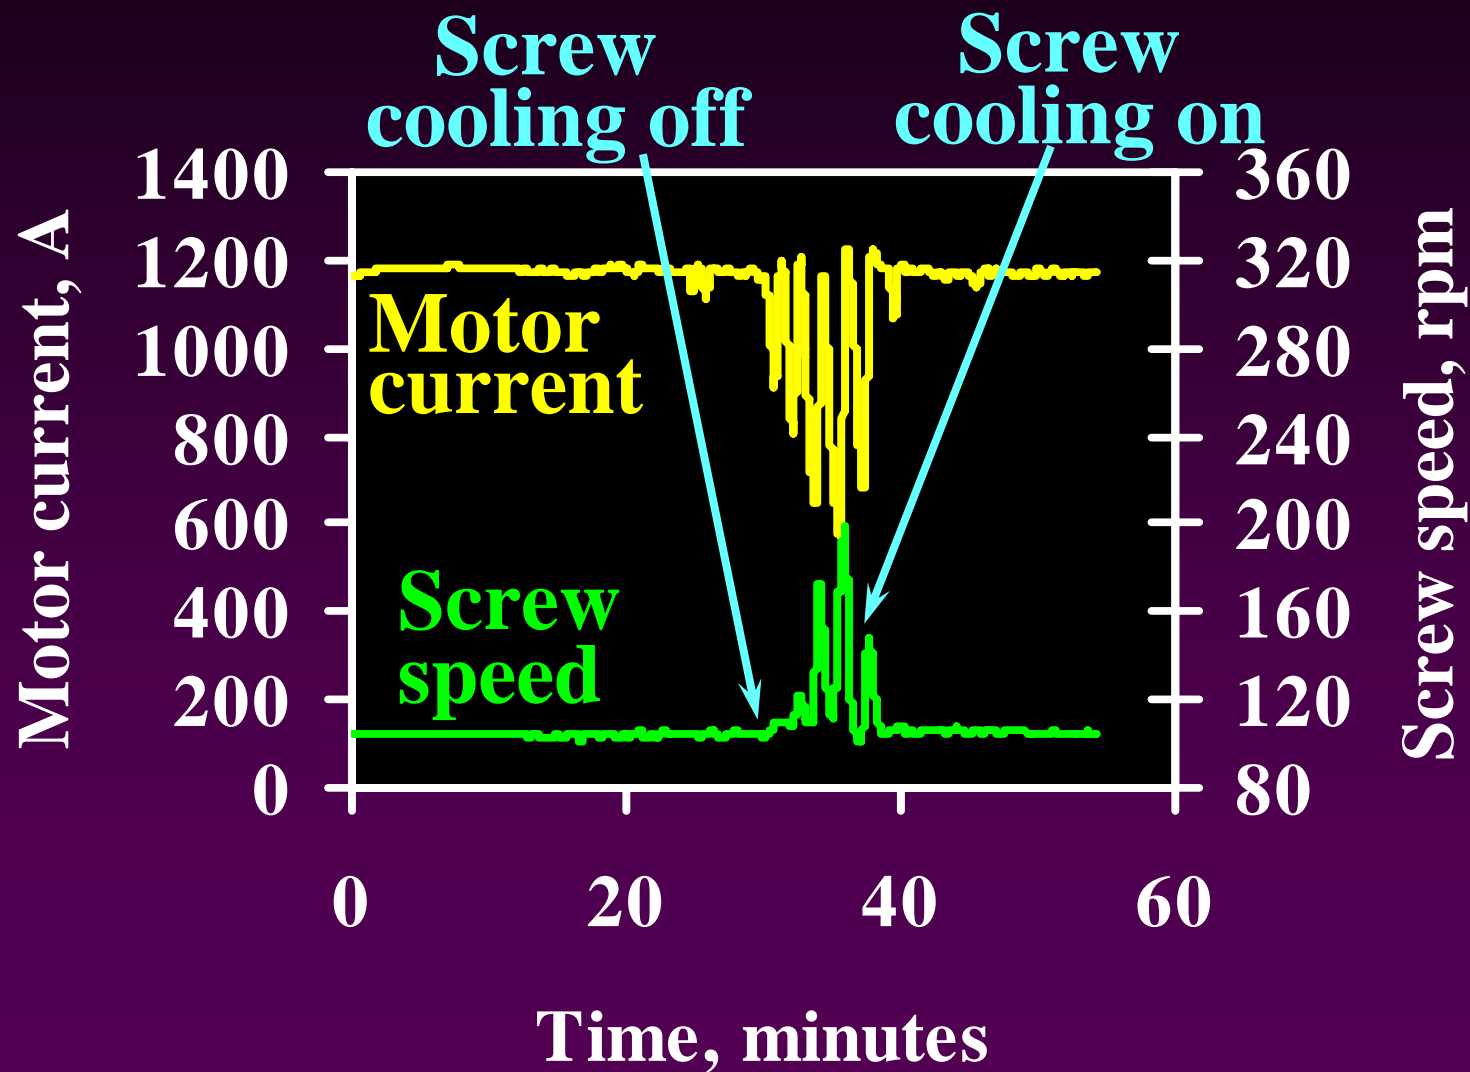
Effect of Screw Cooling

- **Water flow to the screw was turned off during a period of stable operation**
- **Data were collected from the line**

- Cooling hole length was increased from 4 diameters to 7 diameters into the feed
- Rates were increased to 100% of the maximum line rate

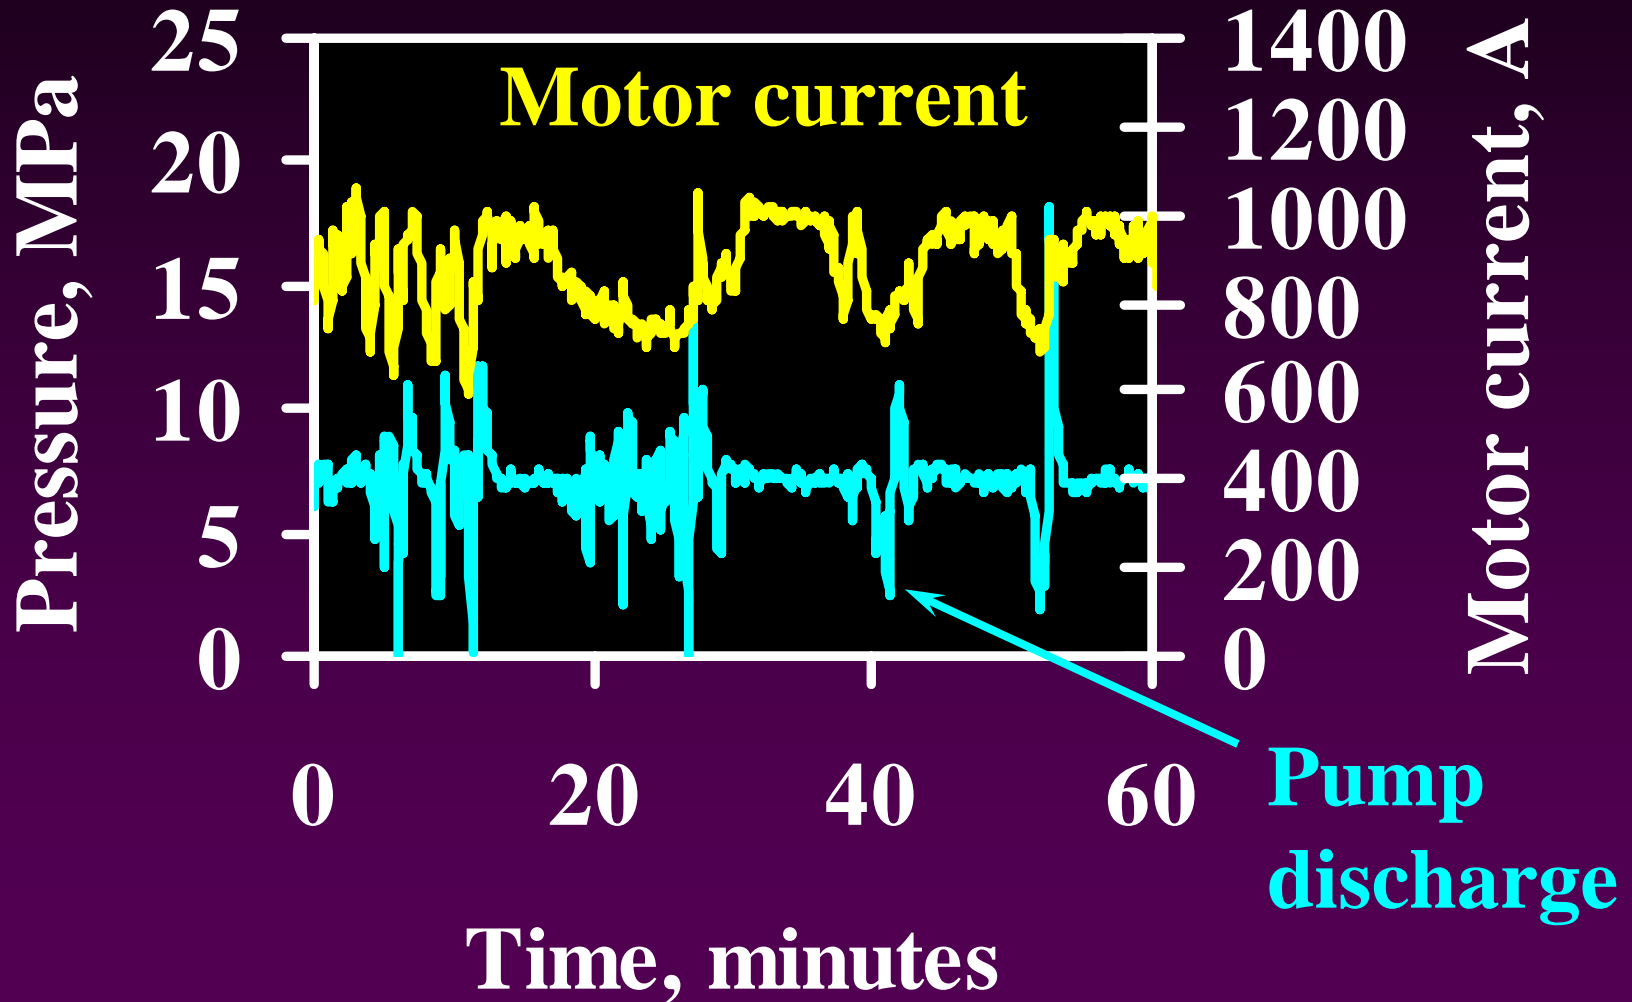
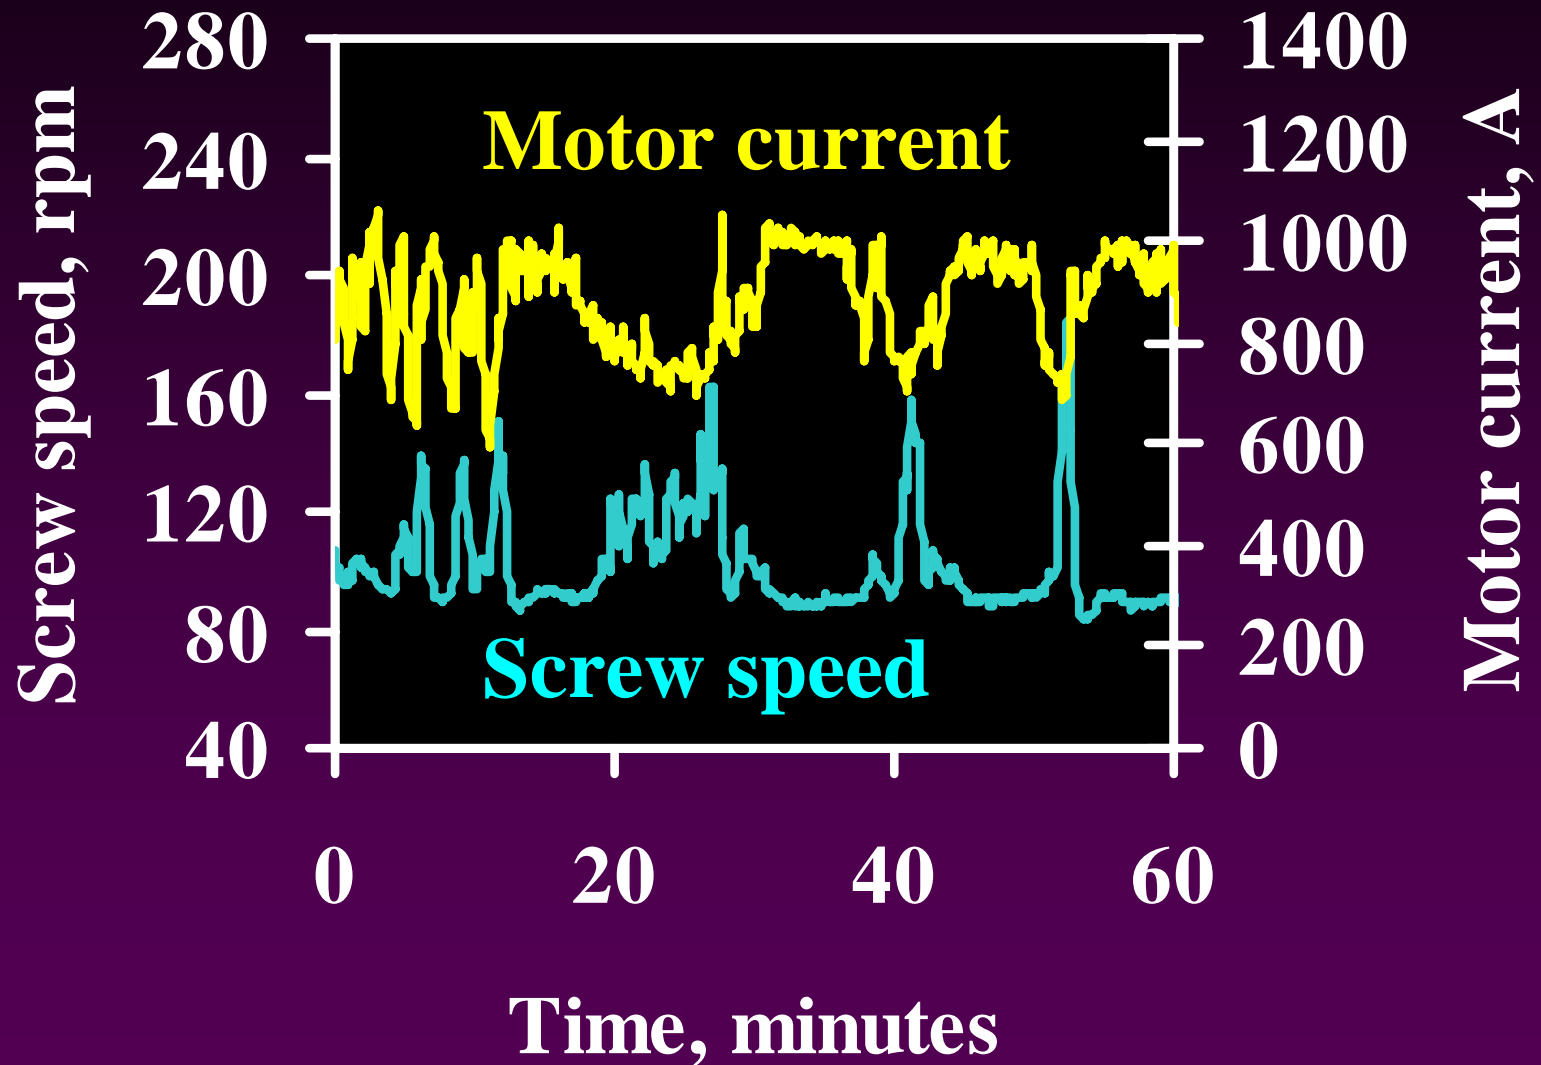
Unstable Extrusion

- On a different occasion, the same extruder started to flow surge, but at a different frequency
- During unstable operation
 - rate reduction
 - 20% lower motor current
 - discharge pressure was extremely oscillatory
 - screw speed was oscillatory

- **Cooling channels in the feed casing were cleaned**
- **A large recirculating pump was installed on the cooling water line**

Rate was increased to 100% of the maximum line rate without surging

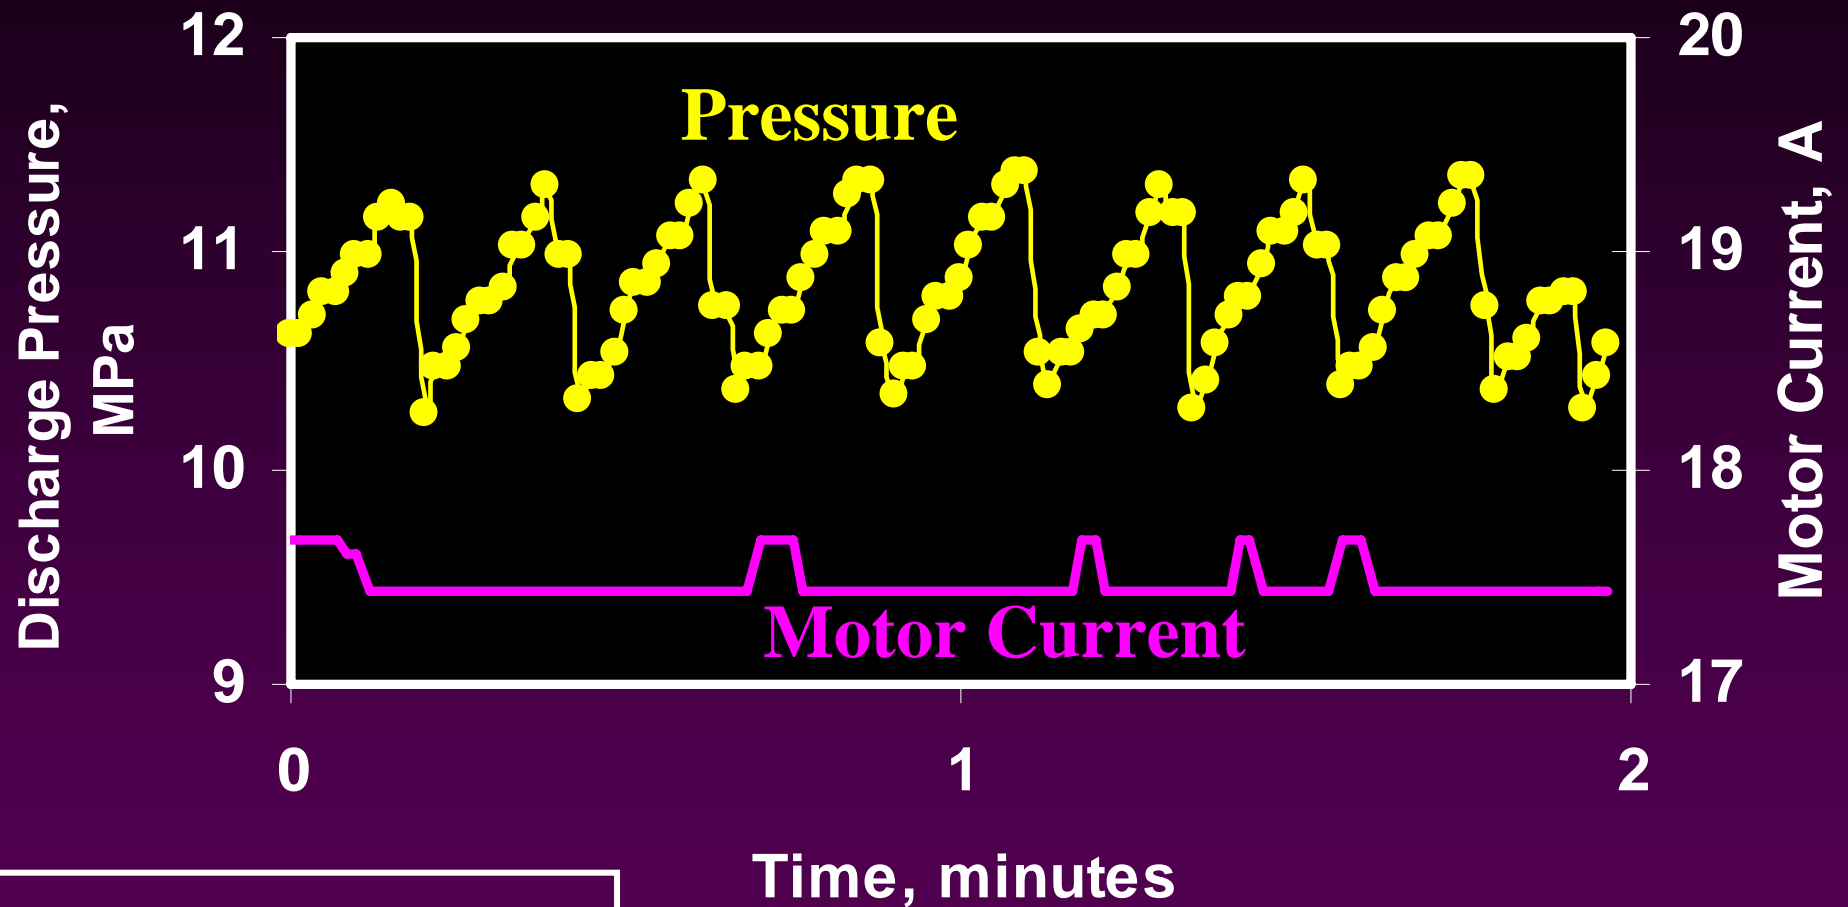
Screw Channel Blockage

Rate estimated at
 53 ± 9 kg/h

- Surges occurred at a frequency of 15 seconds
- Surge was caused by a restriction at the entry to a barrier section
- The introduction of the barrier flight occupied space, limiting the rate and causing the surge

- The entry to an upstream barrier section was determined to be the root cause of the problem

Barrier
flight
removed

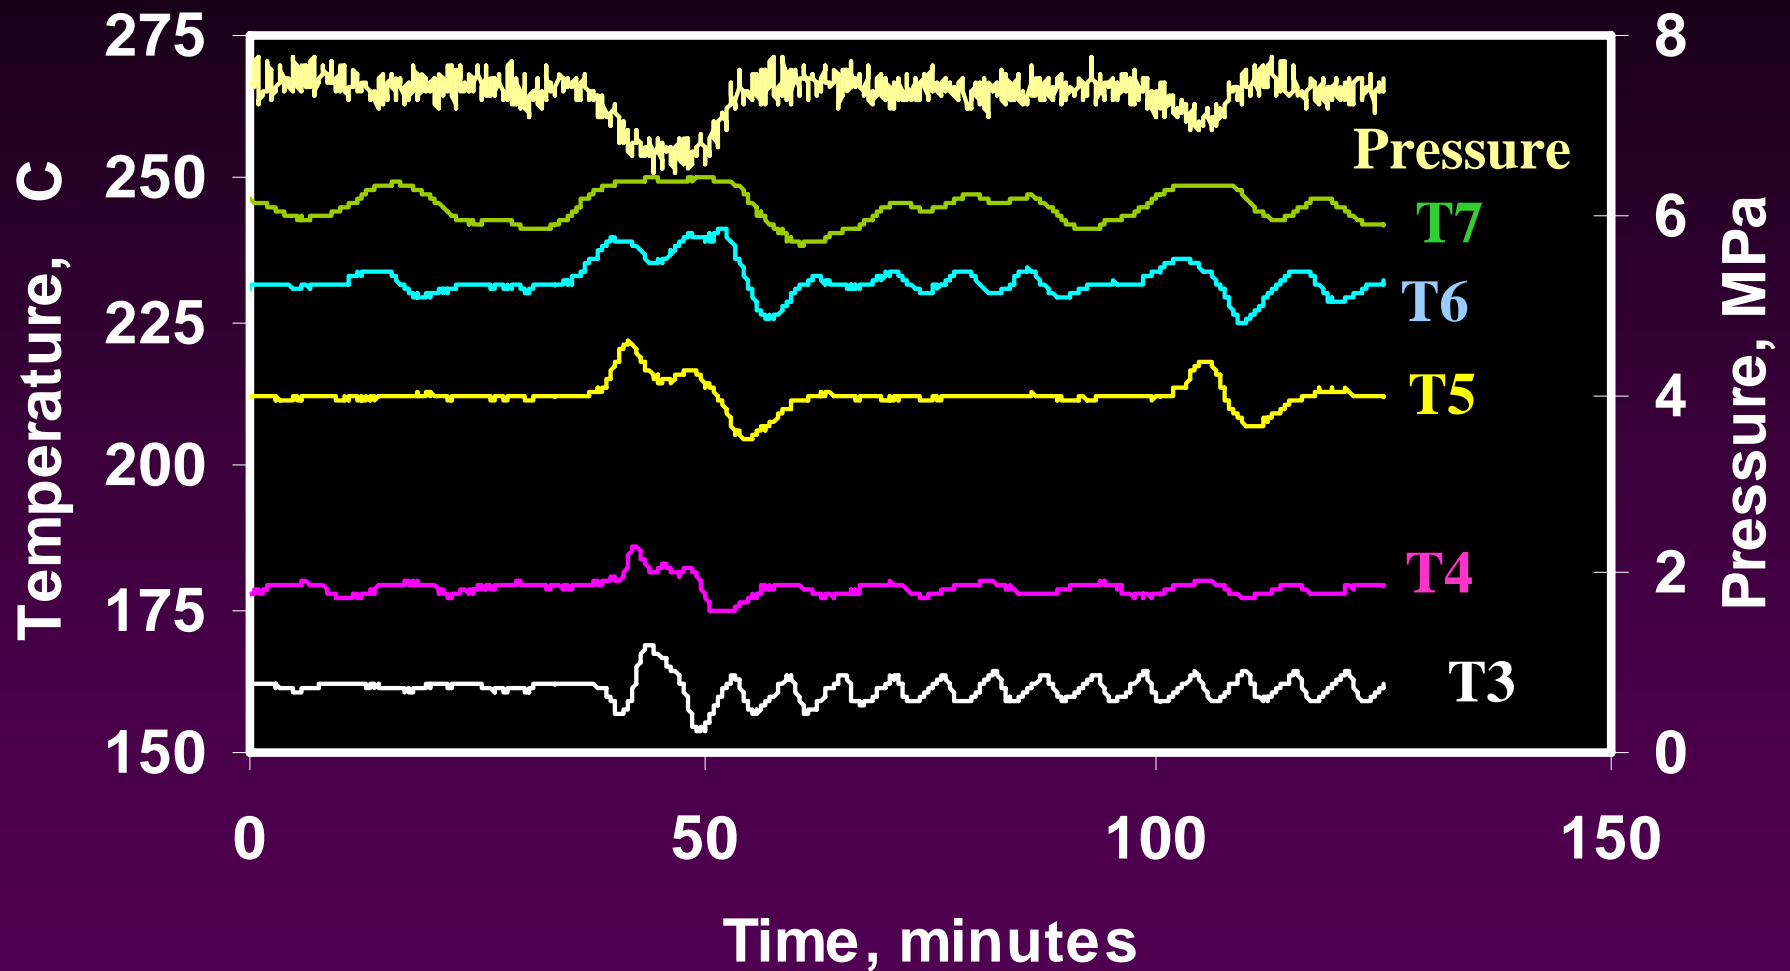
Screw Channel Blockage – ABS Extrusion

Extruder operated stably up to minute 35

- **To eliminate the problem, the spiral dam length was increased from 3.5 diameters to 7 diameters**
- **The entry to the spiral dam was tapered much like that for the barrier section of the small diameter screw**
- **The flow surging problem was eliminated**

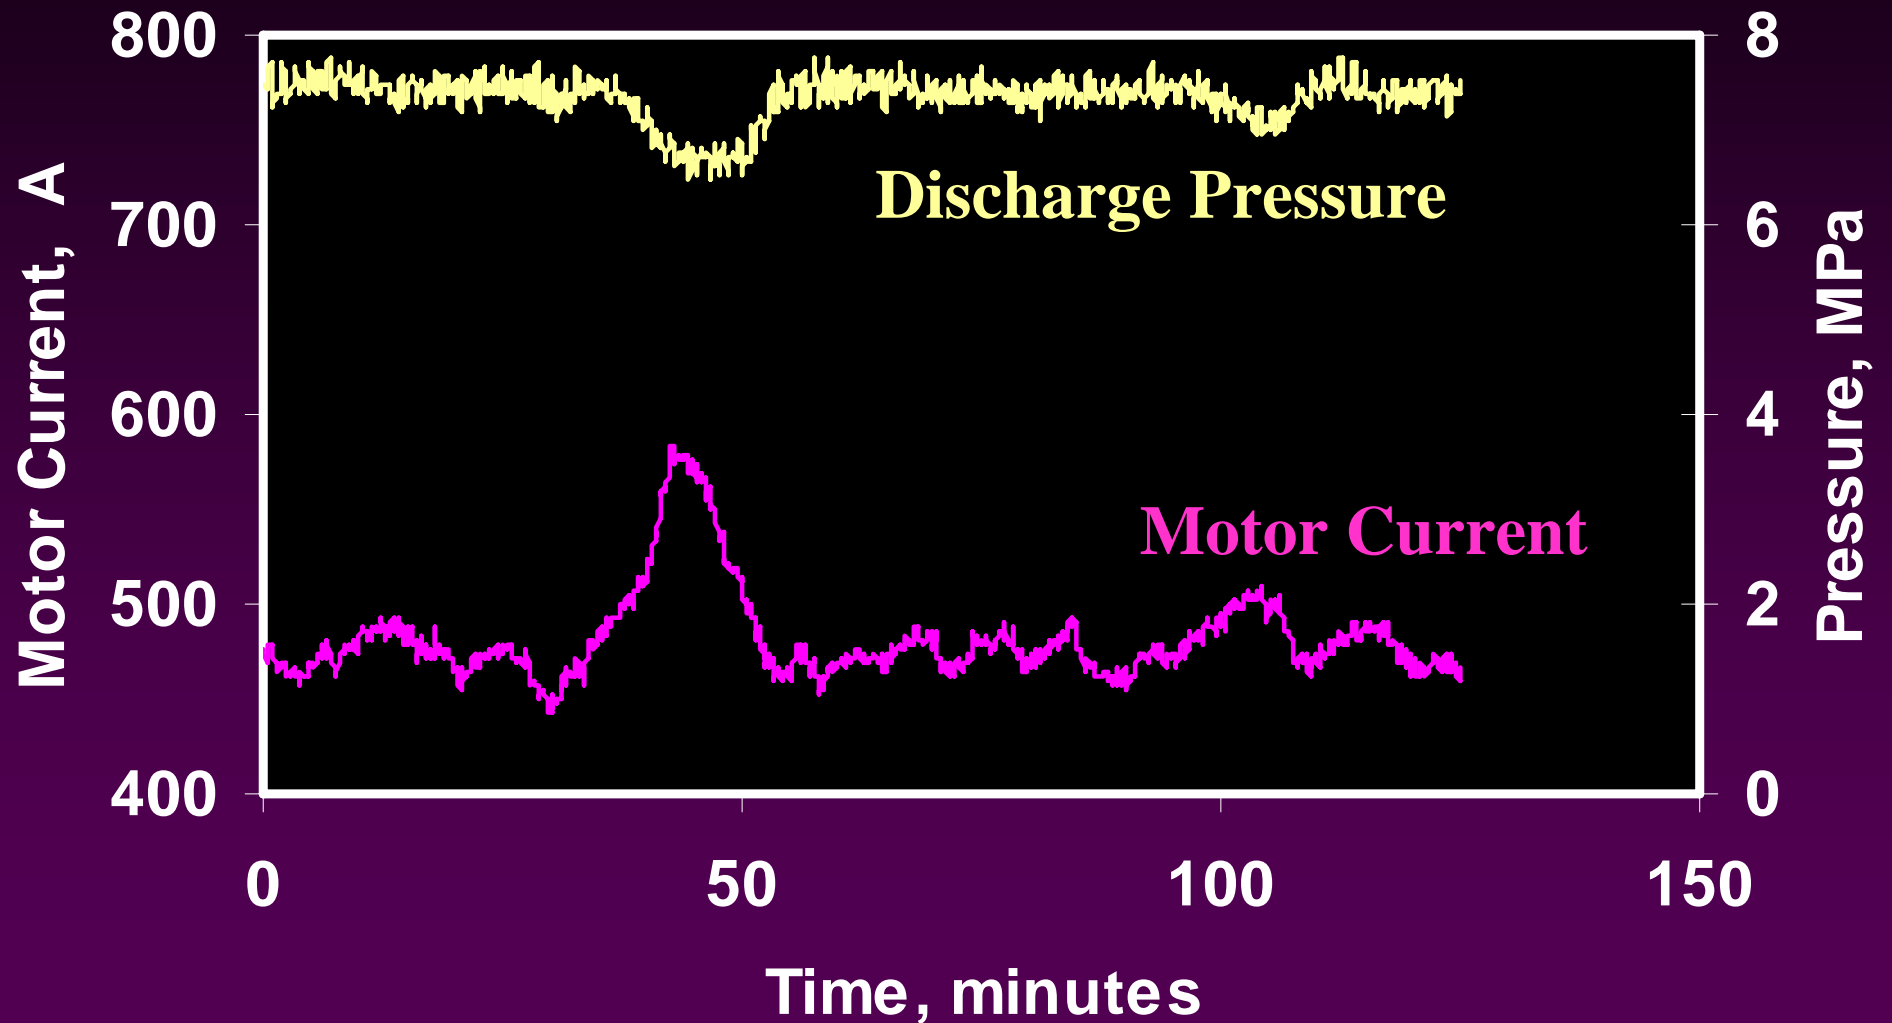
Screw Channel Blockage – ABS Extrusion

- **Screw had a 14 diameter long transition section**
- **A 3.5 diameter long spiral dam was positioned at the end of the transition section**
- **Large solid fragments would occasionally flow downstream and block the channel at the entry to the spiral dam**
- **Discharge pressure would decrease**
