FLOW SURGING IN SINGLE-SCREW, PLASTICATING EXTRUDERS

Mark A. Spalding, Joseph R. Powers, Phillip A. Wagner, and Kun Sup Hyun
The Dow Chemical Company
Midland, MI 48667

*Flow Surging in
Single-Screw, Plasticating
Extruders*

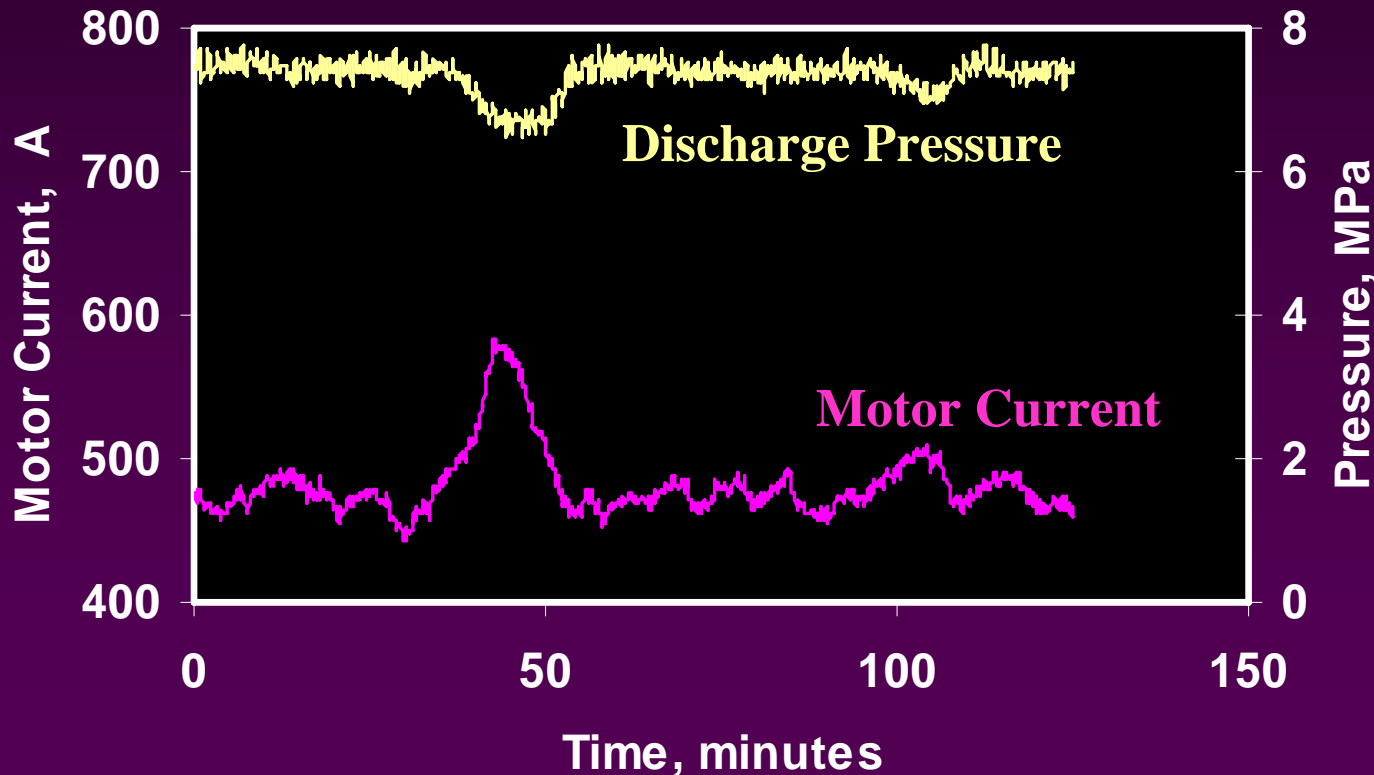
Screw Channel Blockage – ABS Extrusion

- Channel blockage was evident by the decrease in the discharge pressure – reduced rate

- Additional energy was needed to melt the resin at the blockage - increased motor current

- **To eliminate the problem, the spiral dam length was increased from 3.5 diameters to 7 diameters**
- **The entry to the spiral dam was tapered much like that for the barrier section of the small diameter screw**
- **The flow surging problem was eliminated**
